HISTORIC FORT WAYNE MASTER PLAN

DETROIT, MICHIGAN

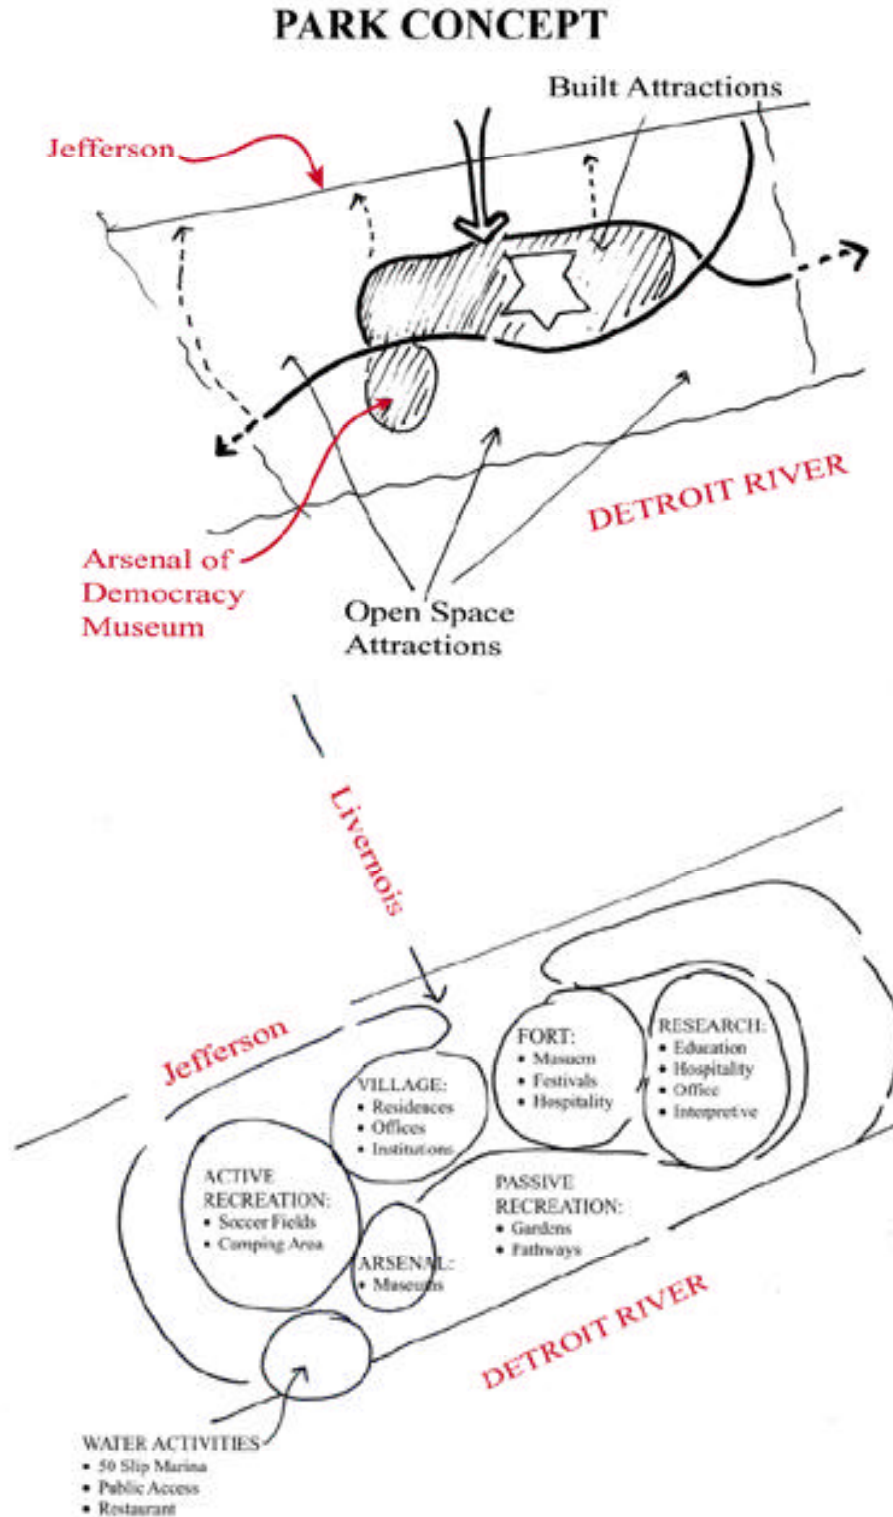
Site Design - The overriding concern for any site design effort was to showcase and enhance the existing historic structures. While there are many recommendations for Fort Wayne, there are three major changes that will significantly improve the Fort's setting. These include:

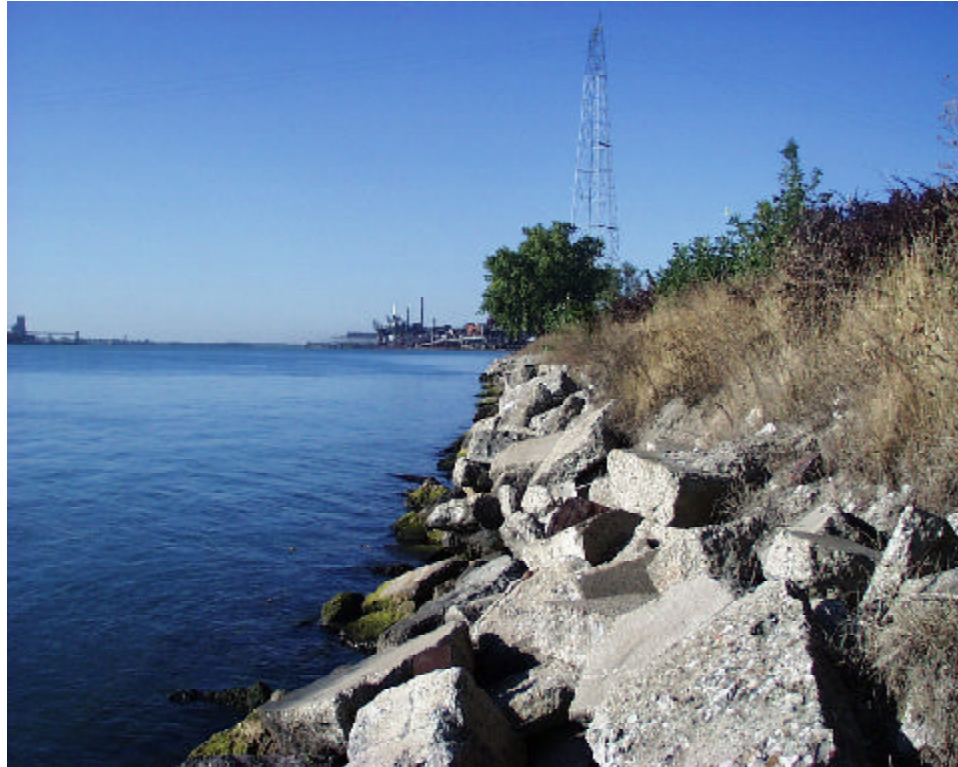
South view of the Detroit River at Historic Fort Wayne.

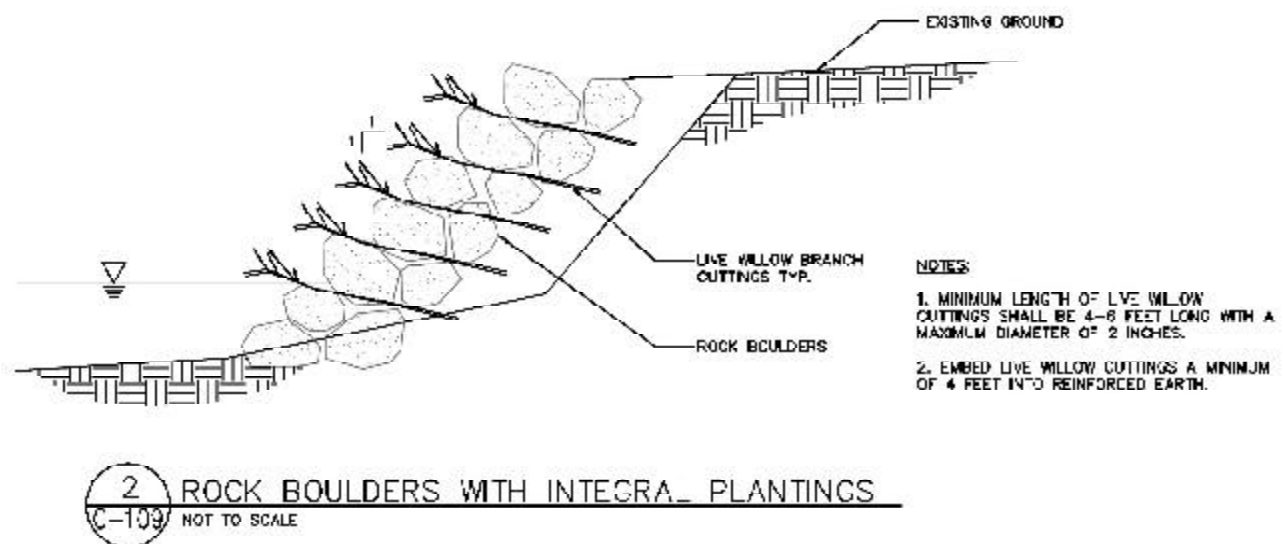
This particular shoreline treatment was chosen for this site based on the following criteria:

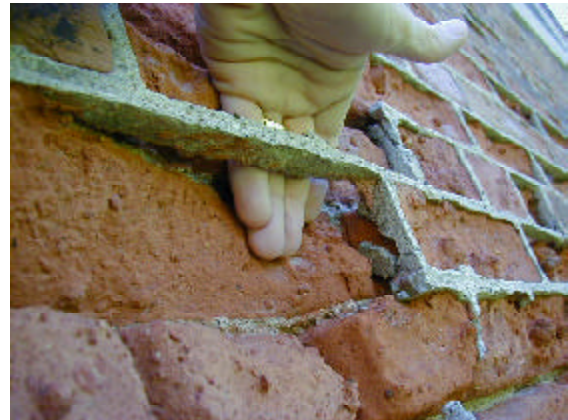
However, portland cement-based mortars are not compatible with soft brick because it is not compressible. Without expansion joints, the rigid portland cement mortars concentrate expansion forces in the adjacent brick, causing the softer brick to crush and spall, while the mortar remains relatively intact. Such deterioration can occur even when portland cement mortars are used for relatively thin repointing applications. Once the spalling occurs, exposing the soft interior of the brick to the weather, the process accelerates, and the deterioration cycle continues. Examples of the results of improper mortar use are most prominently found on the Star Fort west-facing exterior walls.

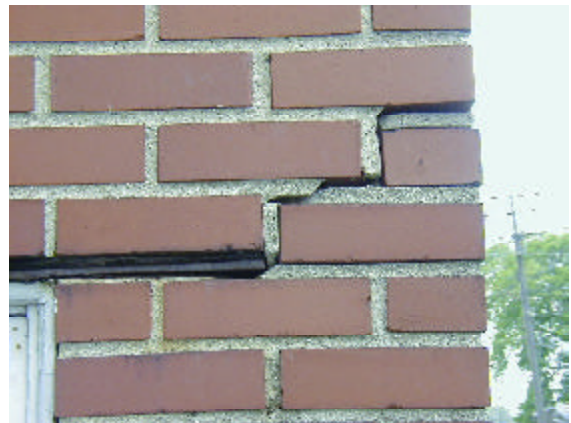
This problem is surprisingly consistent and uniform on new residences constructed in the WPA era: the 1939 construction campaign (buildings 216-219), vestibule additions constructed in the 1930's (front vestibules and sunroom additions at buildings 212-214, rear vestibules at buildings 105-108, and 111-112), and buildings clad with brick veneer in between 1937 and 1939 (buildings 105-109, and 111-112). All of these share the same brick color, mortar and construction detailing, except that additions at buildings 212-214 have a different color brick to match the existing buildings. At the veneered buildings, nearly every lintel suffers from this deterioration and damage. This suggests that some construction detail that was common to the work in that era is

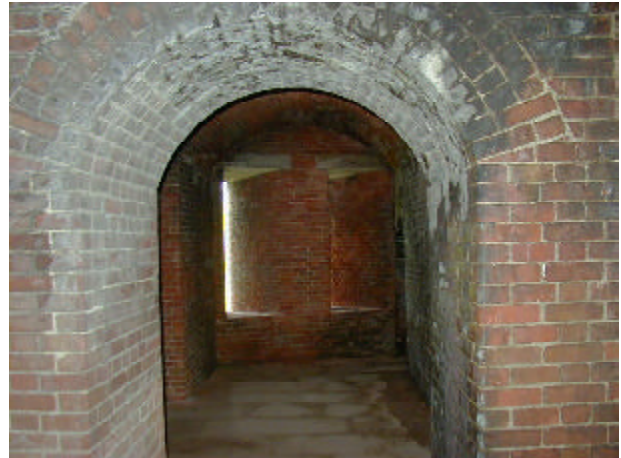
1. Excavate all soil over the vaults, and provide modern waterproofing membrane over the brick, along with a drainage system to move water away from the membrane. This is the most ideal solution, but would be an expensive approach.
2. Excavate to a certain depth and install a drainage field over the area. The goal here would be to intercept as much water as possible, but not all water. This would alleviate moisture penetration due to torrential downpours, and may alleviate, but probably not fully eliminate ongoing soil dampness seeping into the brick vaulting.

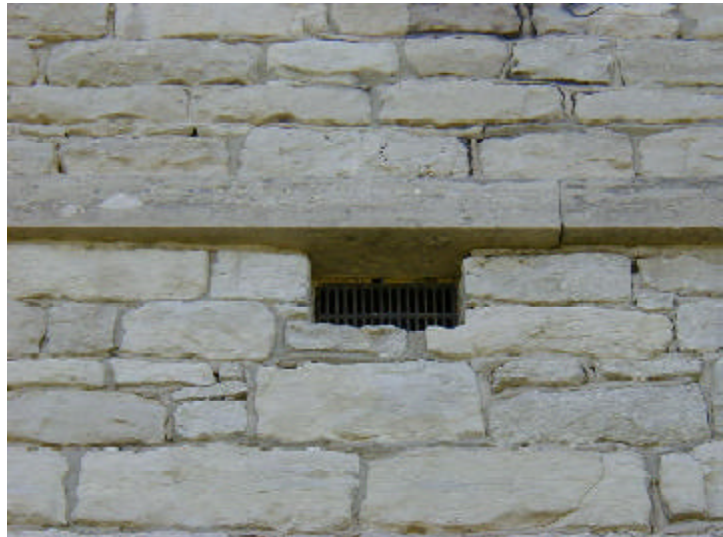
Concerns about the use of high strength modern mortars with soft masonry units are similar, however limestone may have higher compressive strength, and may tolerate somewhat harder mortar than soft bricks. However there is a large variation in types, qualities, and compressive strengths in limestone, and stone quarried in the 19th century, prior to adoption of testing standards for stone, cannot be depended upon to have predictable compressive strengths. In many cases local stone was used for construction simply because it was available, with no knowledge or concern for its compressive strength. It is advisable to test stone for compressive strength to determine if a soft mortar should be utilized. As noted previously, analysis of the original mortar used in the stone masonry should also be tested.

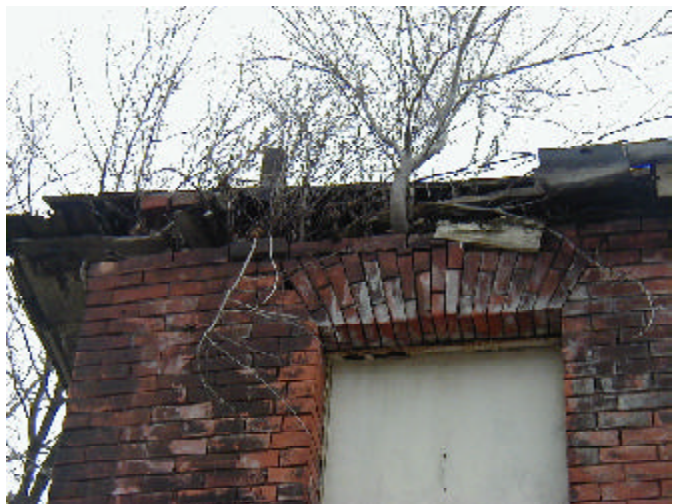
All buildings within the Fort Wayne complex except the Star Fort and Old Barracks have wood trim. Wood trim consists of flat boards and molded trim such as crown moldings found on most all fascia. Some trim includes wood dentils, and smaller ornamental moldings. Wood trim is in generally fair condition, suffering universally from neglect and lack of paint. At locations where roof leaks at soffits are

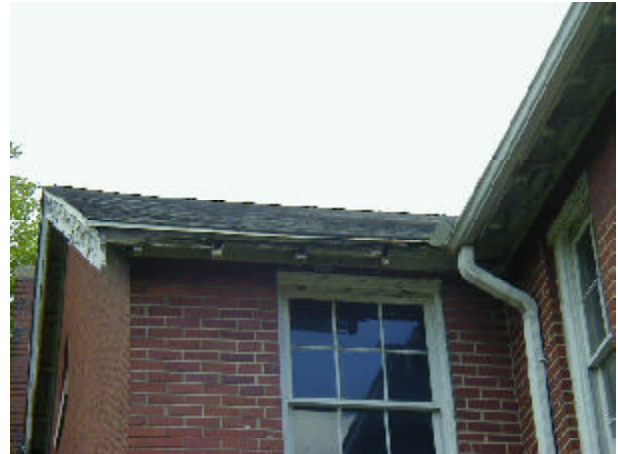
Where total gutter replacement is required, replacements should be half round, with round corrugated leaders. Further research of historic photographs should be conducted to determine if original components were galvanized steel or copper. Buildings should be examined for evidence (holes, silhouettes of brackets) of original leader locations. When roof and gutter replacement is recommended, both should be undertaken at the same time.

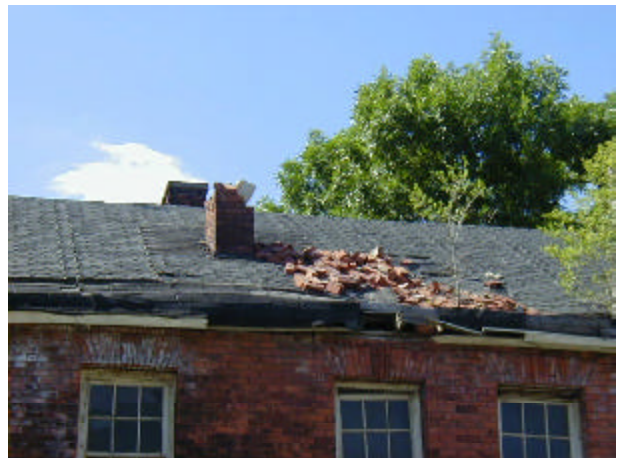
This report recommends asphalt shingles as replacement roofing on sloped roofs. Although not original, it is considered to be compatible with the character of the buildings, does not detract from the overall character of the buildings, and is consistent with the Secretary of the Interior's Standards for Rehabilitation. It may be considered to be a long-term goal to provide historically authentic roofing on the Old Barracks, which is intended to receive more historically faithful treatment than other buildings. It is possible, but not certain that the original roof on the Old Barracks was wood shingles, however this should be verified by research into photo-

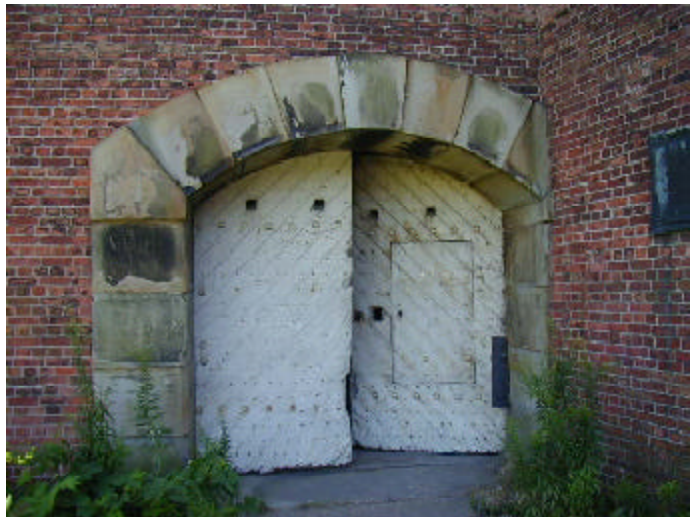
Metal doors fail in the following ways:

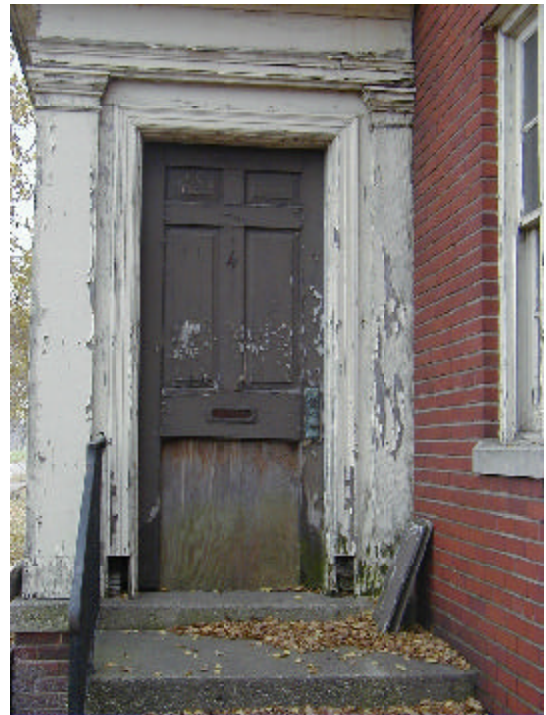
Refer to the "Paint" section below for additional information related to finishing doors.

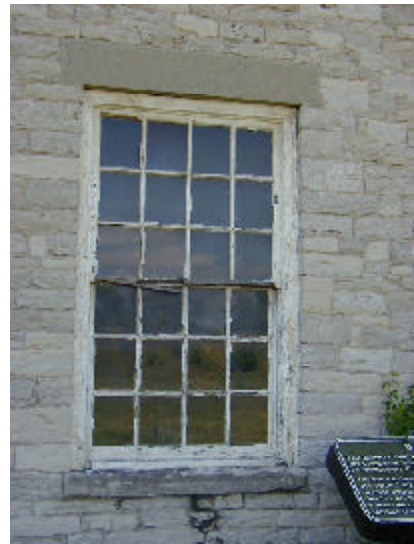
It should be noted that while windows play a role in a building's comfort and thermal performance, their replacement with modern insulating glass windows seldom returns energy savings that will pay back the cost of replacement in a reasonable number of years. Measures such as addition of insulation in attics, and upgrading of inefficient mechanical equipment offer far greater energy cost savings than window replacement. Weatherstrip and storm window installation are more cost effective energy saving treatments for windows.

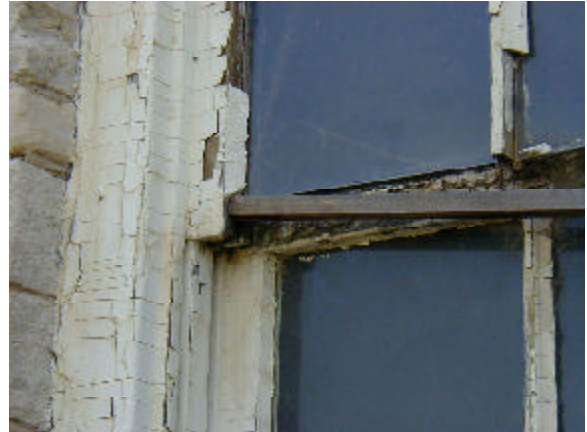
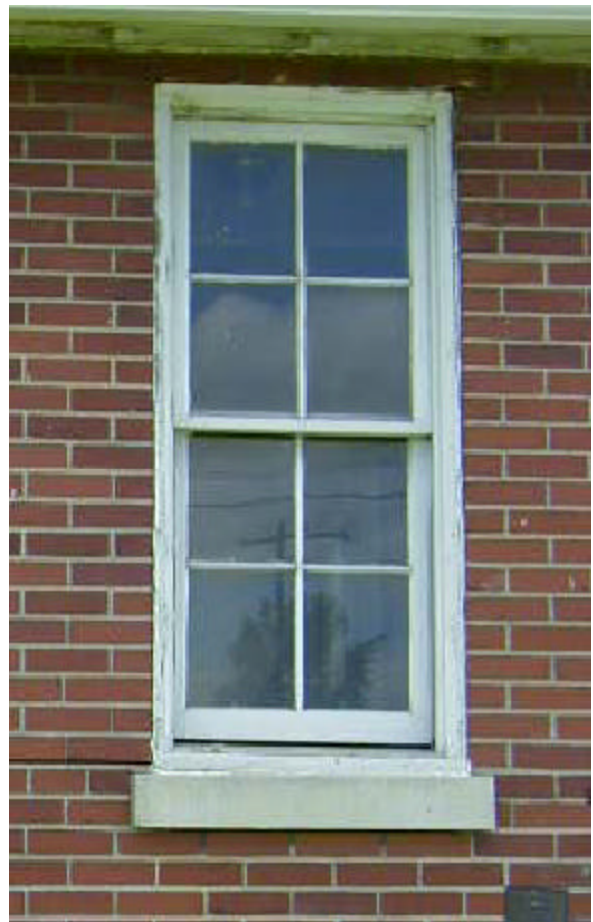
A typical repair package for an existing 1950's era replacement found in many of the residential buildings would be similar to that described above, except that installation of new sash cords is not necessary, and stripping of paint is likely not required.

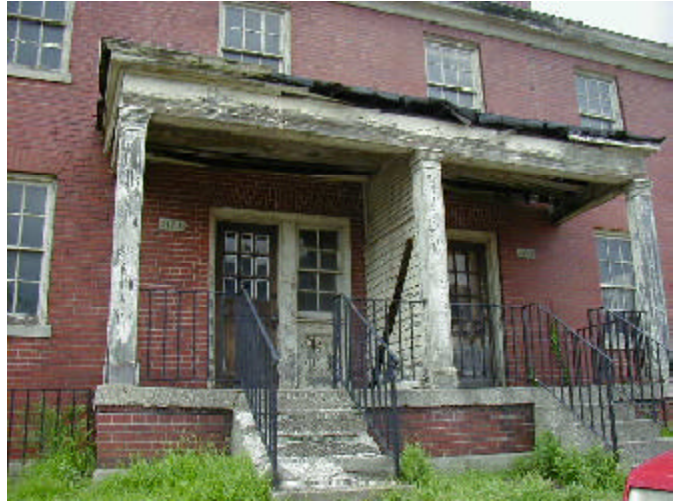
Since most porches are constructed of brick masonry and wood, treatment recommendations found elsewhere in this section address those materials. Other materials not found there are addressed here.

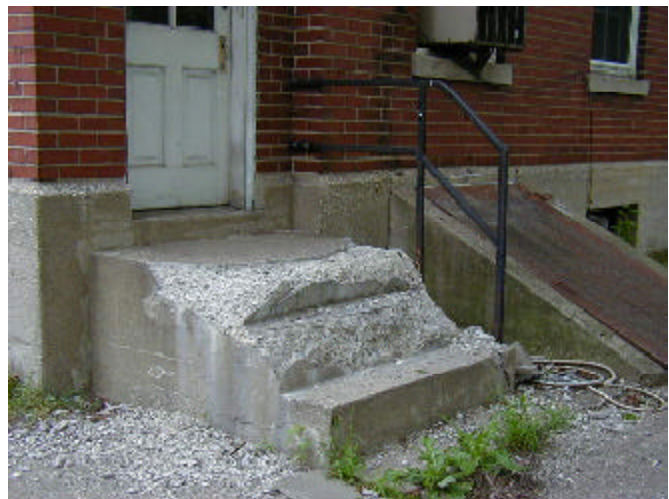
Where concrete has crumbled, each element should

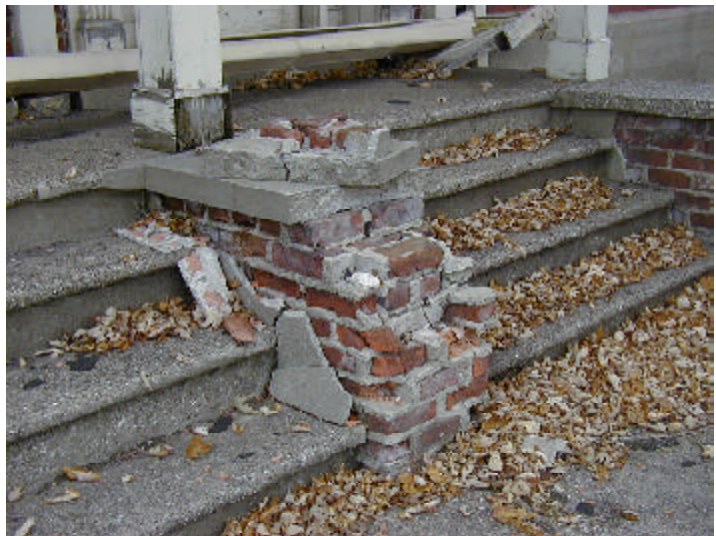
Porches on buildings 105 through 112 have stuccoed brick porch bases. The brick substrate on many of those is badly deteriorated. Substrates should be repaired or rebuilt using materials matching the original. New stucco should be applied using galvanized metal lath, and should be held away from the ground to prevent contact with moist soil.

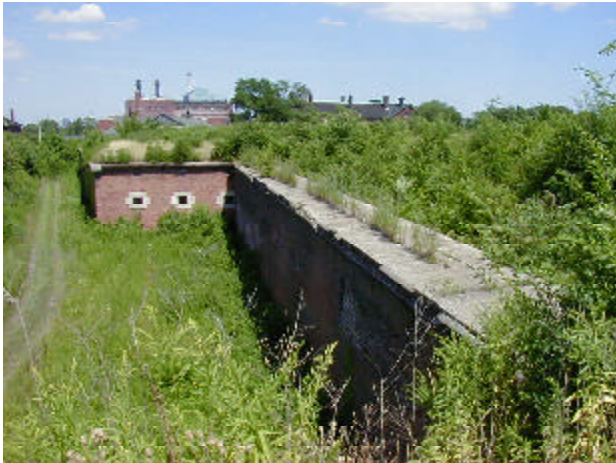
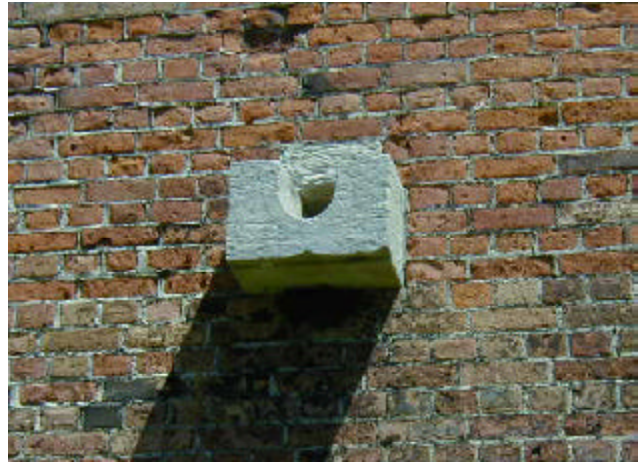
constructed without any waterproofing system on surfaces that are in contact with the retained earth berms. Although there is a drainage system associated with the trenches (scuppers are located at various points along their length), it is not known if these are still functional. It is not known if there is any drainage system to carry water away from the center of the fort.

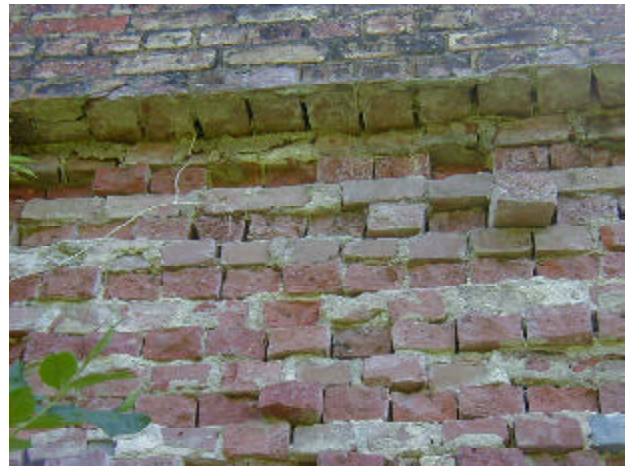
- 1 Trenches. The most severe deterioration corresponds with location of the trenches behind the walls. It is likely that the drainage scuppers serving these trenches are blocked, and that drainage tiles (if they even exist) are damaged, clogged or inadequate. It is clear that this condition has collected water and concentrated it along walls for decades.
- 2 Wall Caps. The concrete wall caps on top of the massive brick masonry walls are severely cracked in many places. They appear to have been built with no expansion joints, and no through-wall flashing. This condition provides many openings for moisture to enter directly into the wall. In addition, the edge details of the caps lack drips, and are very deteriorated and porous. This condition provides an entry point for moisture at a point where there is very vulnerable brick corbelling immediately below.

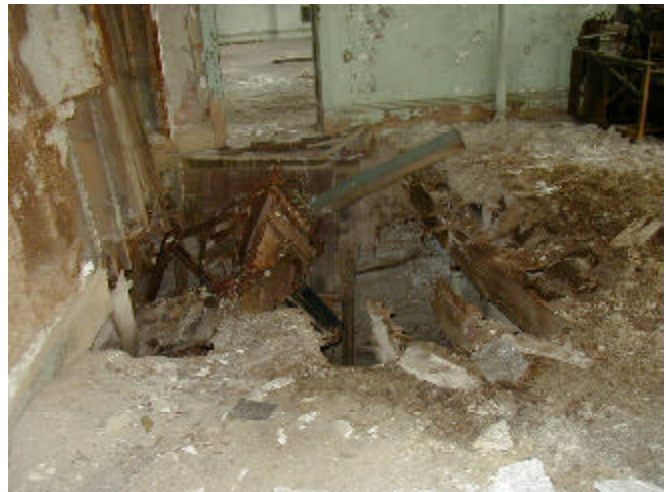
It should be noted that structural analysis of wood floor load capacities is based on visual observations of joist sizes and spacing where possible. In many cases, joists were not readily observable and size and spacing could not be measured. In those cases, sizes and spacing have been estimated based on floor thickness, and assumed spacing.

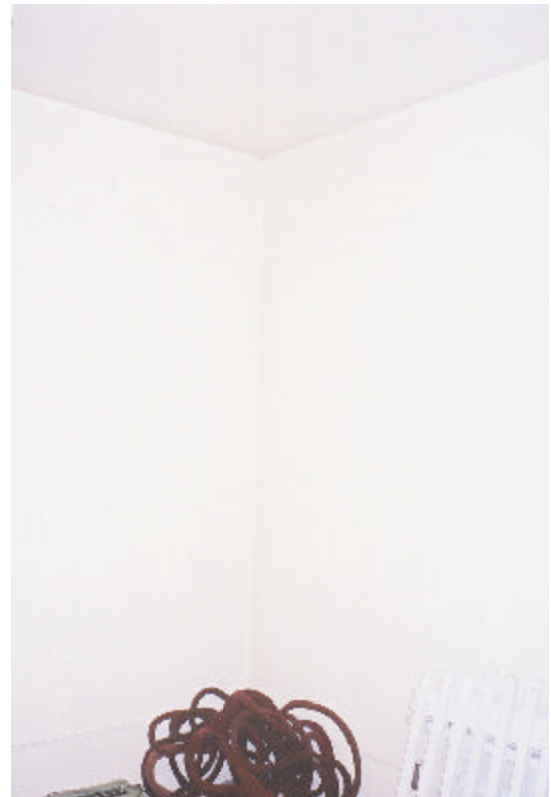
Plaster in Good Condition

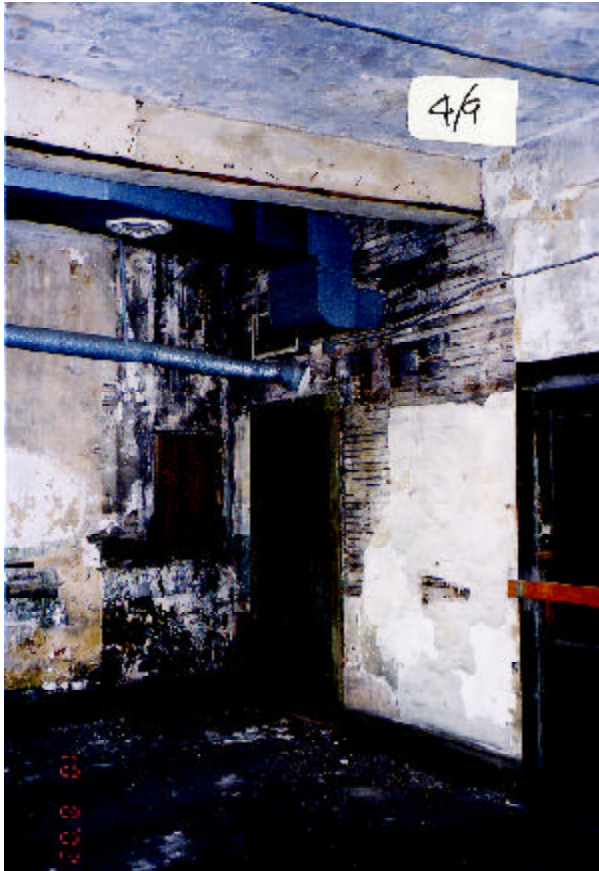
Deteriorated Plaster on Wood Lath

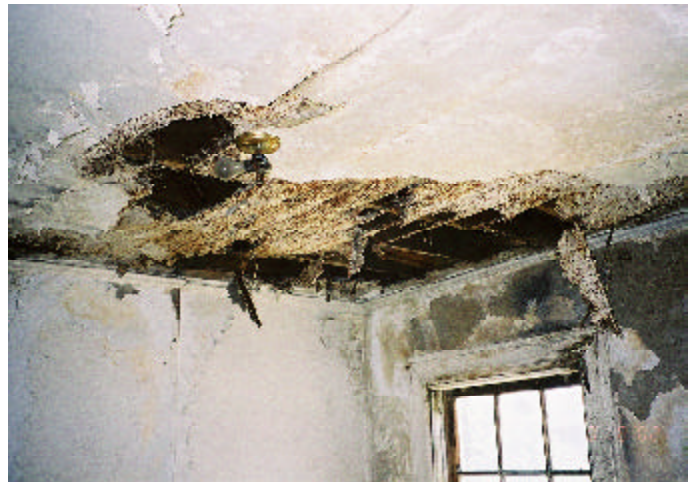
Extensive Deterioration and Collapse

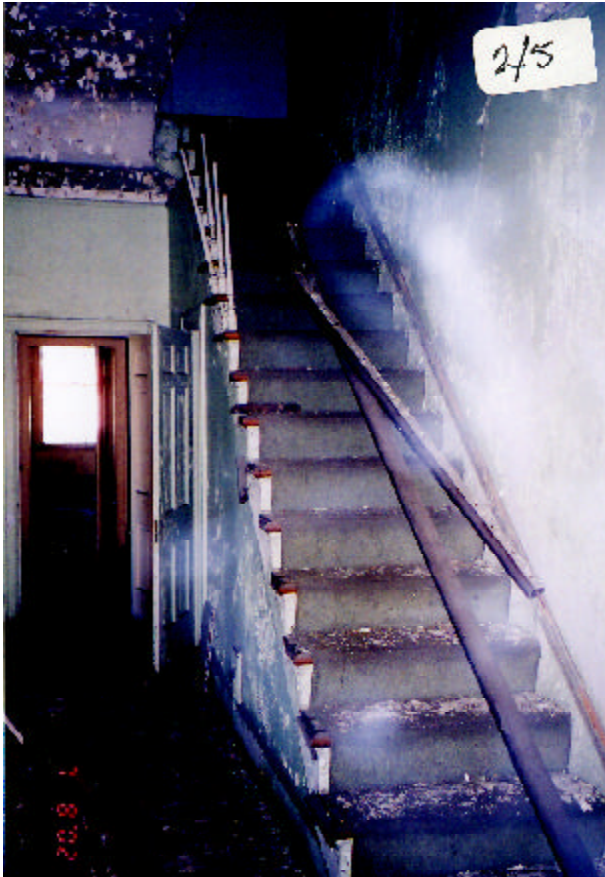
Entire Railing Missing

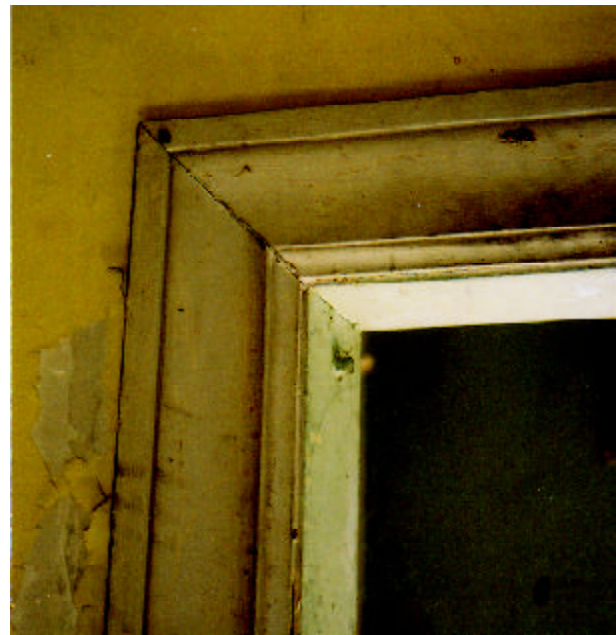
1930's Remodeled Door Casing

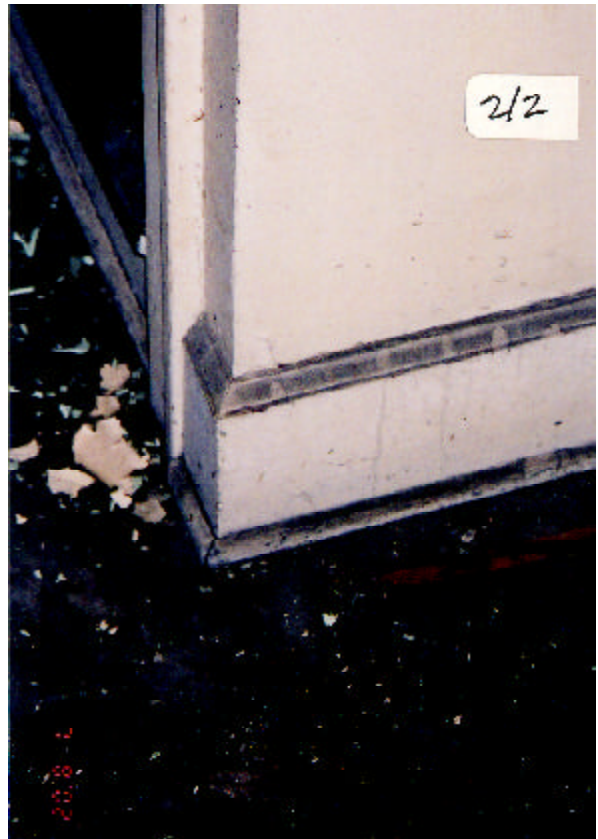
All other painted surfaces should be cleaned and repainted with two coats. Surfaces on which existing surfaces are not damaged do not need to have existing paint removed. On surfaces that have extensive peeling paint or the paint surface is friable, existing finish material must be totally removed. Note: This may contain lead and a specialty, hazardous materials abatement contractor may need to be retained to undertake removal.

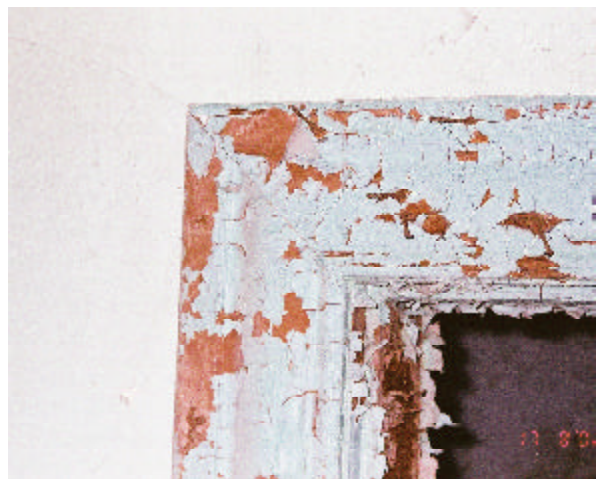
Damaged Paint Finish

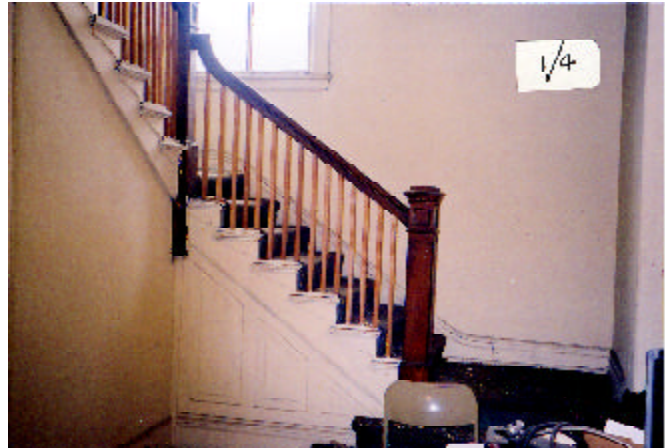
Stained Front Stair Railing

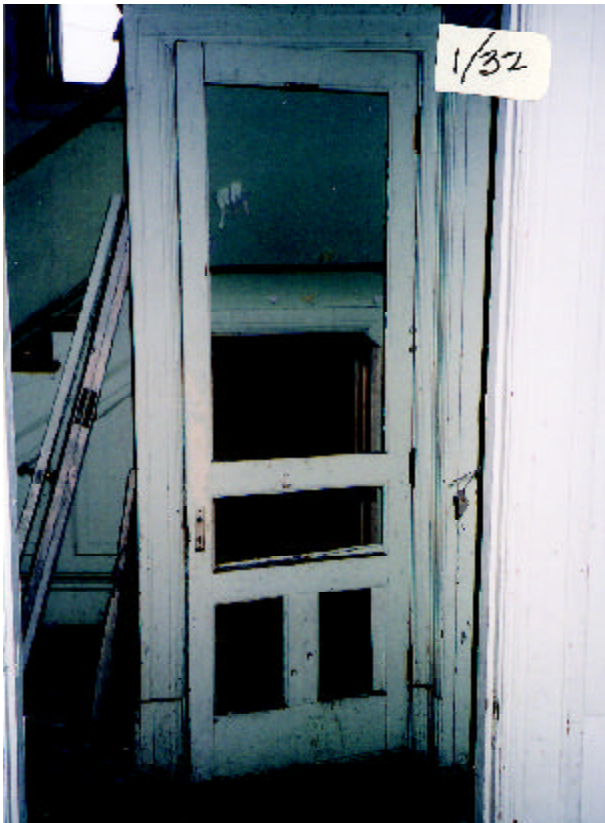
Damaged Five Panel Door
(panels missing)

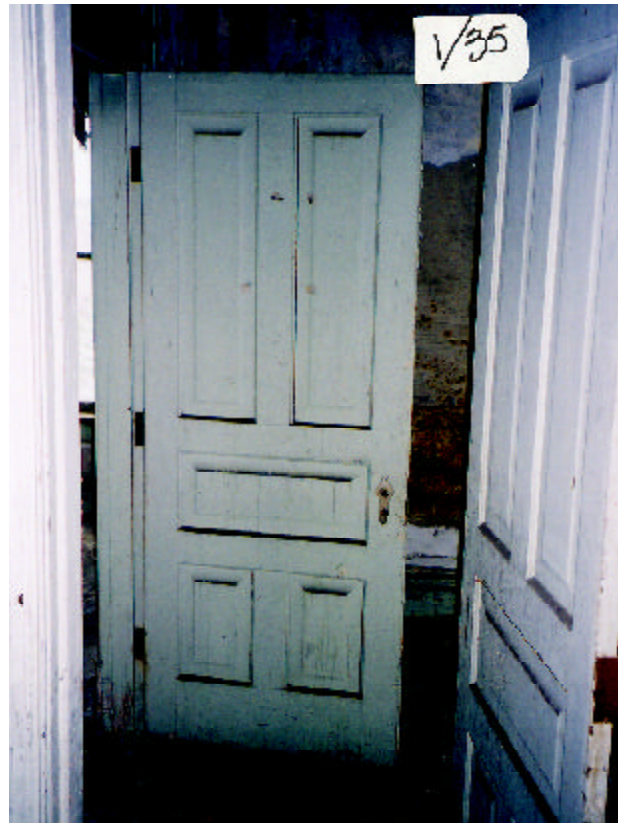
Intact Five Paneled Door
(hardware missing)

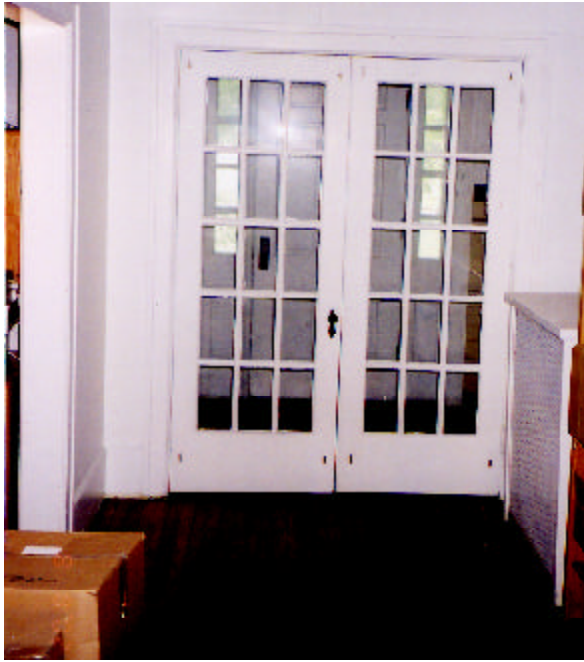
Intact 15 Lite Glazed Doors

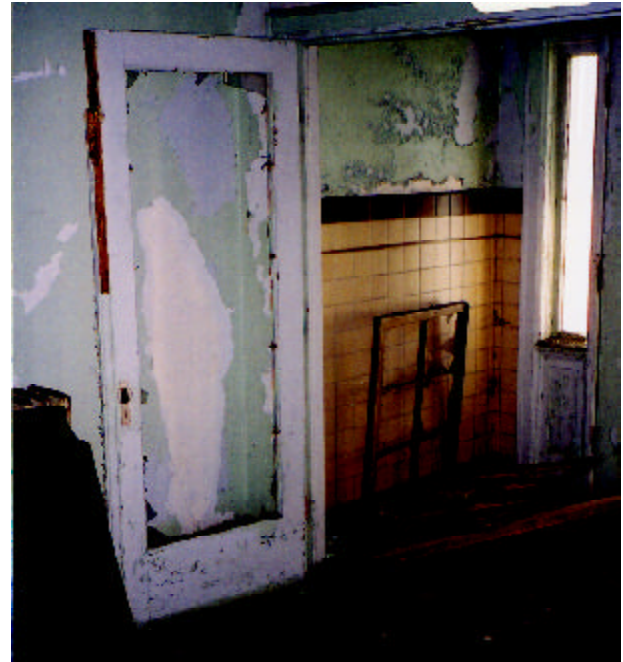
Damaged 15 Lite Glazed Door

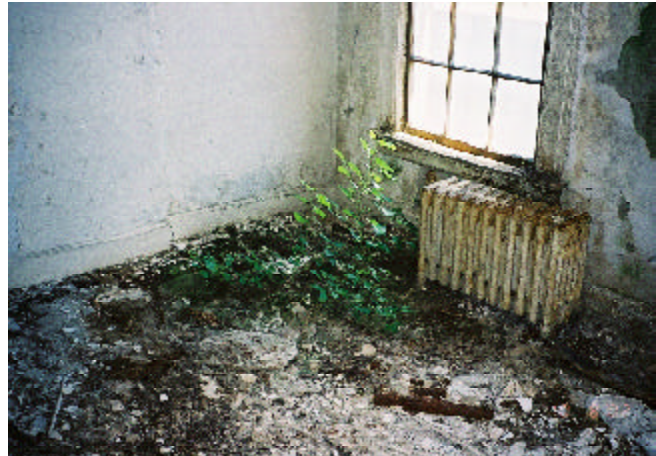
Bathrooms and rest rooms throughout the fort appear to have been remodeled in the 1930's or later. Most floor are ceramic

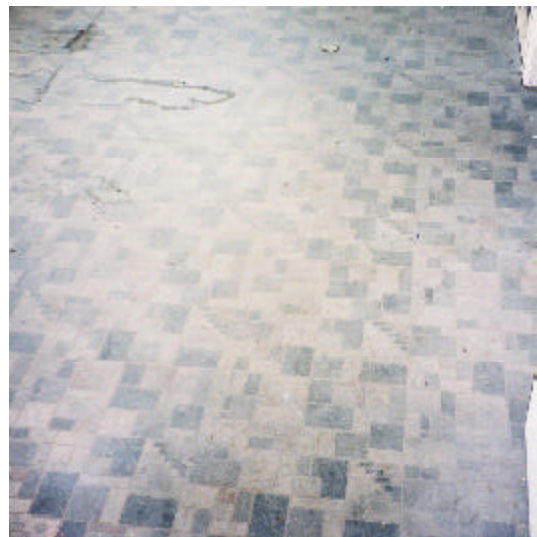
Wood Floor Adjacent to Asphalt Tile

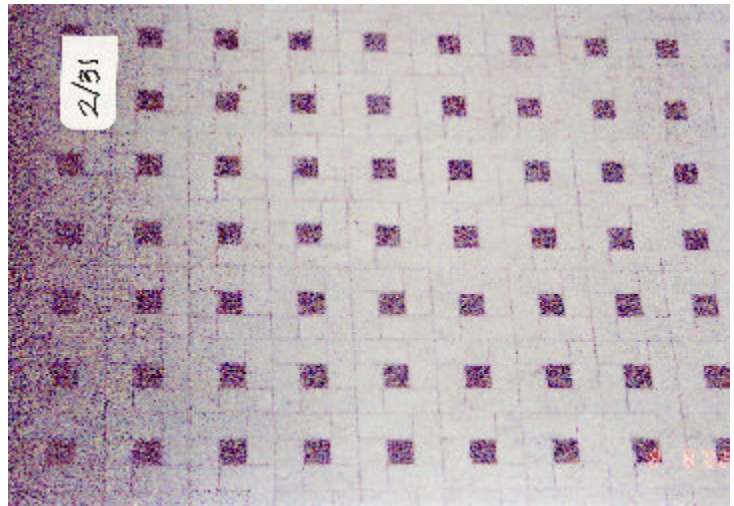
Bathroom Ceramic Tile Floor

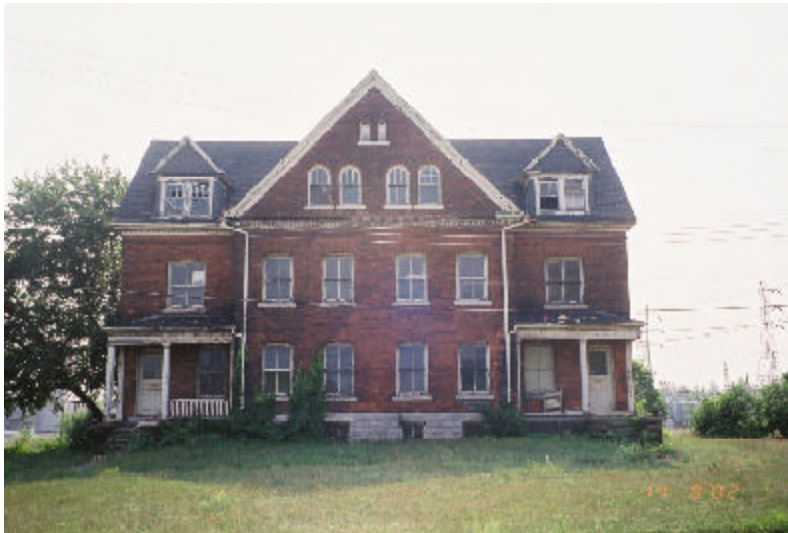
BUILDING 102 A / B
OFFICER'S QUARTERS

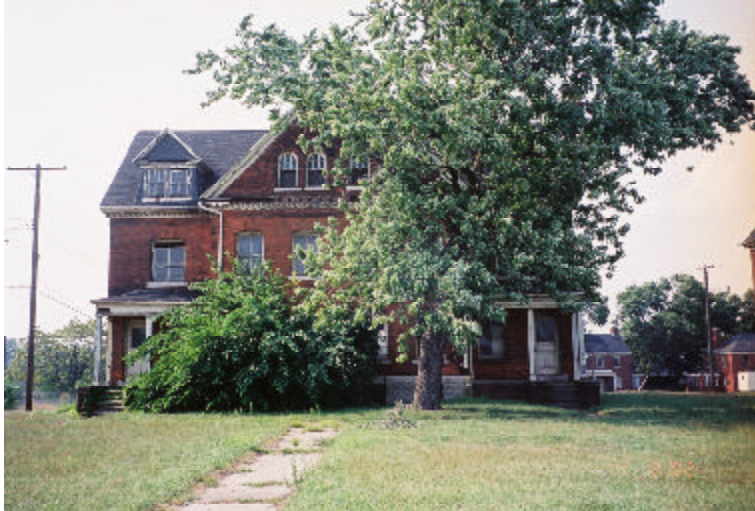
BUILDING 103 A / B
OFFICER'S QUARTERS

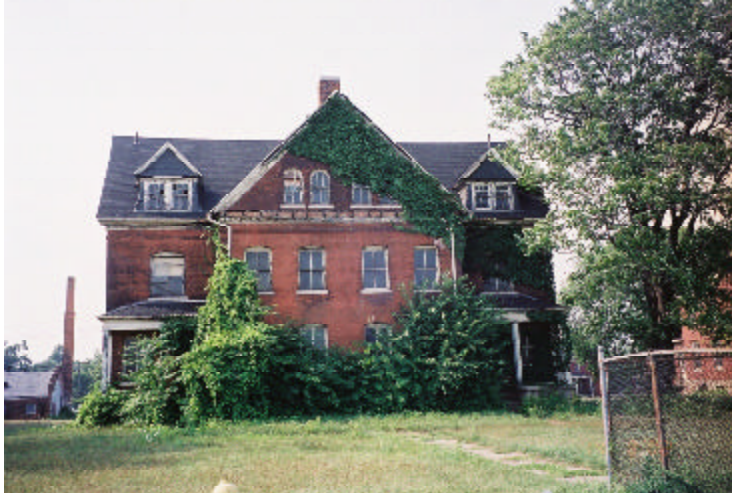
BUILDING 104 A / B
OFFICER'S QUARTERS

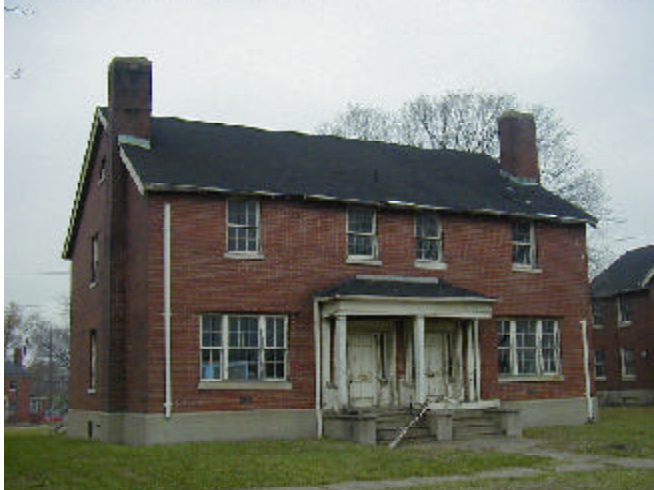
BUILDING 105 A / B
OFFICER'S QUARTERS

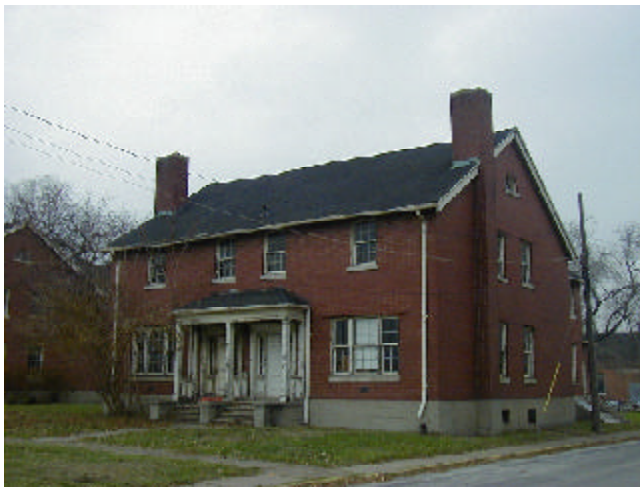
BUILDING 107 A / B
OFFICER'S QUARTERS

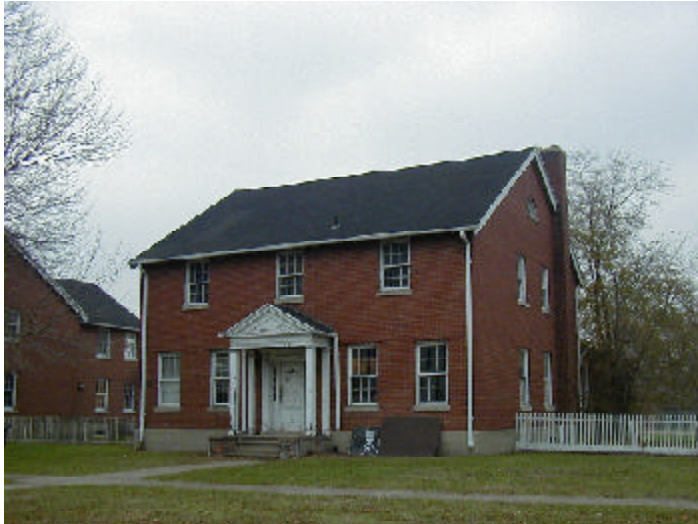
BUILDING 109 A / B
OFFICER'S QUARTERS

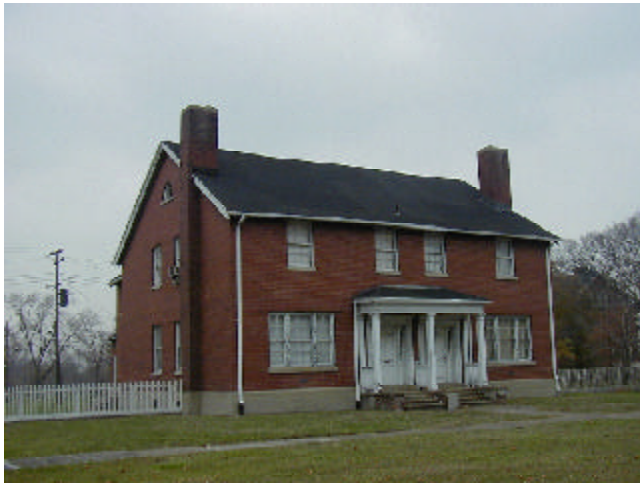
Replace existing overhead electrical distribution with new underground service. Undertake further investigation to determine if new electrical substation is required.

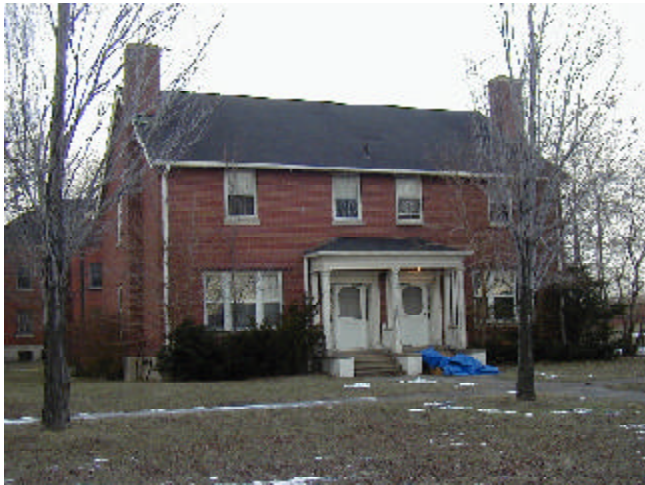
BUILDING 112 A / B
OFFICER'S QUARTERS

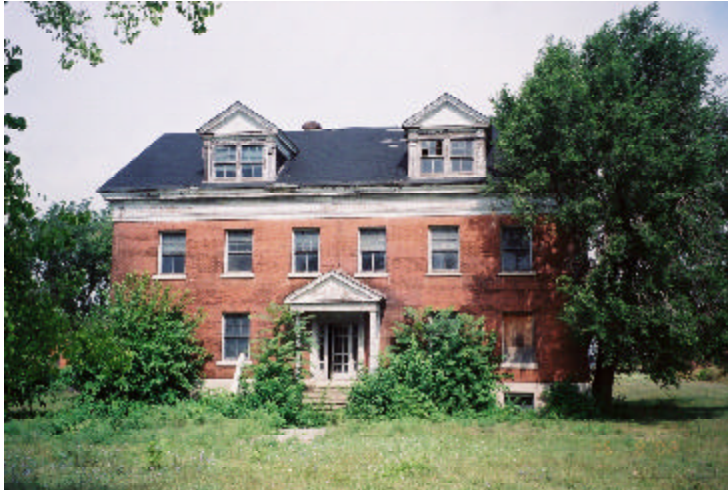
BUILDING 114
OFFICER'S QUARTERS

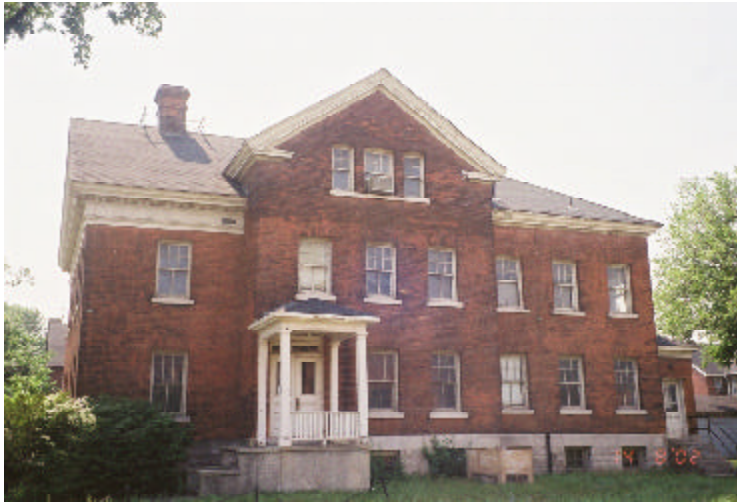
**BUILDING 117****OFFICER'S QUARTERS**

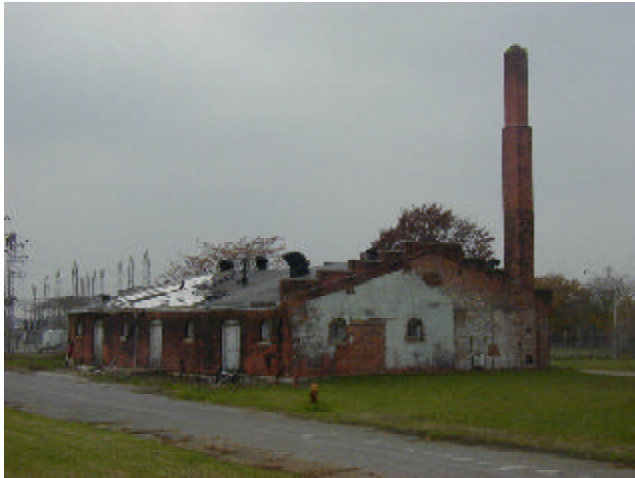
BUILDING 201
MAINTENANCE

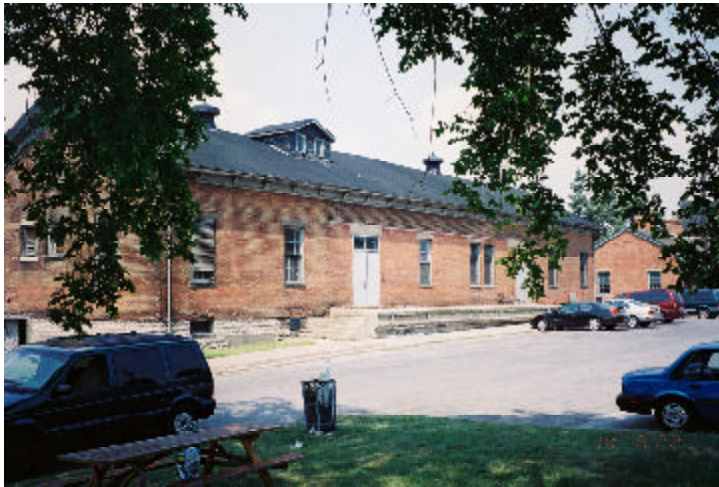
Replace existing overhead electrical distribution with new underground service. Undertake further investigation to determine if new electrical substation is required.

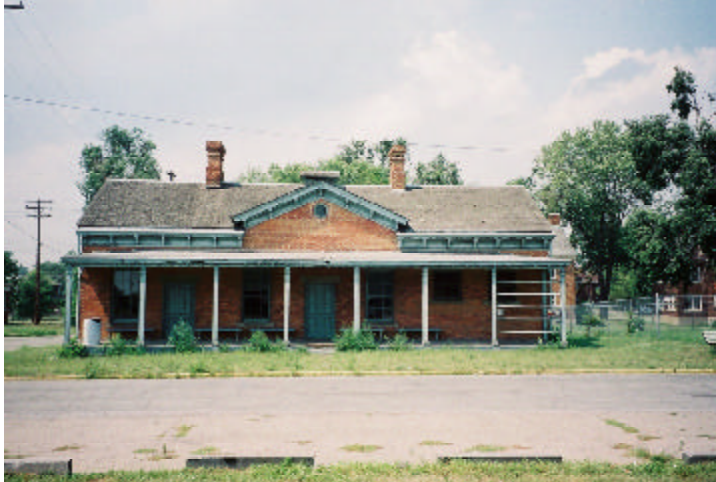
**BUILDING 205****“OLD” GUARDHOUSE**

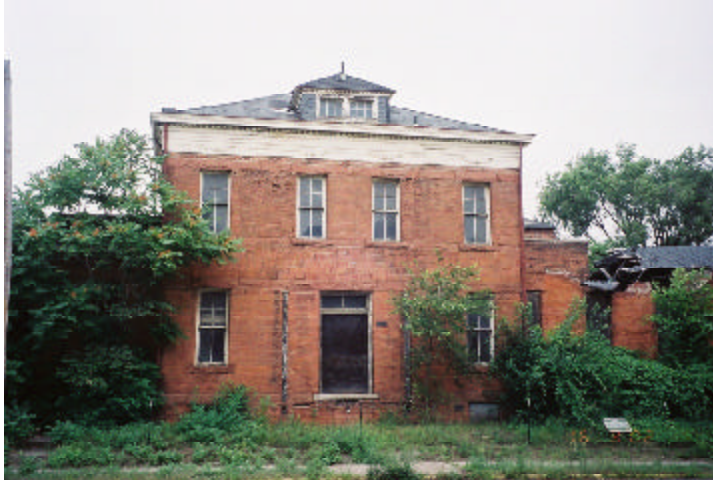
Replace existing overhead electrical distribution with new underground service. Undertake further investigation to determine if new electrical substation is required.
