HISTORIC FORT WAYNE MASTER PLAN

DETROIT, MICHIGAN

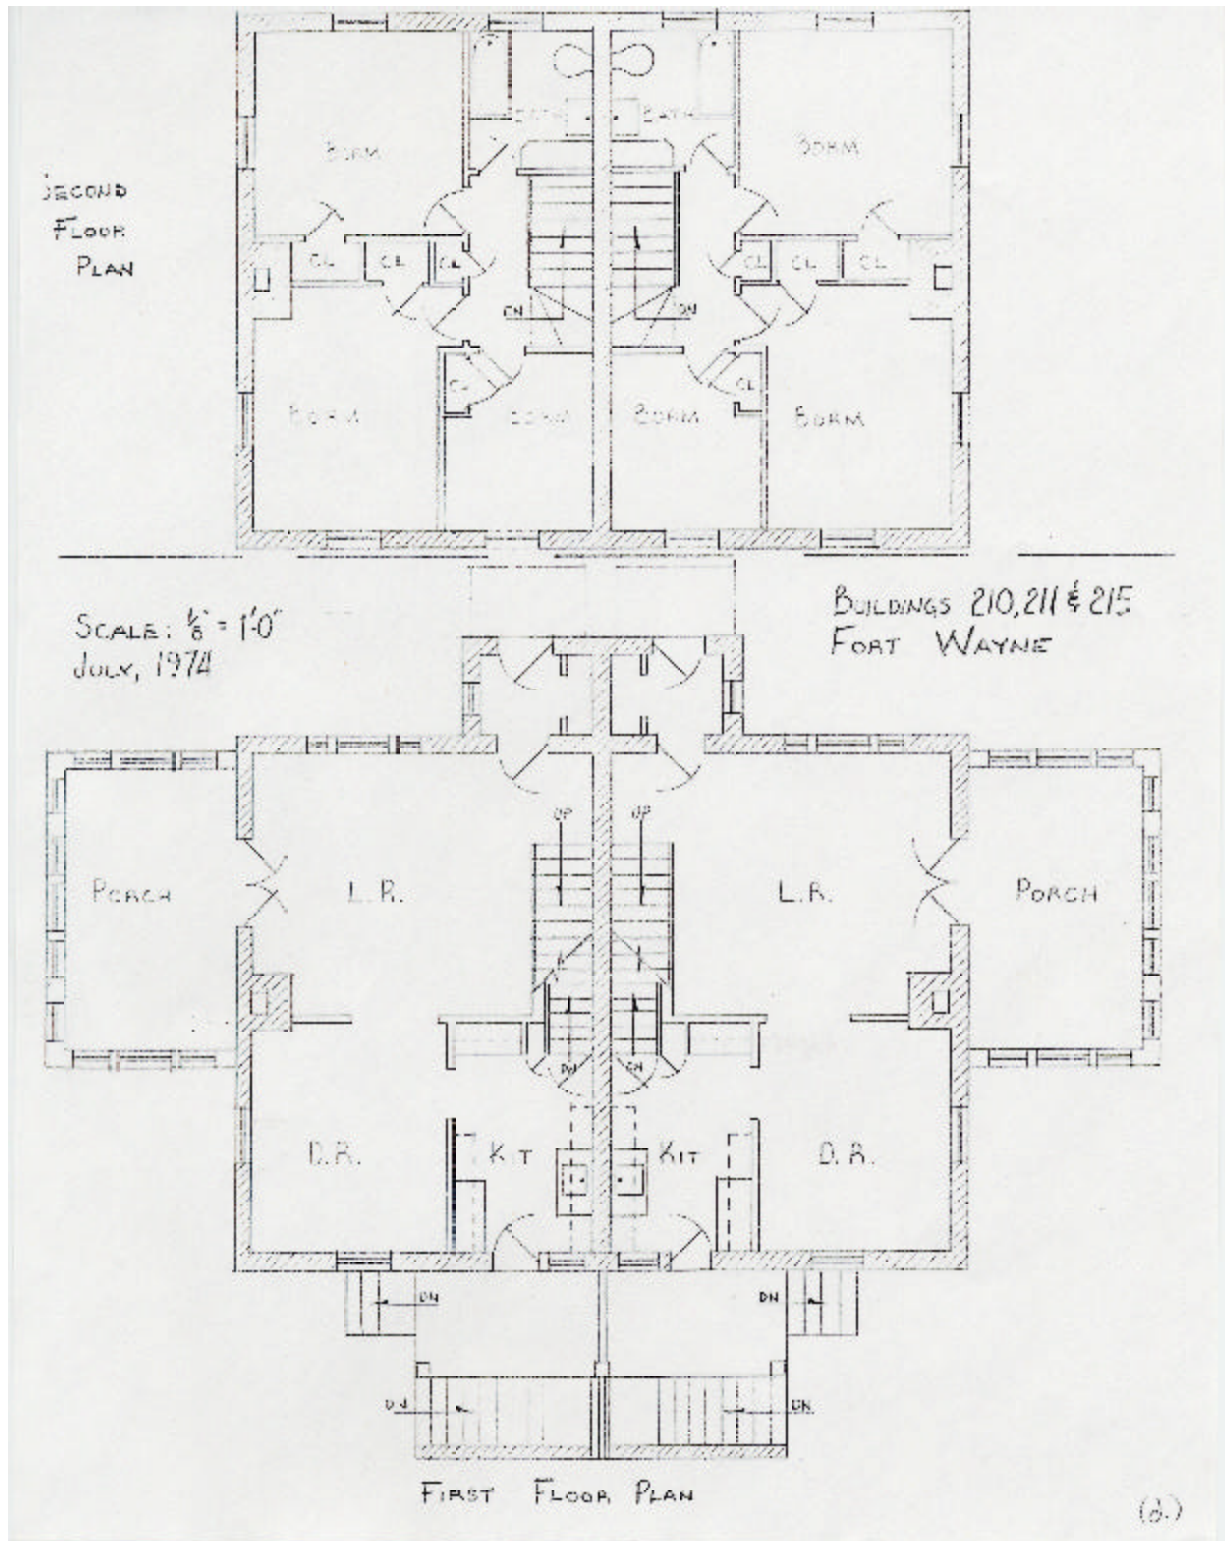
This duplex NCO building is two stories with basement. Original side porches for each unit have been removed but double entrance door openings still exist and are nailed shut with plywood. Each unit's first floor consists of a living room, dining room, and kitchen plus an enclosed front entrance vestibule. The stair to the second floor is open to the living room. Second floors contain a stair hall, three bedrooms, and a three-piece bathroom. The two main floor levels have original fully plastered walls and ceilings. Floors are wood with some carpet. The kitchen floor is covered with linoleum. The bathroom has plastered walls and ceramic tile wainscot and floor that is different in color and size than the typical green/black remodeling tile of 1935-39. It is therefore felt to be original to the 1931 construction date.

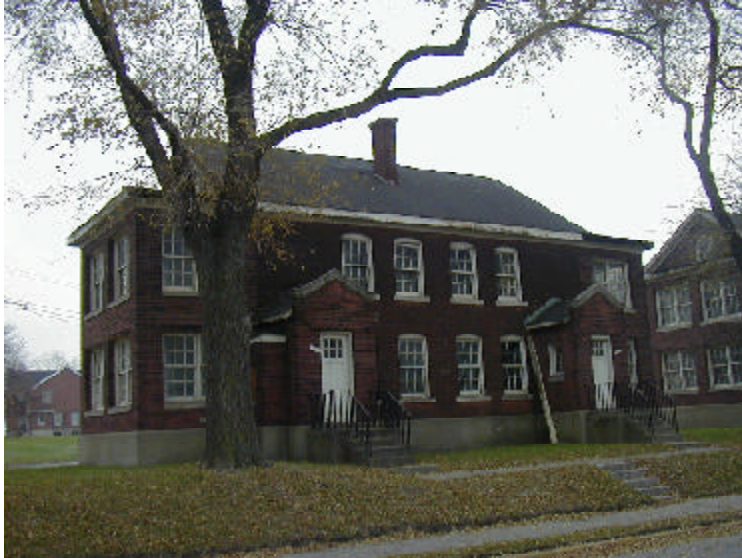
BUILDING 212A / B
NCO QUARTERS

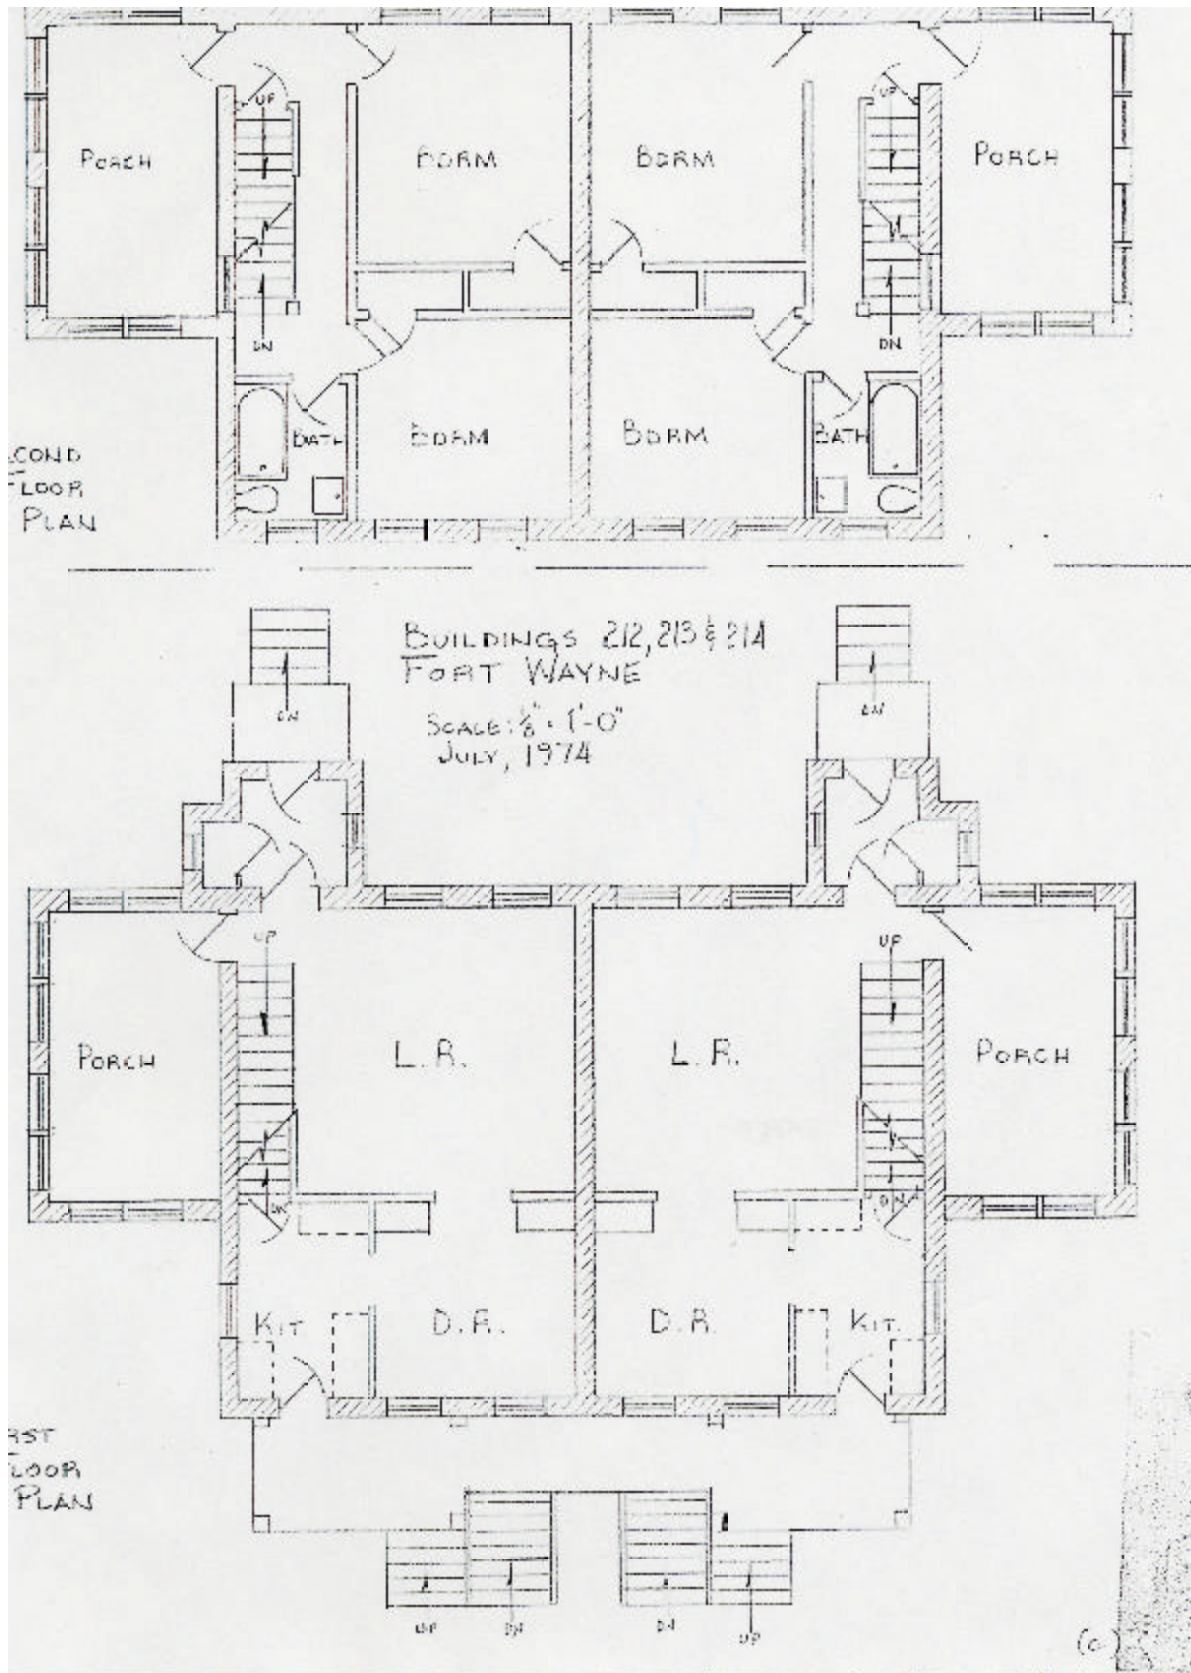
Exterior Conditions**Exterior Recommendations**

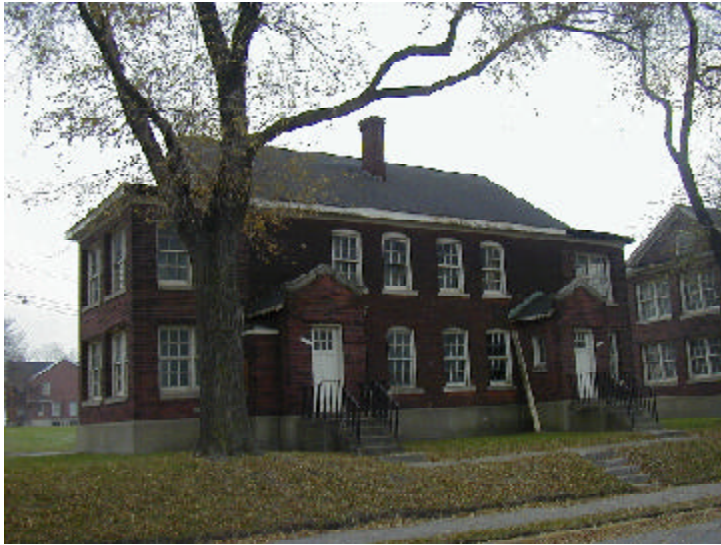
SmithGroup
BUILDING 213 A / B
 NCO QUARTERS

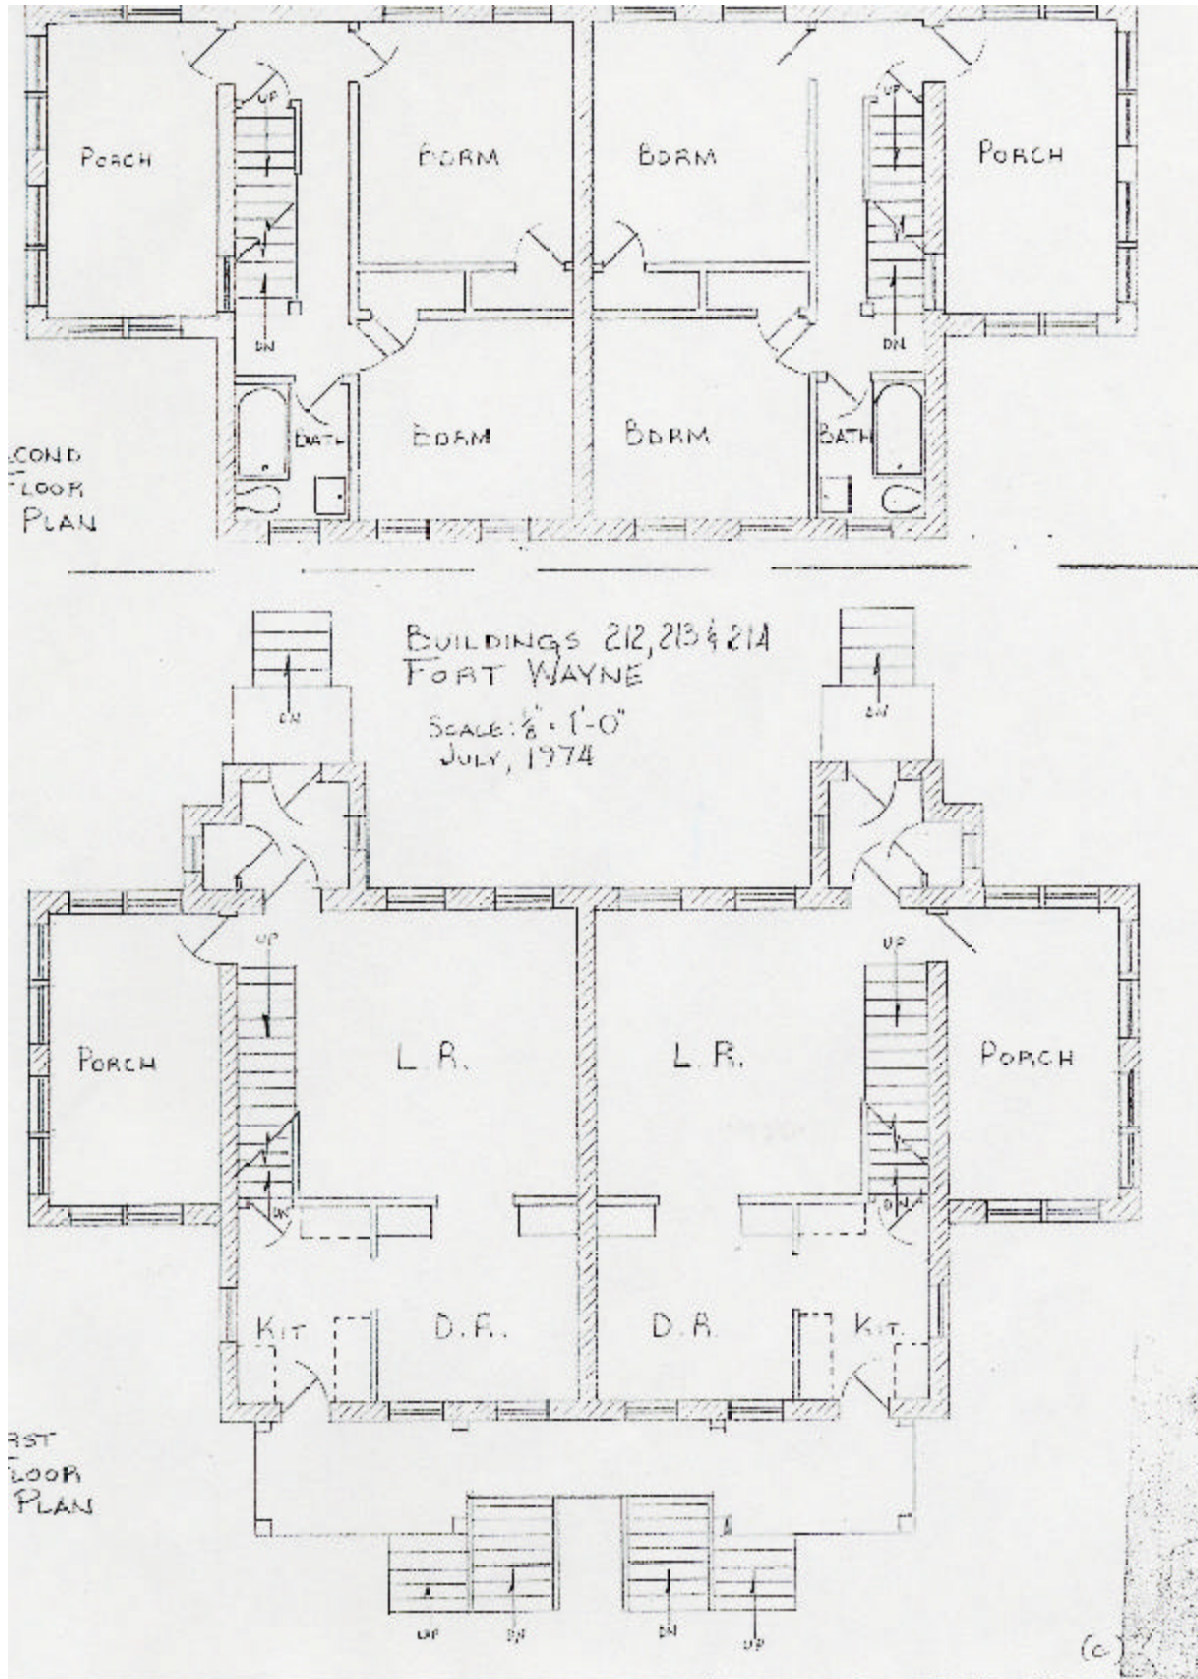
This duplex NCO building is two-and-one-half stories with basement. Each unit's first floor consists of a living room, dining room, and kitchen plus an enclosed front entrance porch and sunroom. The stair to the second floor is open to the living room. Second floors contain a stair hall, two bedrooms, and a full three-piece bathroom. A stair leads from the second floor to a finished attic. The two main floor levels have fully plastered walls and ceilings. All original plaster and woodwork was removed and replaced in 1935-39. Floors are wood with the kitchen floor covered with linoleum. The bathroom has plastered walls and a ceramic tile wainscot and floor (circa 1935-39). The attic is finished plastered and basement is partially finished.

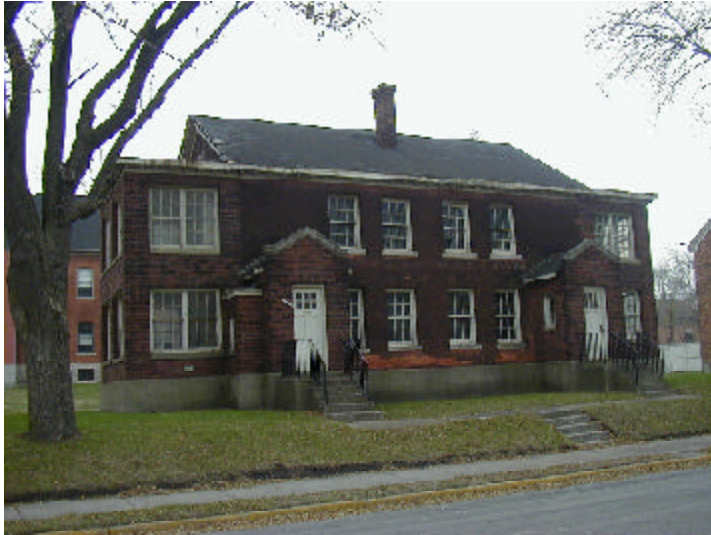
Constructed:	1897
Building Type:	2
Proposed Use:	Office or Residential Rental/ 2 Unit
Area:	2,920 SF (+ 1,430 SF Basement)
Conceptual Cost Estimate:	\$690,000 - \$860,000

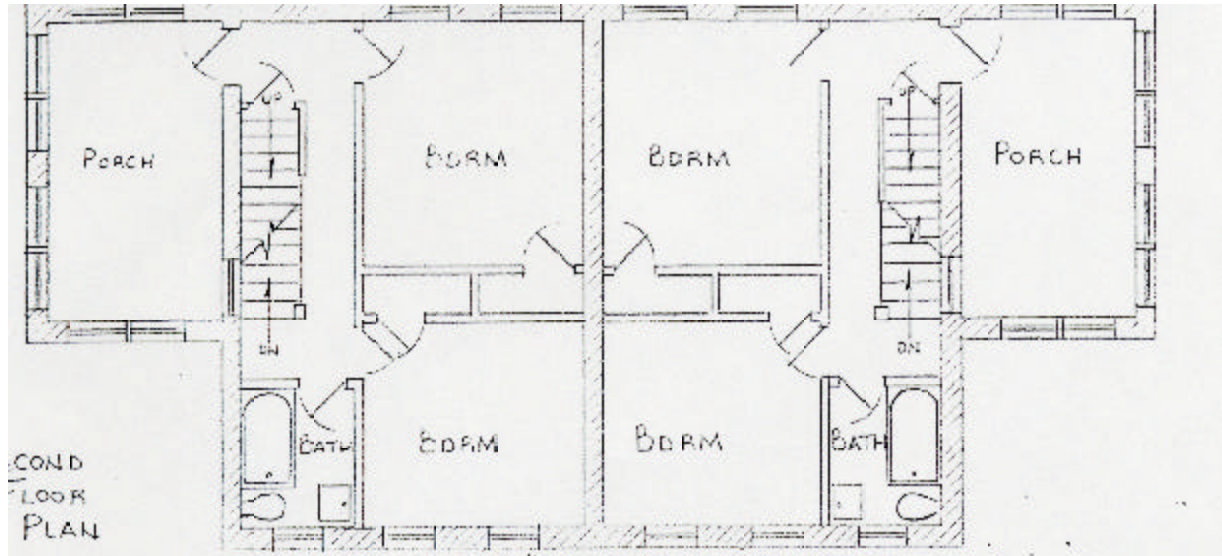
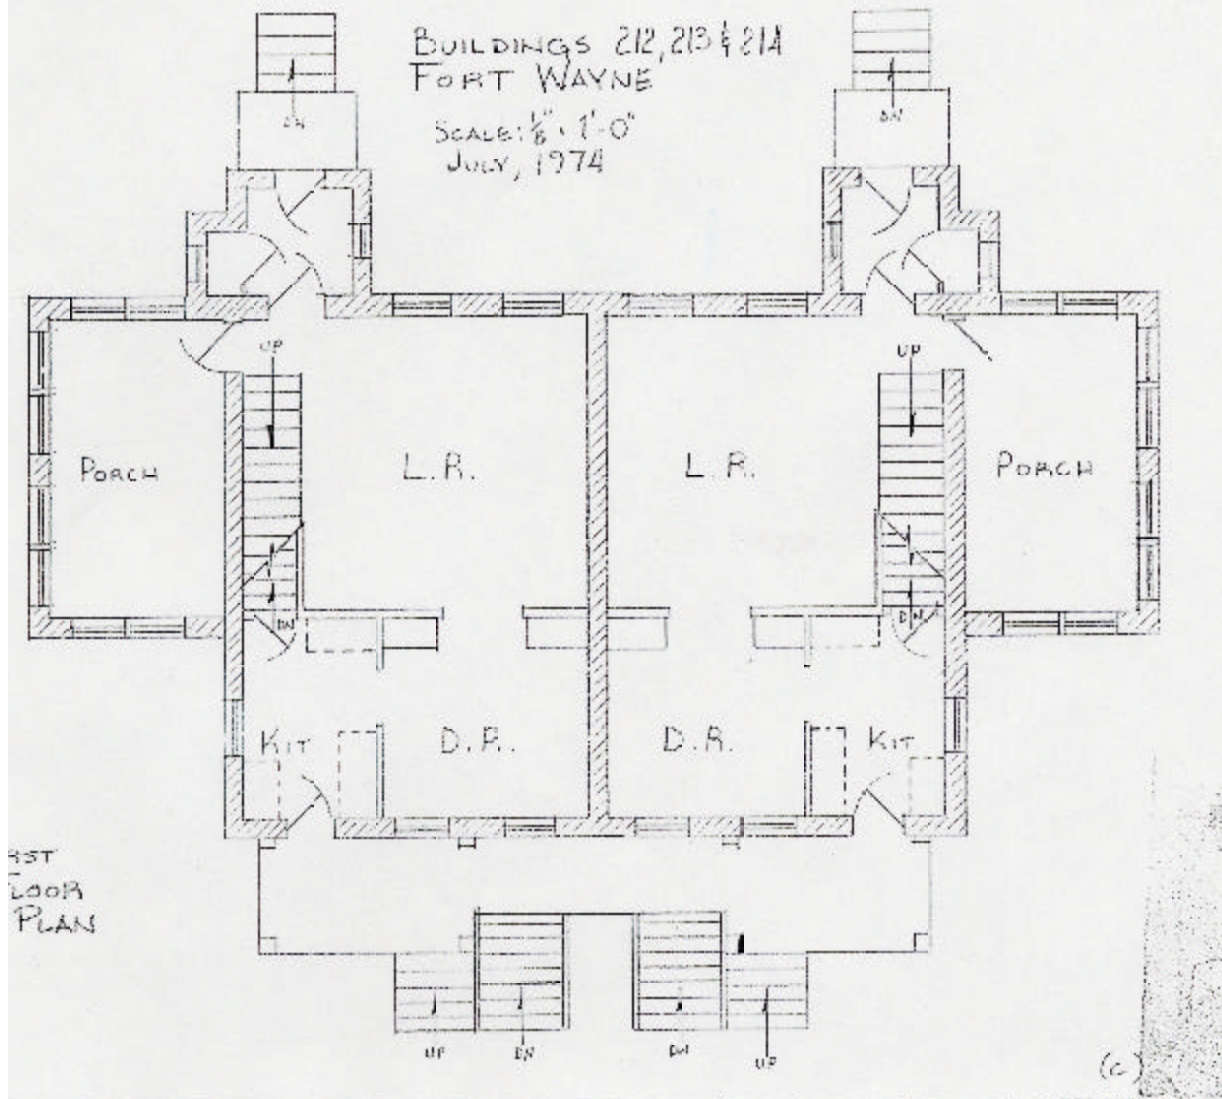
This duplex NCO building is two-and-one-half stories with basement. Each unit's first floor consists of a living room, dining room, and kitchen plus an enclosed front entrance porch and sunroom. The stair to the second floor is open to the living room. Second floors contain a stair hall, two bedrooms, and a full three-piece bathroom. A stair leads from the second floor to a finished attic. The two main floor levels have fully plastered walls and ceilings. All original plaster was removed and replaced in 1935-39. Floors are wood with the kitchen floor covered with linoleum. The bathroom has plastered walls and a ceramic tile wainscot and floor (circa 1935-39). The attic is finished plastered and basement is partially finished.

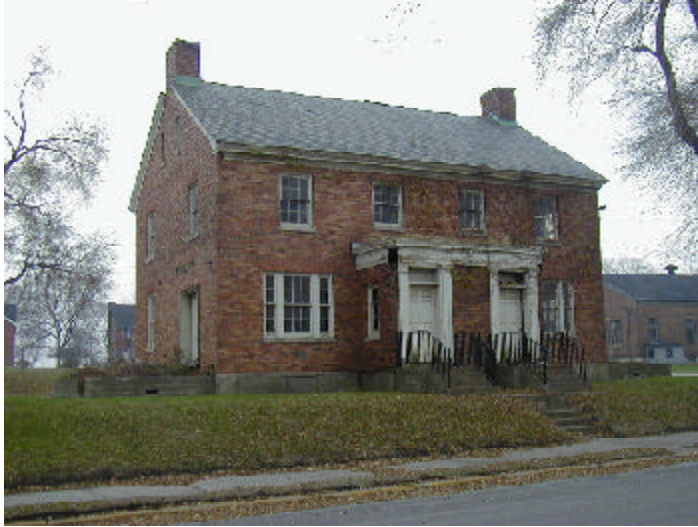
BUILDING 215 A / B
NCO QUARTERS

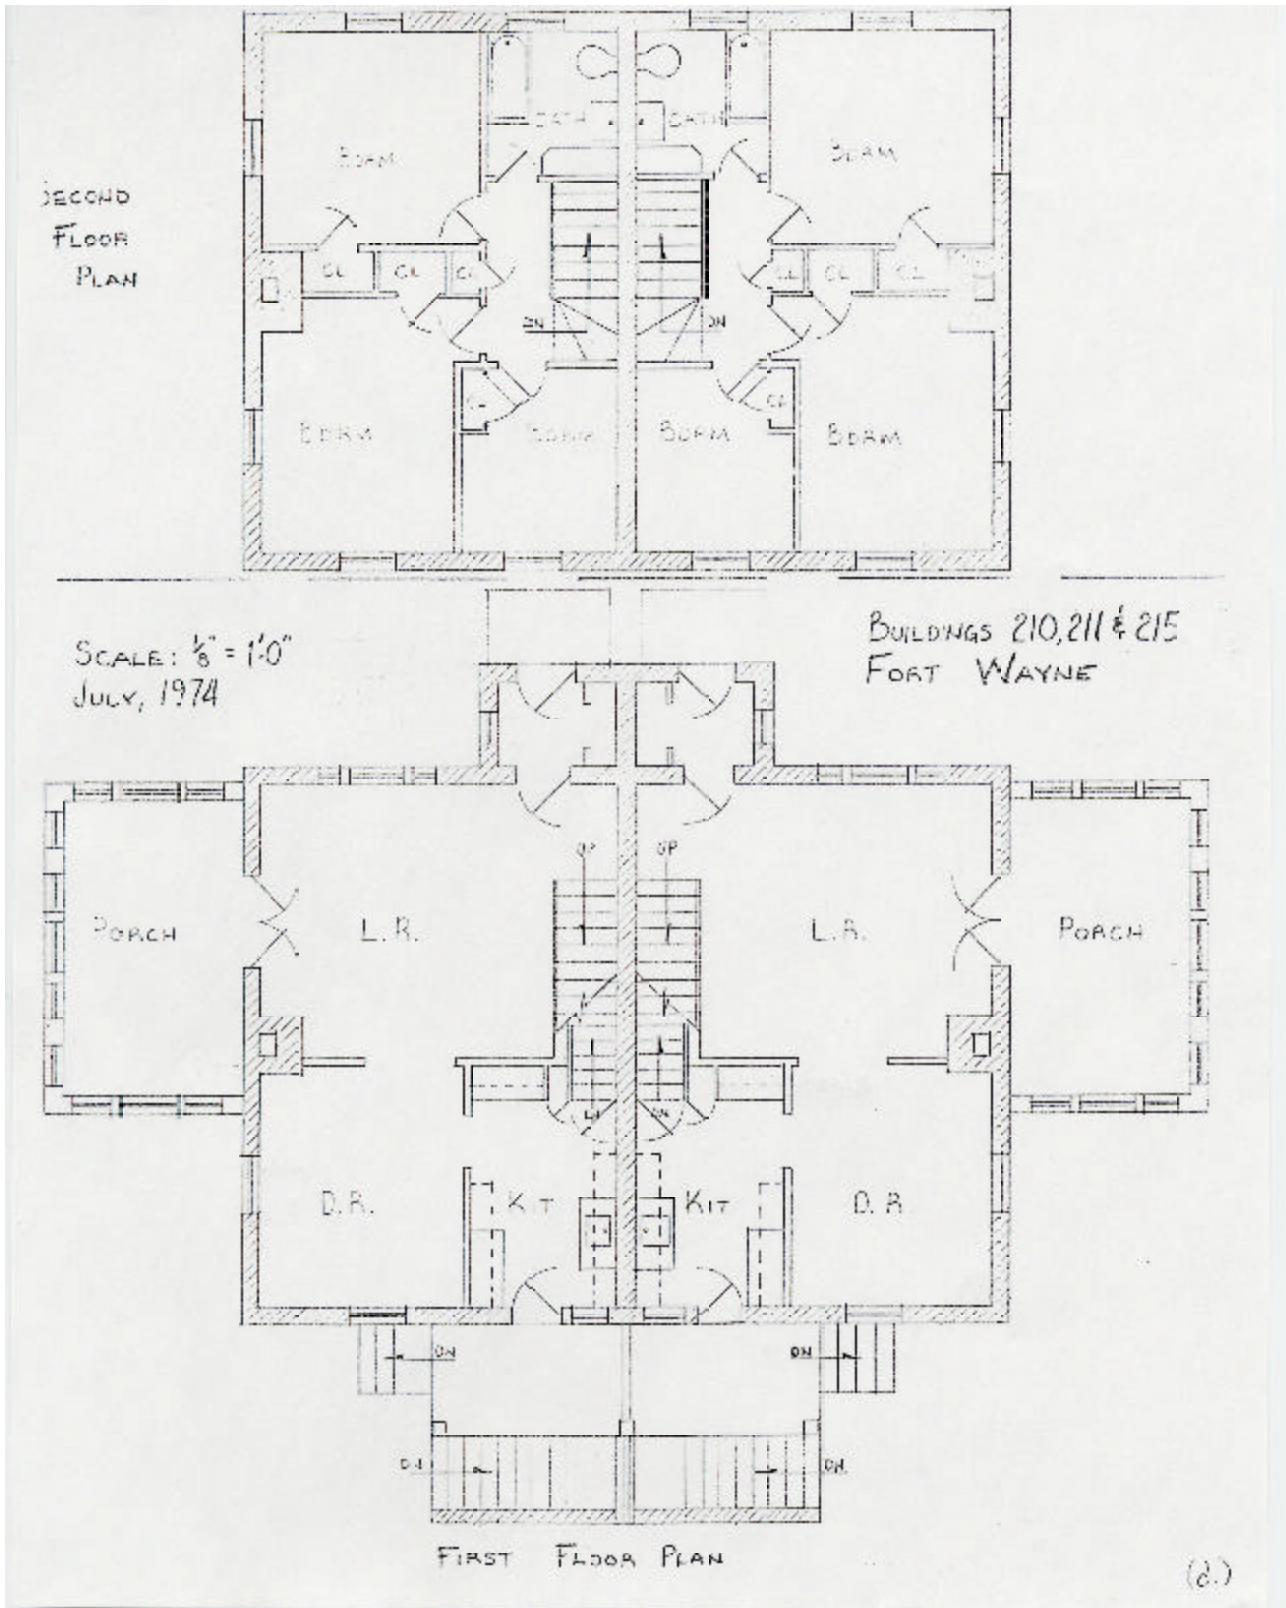
This duplex NCO building is two stories with basement. Original side porches for each unit have been removed but double entrance door openings still exist and are nailed shut with plywood. Each unit's first floor consists of a living room, dining room, and kitchen plus an enclosed front entrance vestibule. The stair to the second floor is open to the living room. Second floors contain a stair hall, three bedrooms, and a three-piece bathroom. The two main floor levels have original fully plastered walls and ceilings. Floors are wood with some carpet. The kitchen floor is covered with linoleum. The bathroom has plastered walls and ceramic tile wainscot and floor that is different in color and size than the typical green/black remodeling tile of 1935-39. It is therefore felt to be original to the 1931 construction date.

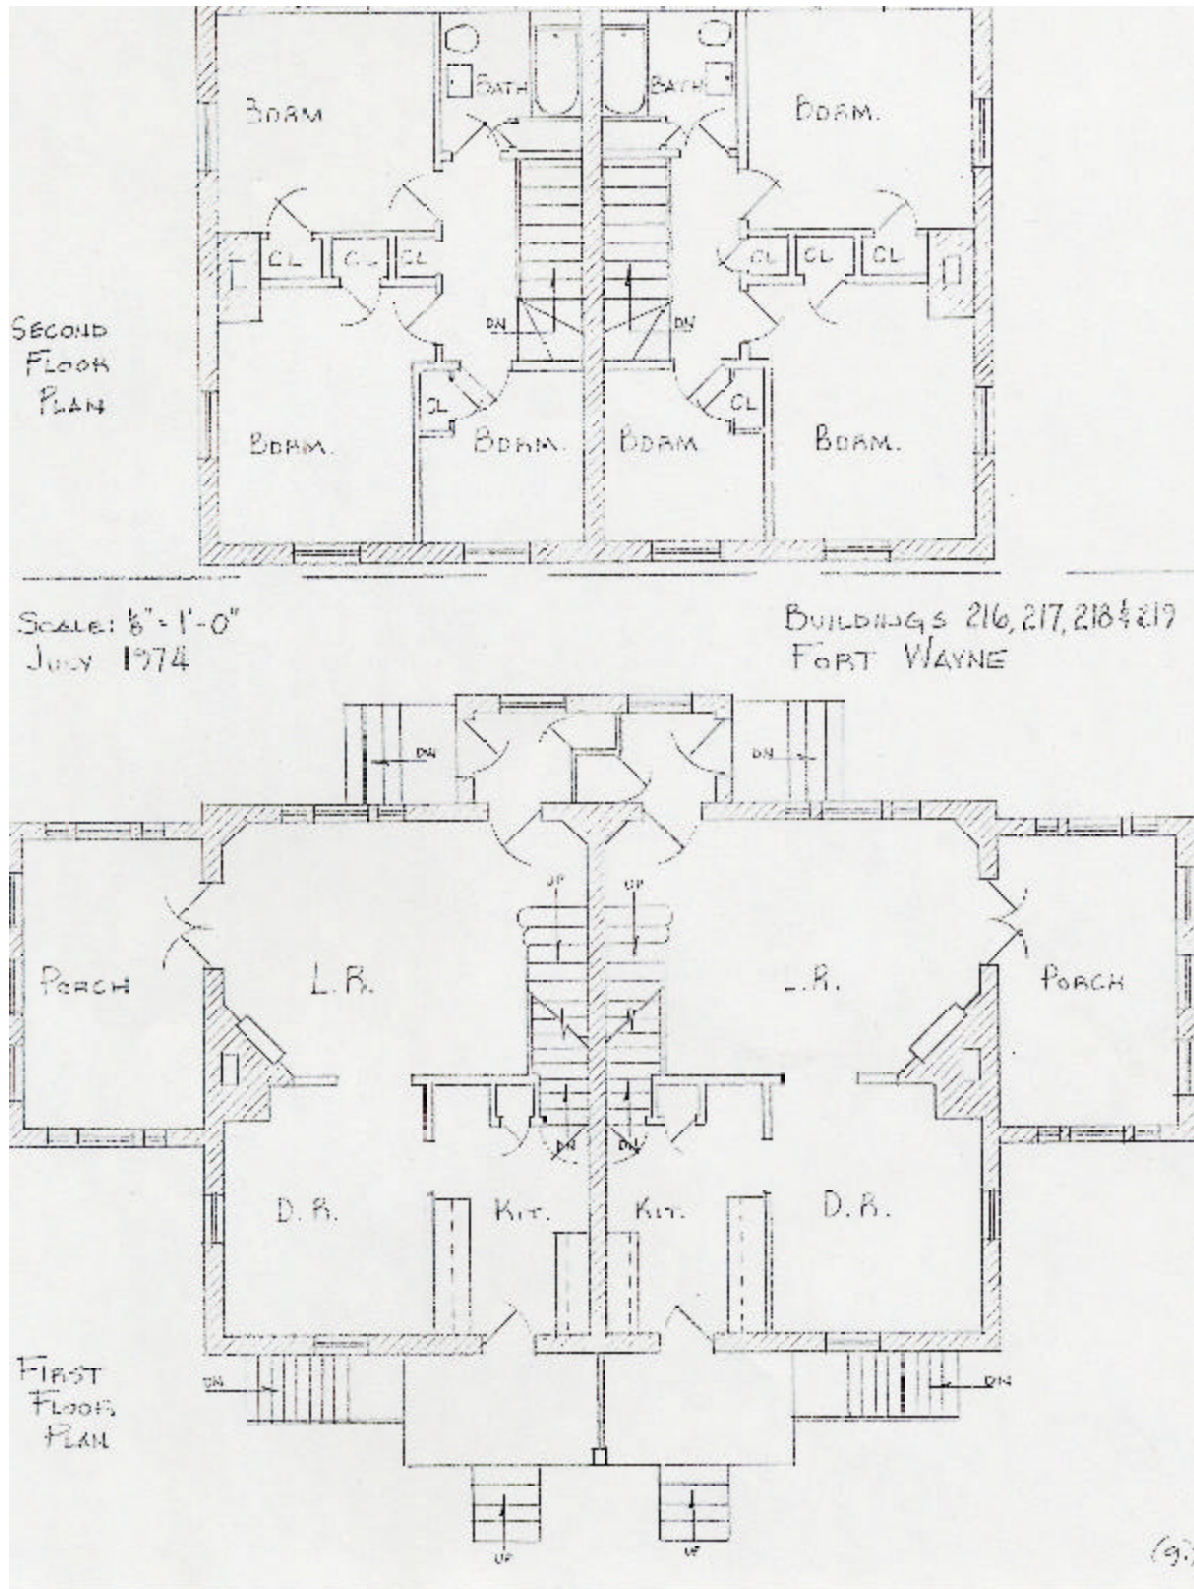
This duplex NCO building is two stories with basement. Each unit's first floor consists of a living room, dining room, kitchen, enclosed side porch and a separate enclosed front entrance vestibule for each unit. The stair to the second floor is open to the living room. Second floors contain a stair hall, three bedrooms, and a three-piece bathroom. The two main floor levels have original fully plastered walls and ceilings. Except as noted, floors are wood. The kitchen floor is wood covered with linoleum. The bathroom has plastered walls and original ceramic tile wainscot and floor that is typical of the 1935-39 remodeling of other buildings.

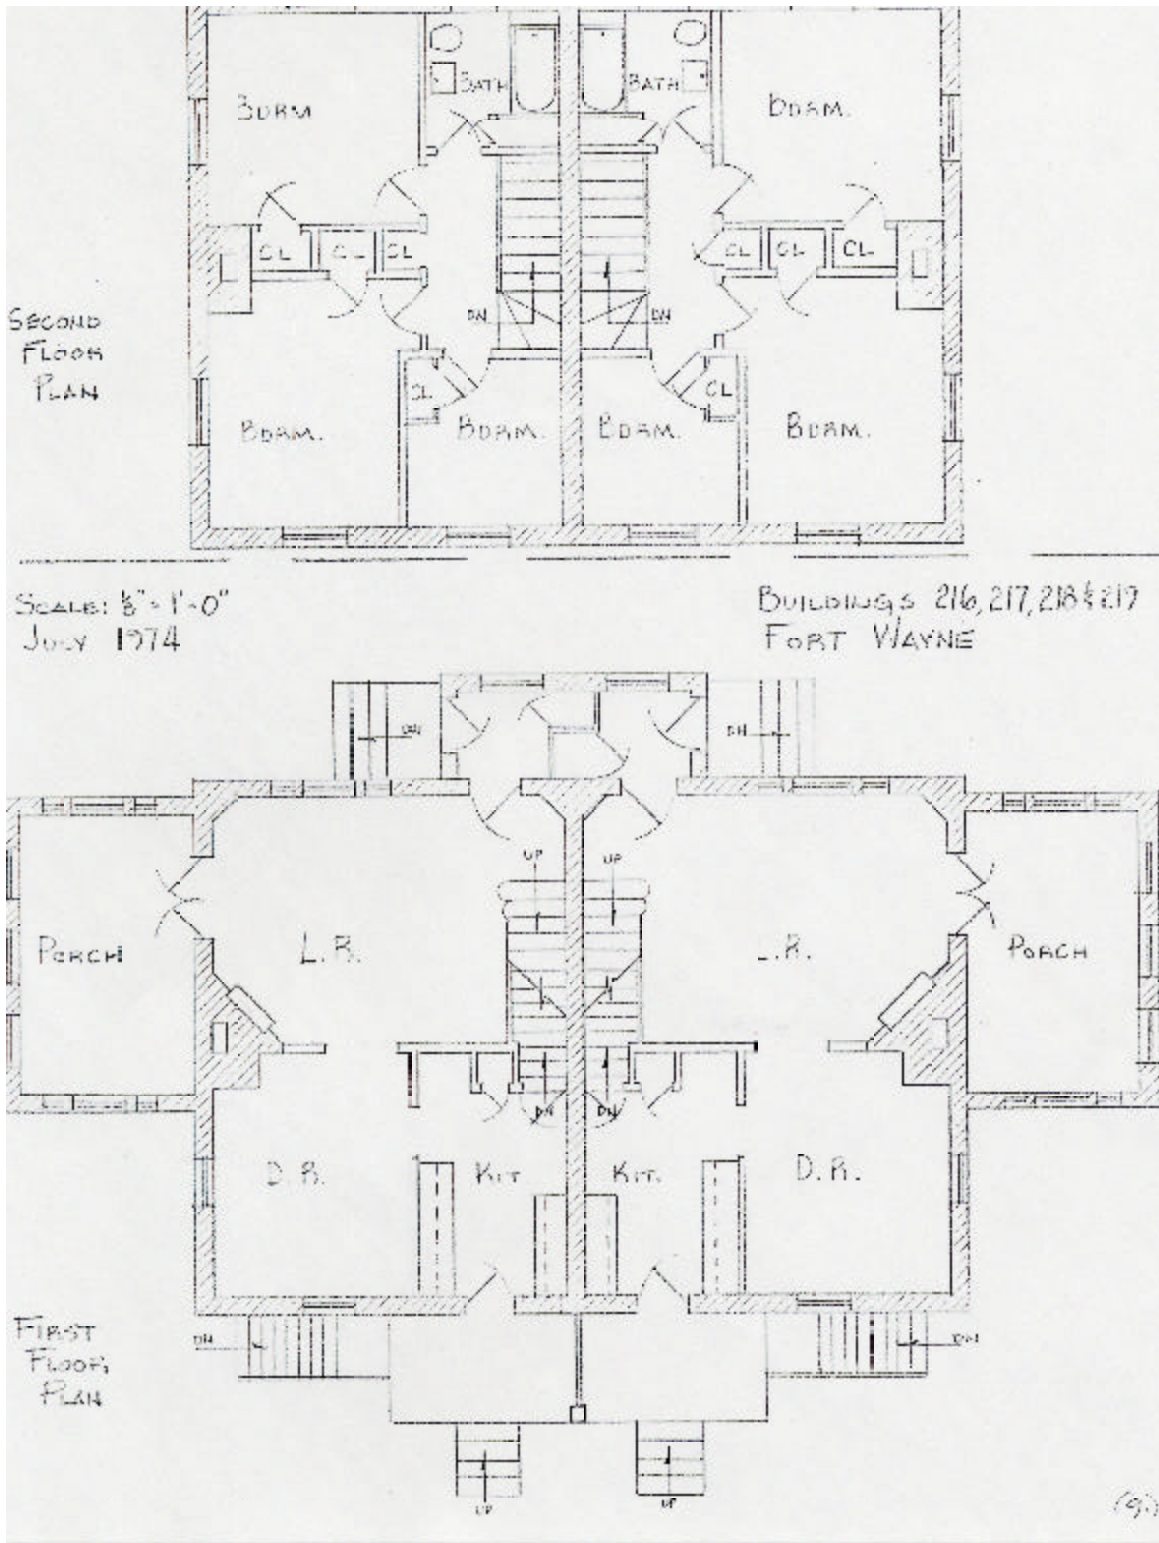
This duplex NCO building is two stories with basement. Each unit’s first floor consists of a living room, dining room, kitchen, enclosed side porch and a separate enclosed front entrance vestibule for each unit. The stair to the second floor is open to the living room. Second floors contain a stair hall, three bedrooms, and a three-piece bathroom. The two main floor levels have original fully plastered walls and ceilings. Except as noted, floors are wood. The kitchen floor is wood covered with linoleum. The bathroom has plastered walls and original ceramic tile wainscot and floor that is typical of the 1935-39 remodeling of other buildings.

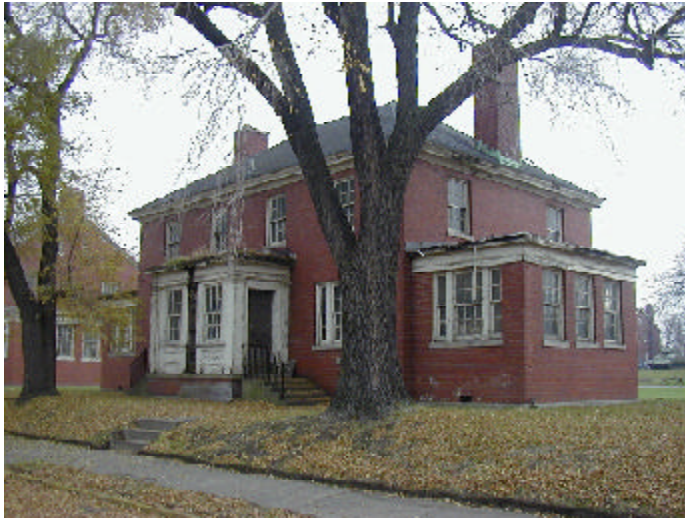
BUILDING 218 A / B
NCO QUARTERS

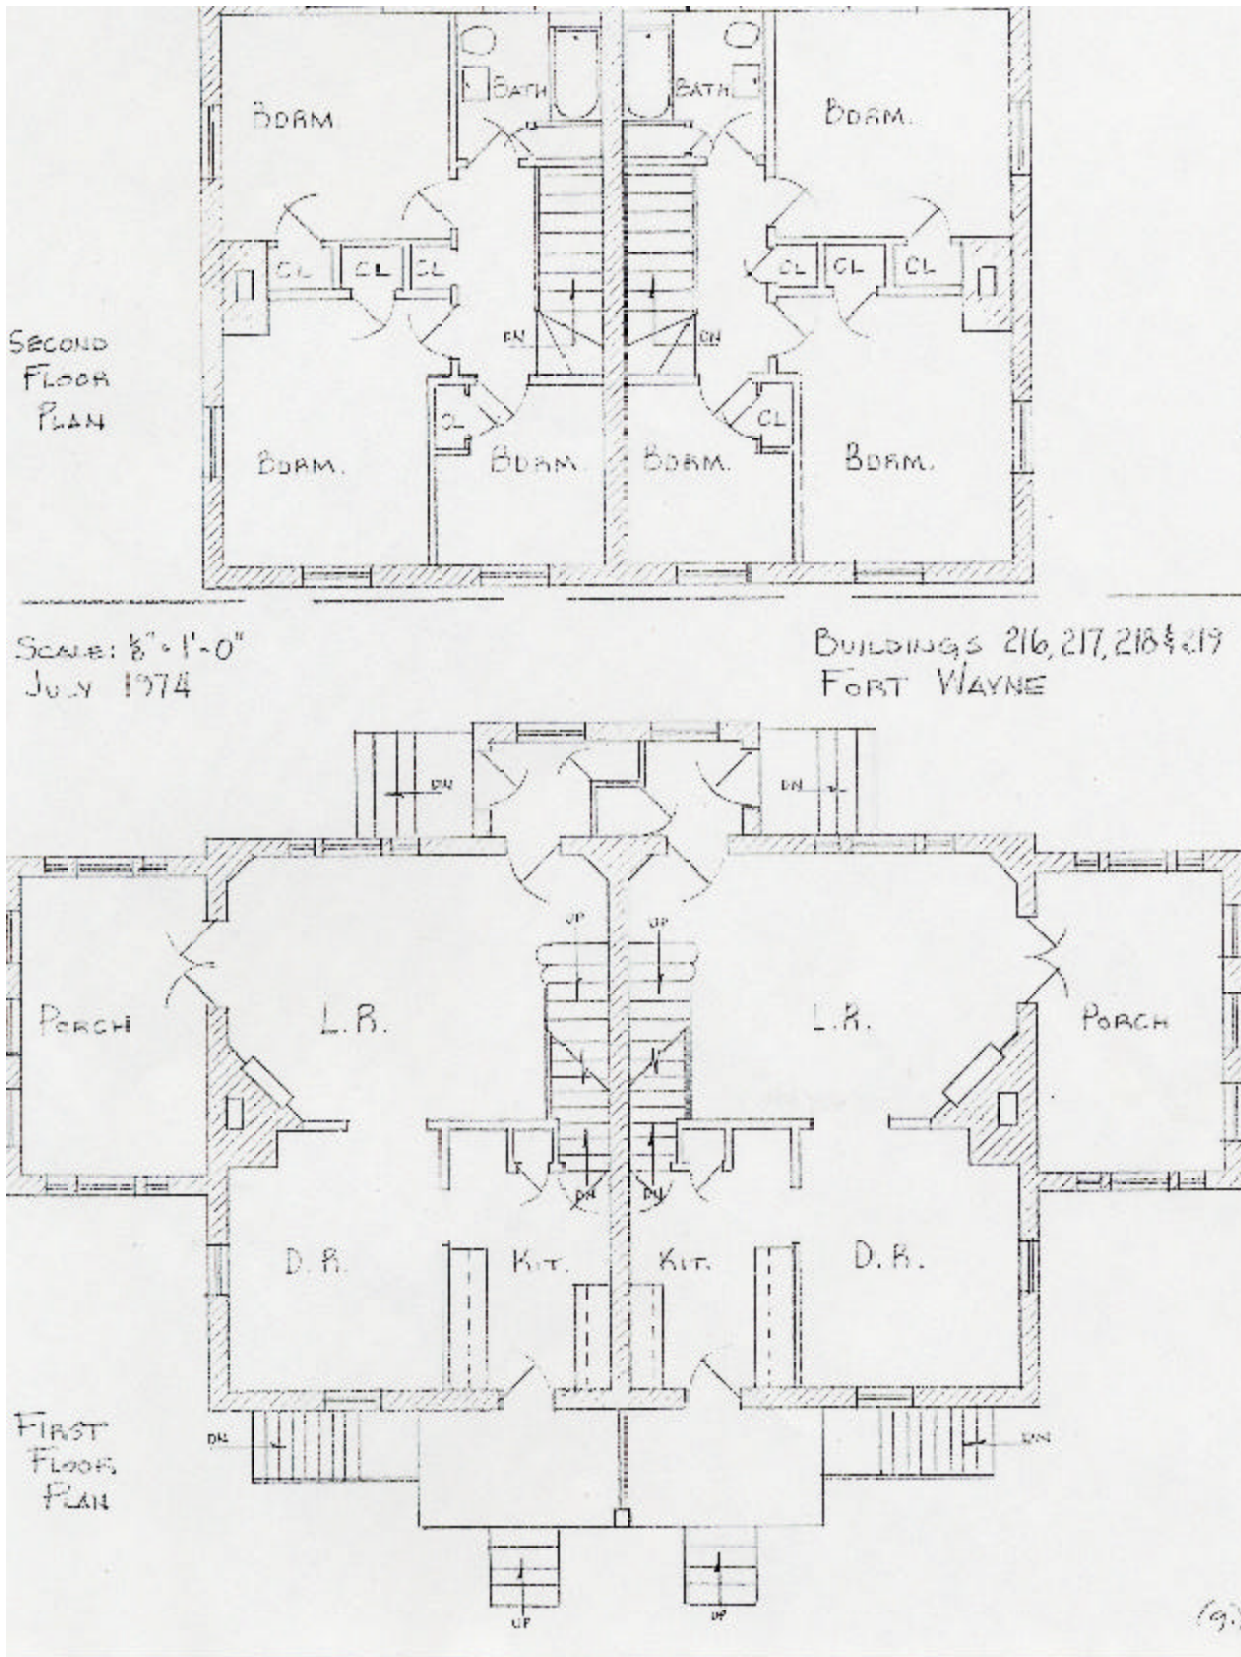
This duplex NCO building is two stories with basement. Each unit’s first floor consists of a living room, dining room, kitchen, enclosed side porch and a separate enclosed front entrance vestibule for each unit. The stair to the second floor is open to the living room. Second floors contain a stair hall, three bedrooms, and a three-piece bathroom. The two main floor levels have original fully plastered walls and ceilings. Except as noted, floors are wood. The kitchen floor is wood covered with linoleum. The bathroom has plastered walls and original ceramic tile wainscot and floor that is typical of the 1935-39 remodeling of other buildings.

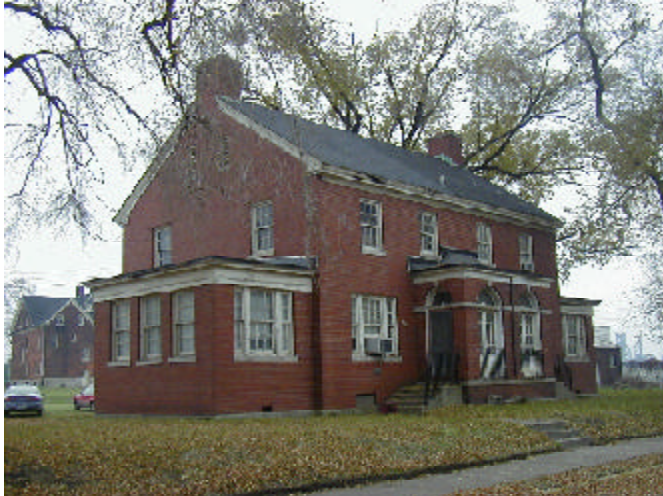
BUILDING 219 A / B
NCO QUARTERS

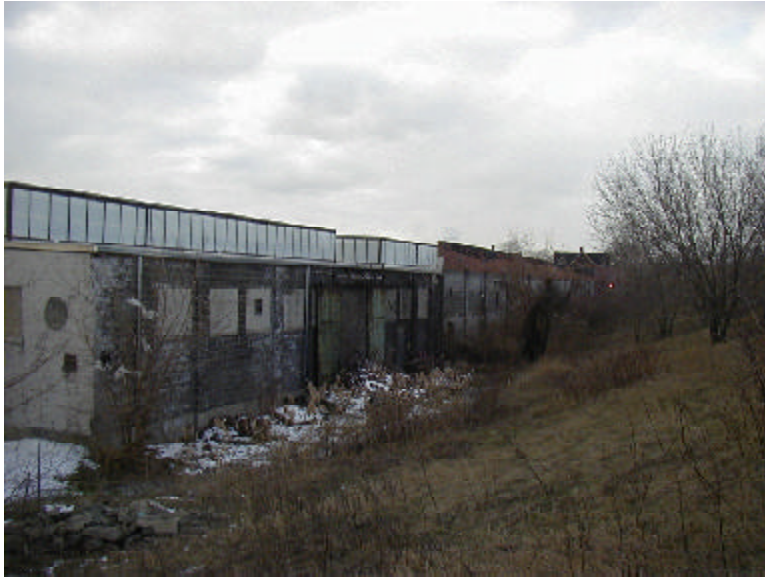
BUILDING 2B
WAREHOUSE

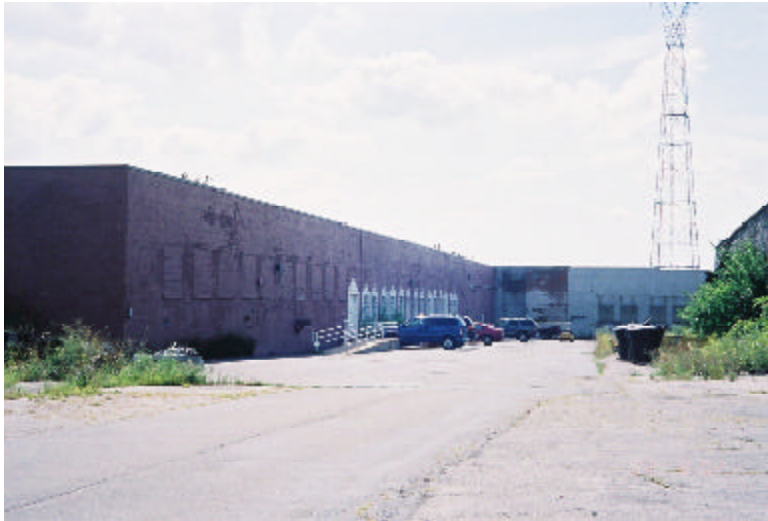
Constructed:	1942
Proposed Use:	Interactive Museum
Area:	27,500 SF
Conceptual Cost Estimate:	\$1,270,000-\$1,580,000*

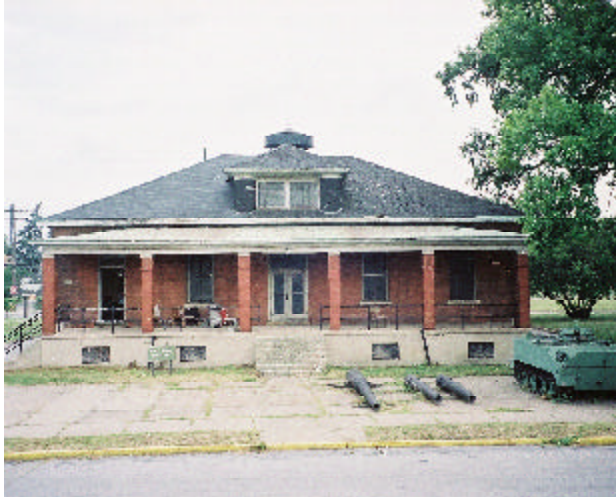
**“NEW” GUARDHOUSE**

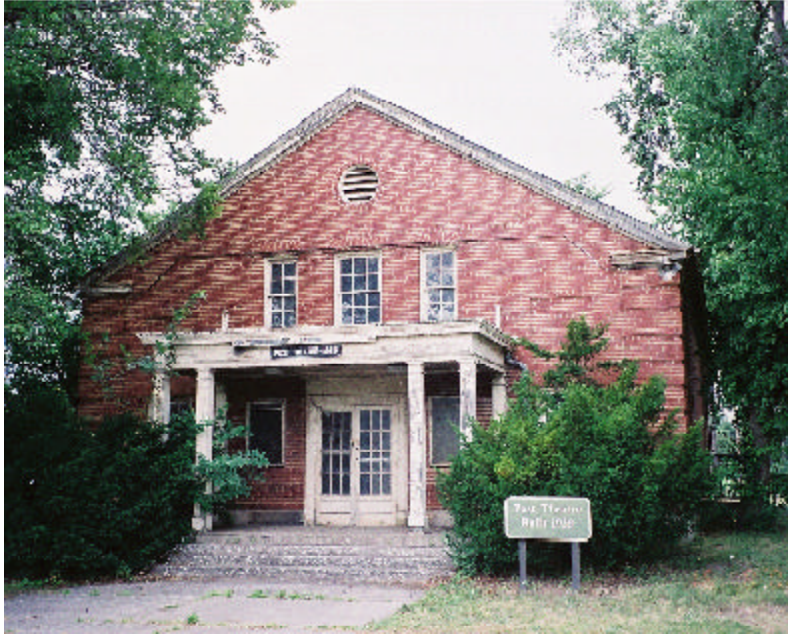
**BUILDING 303****THEATER**

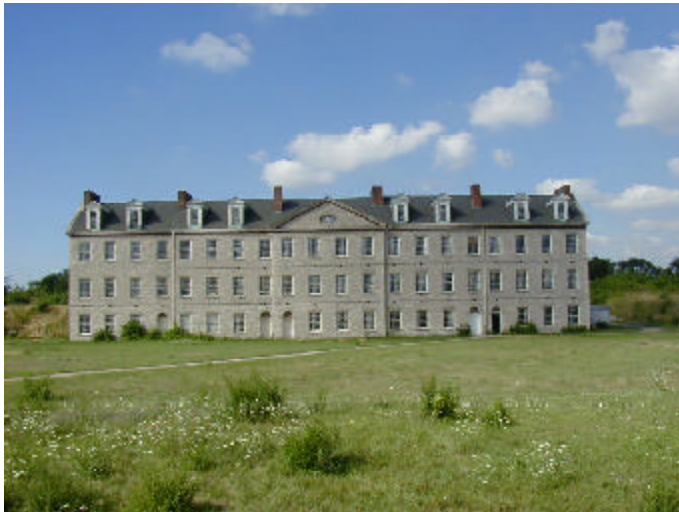
Constructed: 1848 - 1849
