## Building 108: Duplex Officer's Quarters

**Condition:** Poor<sup>1</sup>

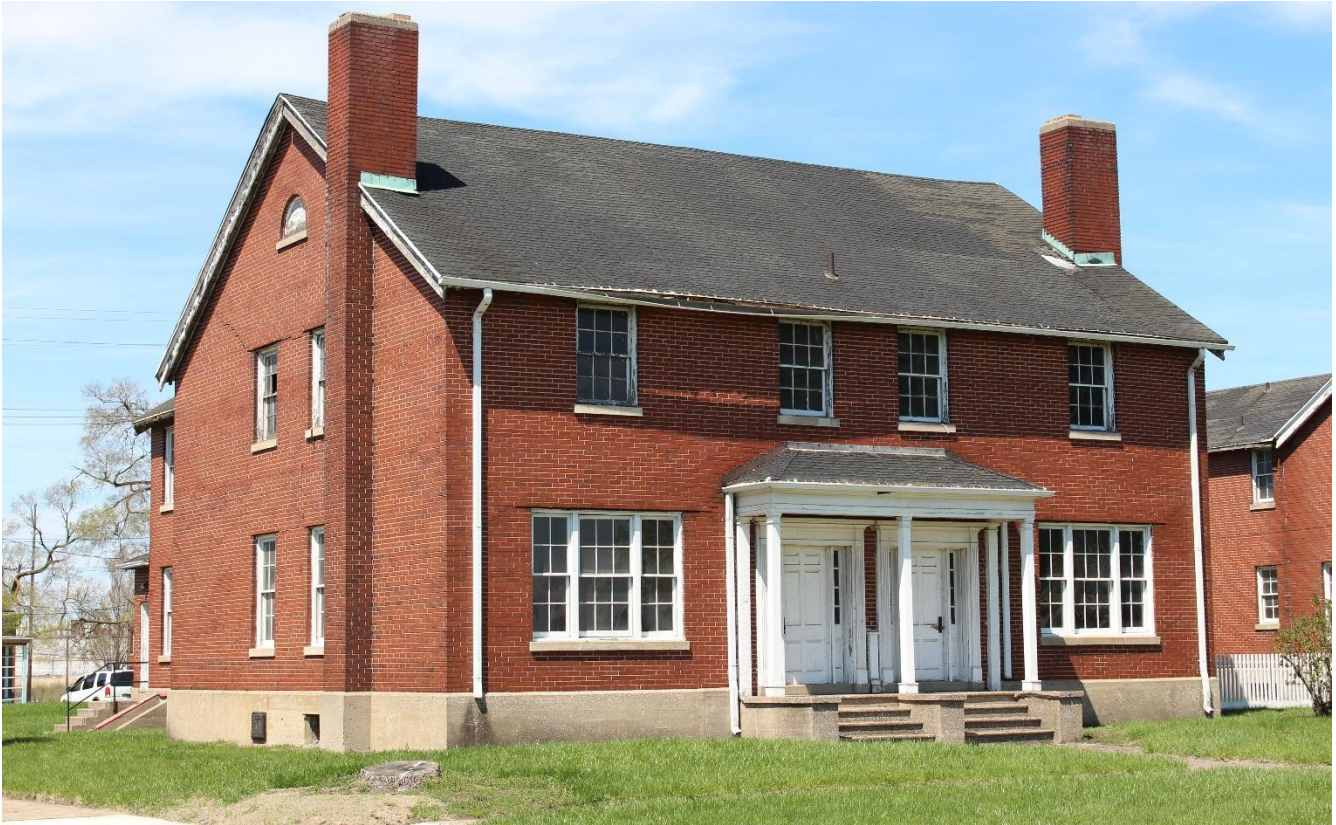
*Front (southeast) facade, April 2019*

**General Condition:** This building is in poor condition, according to a 2015 report. A condition assessment conducted in 2008 identifies rusted lintels, shifted brick veneer, eroded mortar, deteriorated or missing mortar at vertical sill joints and each brick chimney, rotted and damaged fascia, deteriorated rafter tails, missing flashing and chimney crickets, and a bowed roof ridge. The front porch is in poor condition. The building has suffered additional deterioration since 2008.
