Building 111: Duplex Officer's Quarters

Front (southeast) facade, April 2019

Condition: Fair¹

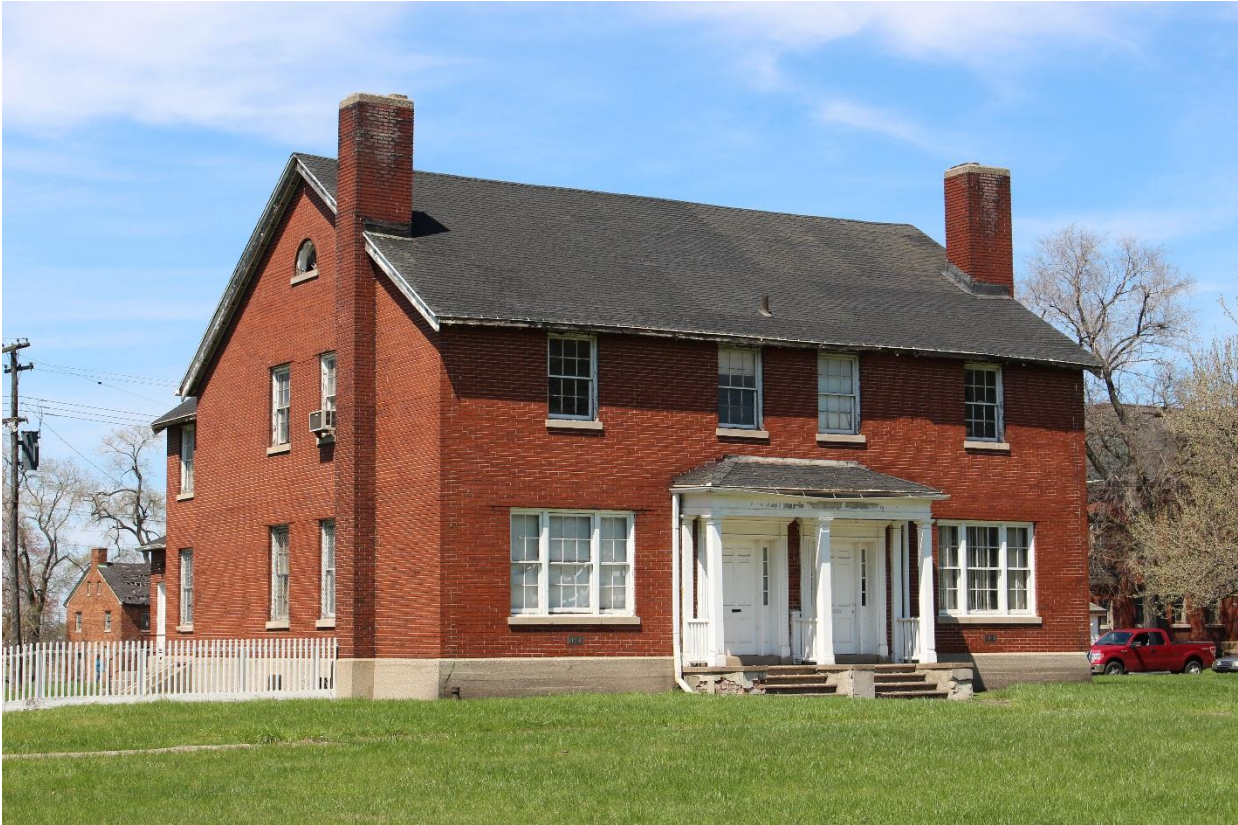
General Condition: This building is in fair condition, according to a 2015 report. A condition assessment conducted in 2008 identifies rusted lintels, shifted brick veneer, eroded mortar due to pressure washing, rotted and damaged fascia, no gutters or leaders, roofs in poor condition with deteriorated valleys, missing chimney cricket, bowed roof ridge, front porch roof in poor condition with inadequate flashing, rear porch roof in fair condition, porches in fair condition with missing railings. Foundations are in good condition. The building has suffered additional deterioration since 2008.
