Building 114: Officer's Quarters

Front (south) facade, April 2019

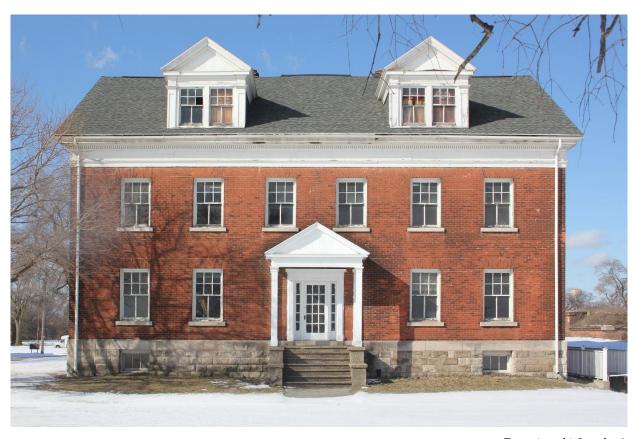
This building is in good condition, according to a 2015 report. Significant interior and exterior rehabilitation work was undertaken in the 2000s.
