Building 117: Officer's Quarters

Front (southeast) facade, April 2019

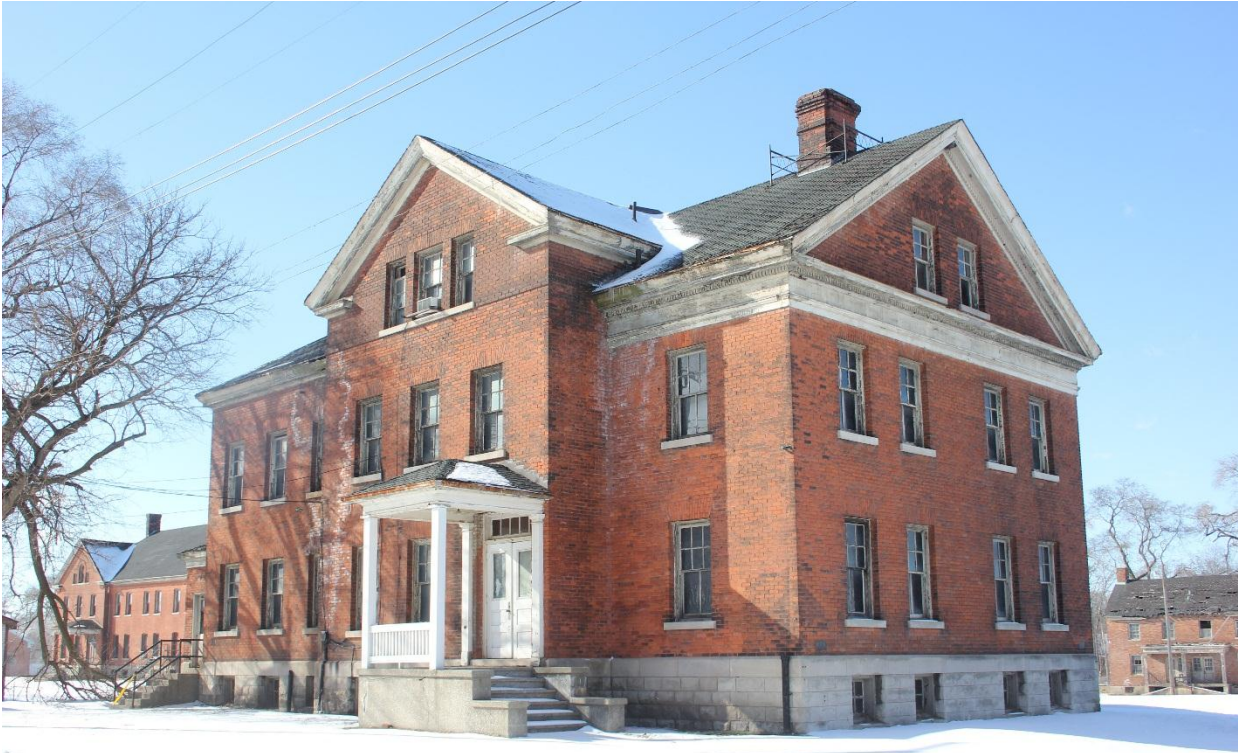
General Condition: This building is in poor condition, according to a 2015 report. A condition assessment conducted in 2008 identifies rusted lintels, mortar in poor condition with many open joints, deteriorated chimney mortar, deteriorated front porch masonry, wood trim in fair or good condition, deteriorated gutters with leaders missing, paint in poor condition, main roof in poor condition with some damage to structure, porch roofs in poor condition with deteriorated column bases and concrete steps. The building has suffered additional deterioration since 2008.
