Building 216: Duplex Noncommissioned Officer's Quarters

Condition: Threatened¹

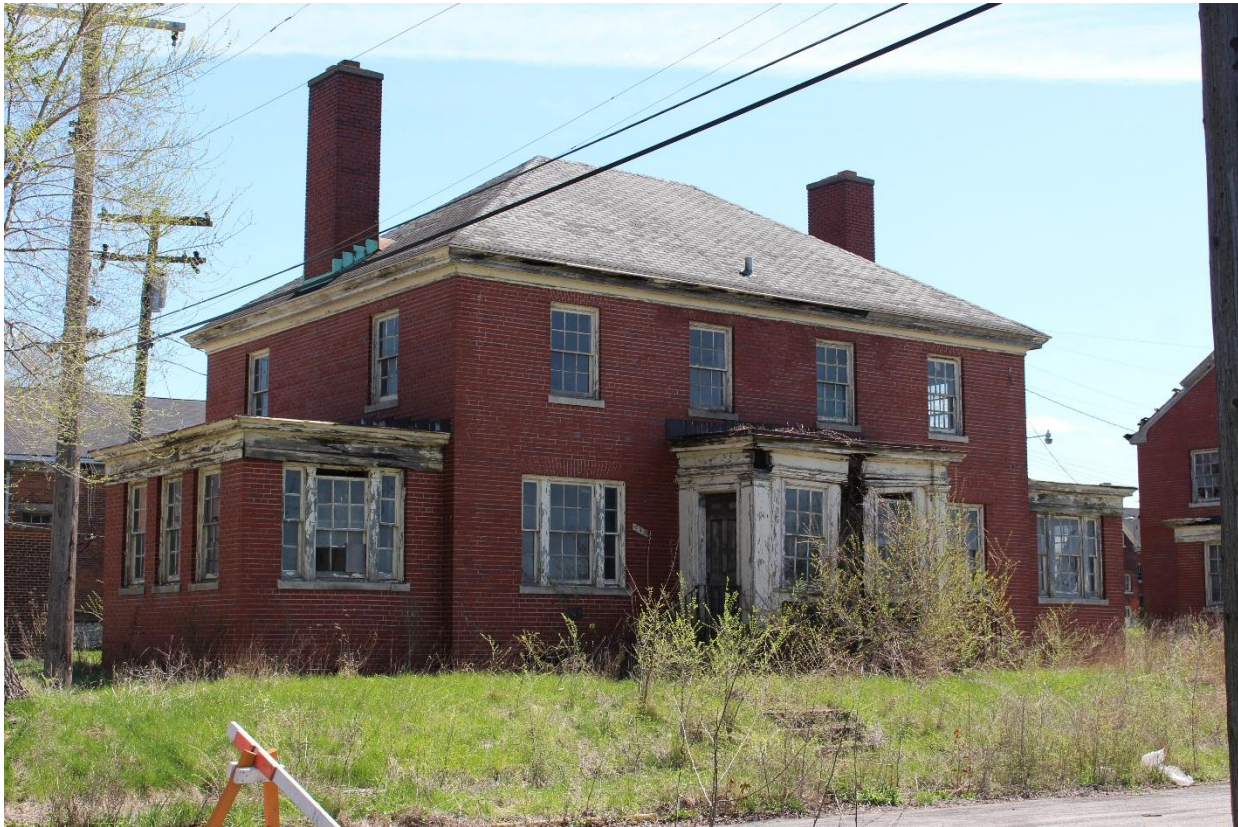
Front (northwest) facade, April 2019

General Condition: This building is in threatened condition, according to a 2015 report. A condition assessment conducted in 2008 identifies mortar in good condition with the exception of deteriorated chimney mortar, front porch brick deterioration, rotted fascia, missing gutters and leaders, paint in poor condition, roof in poor condition including all porch roofs and sunroom roofs, porches in poor condition with rear porches collapsing. The building has suffered additional deterioration since 2008.
