Building 217: Duplex Noncommissioned Officer's Quarters

Construction Date: 1939

Condition: Threatened¹

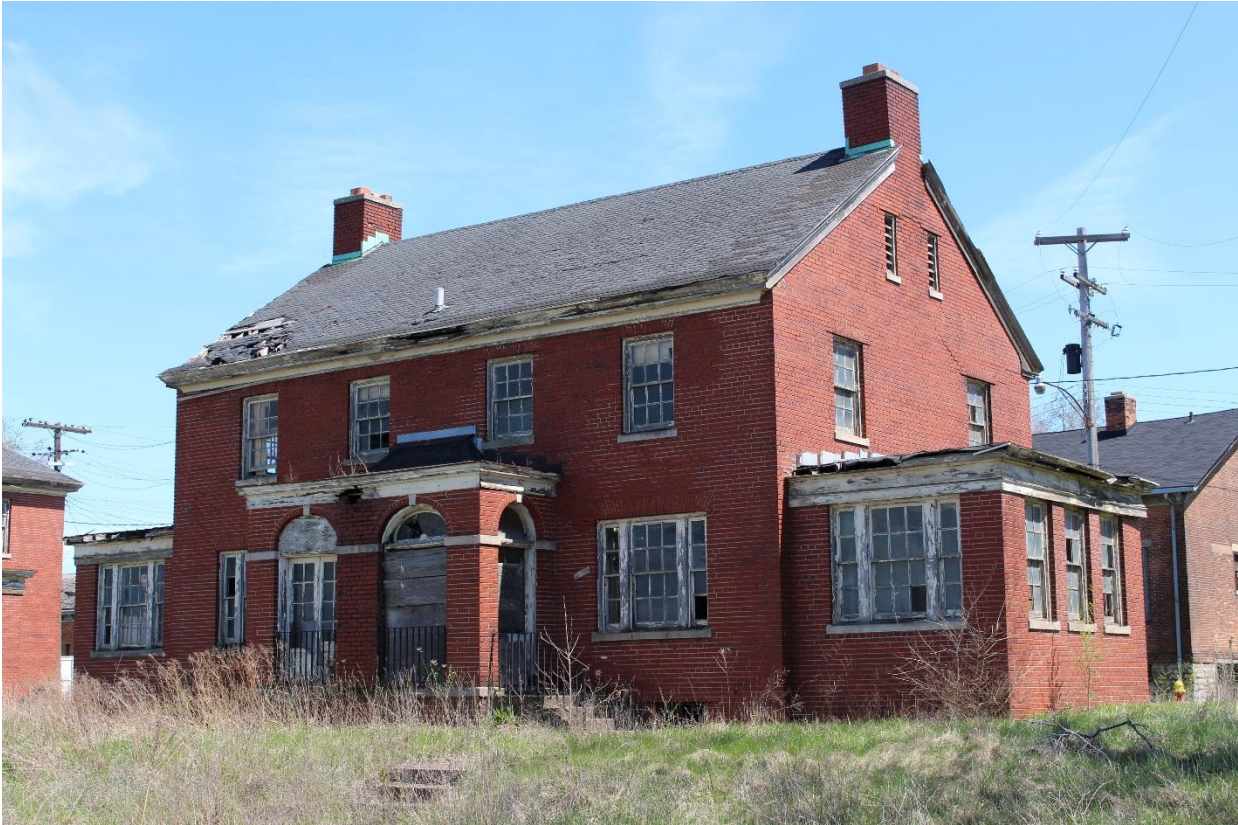
Front (northwest) facade, April 2019
