Building 218: Duplex Noncommissioned Officer's Quarters

BUILDINGS 216, 217, 218 & 219
FORT VAYNE

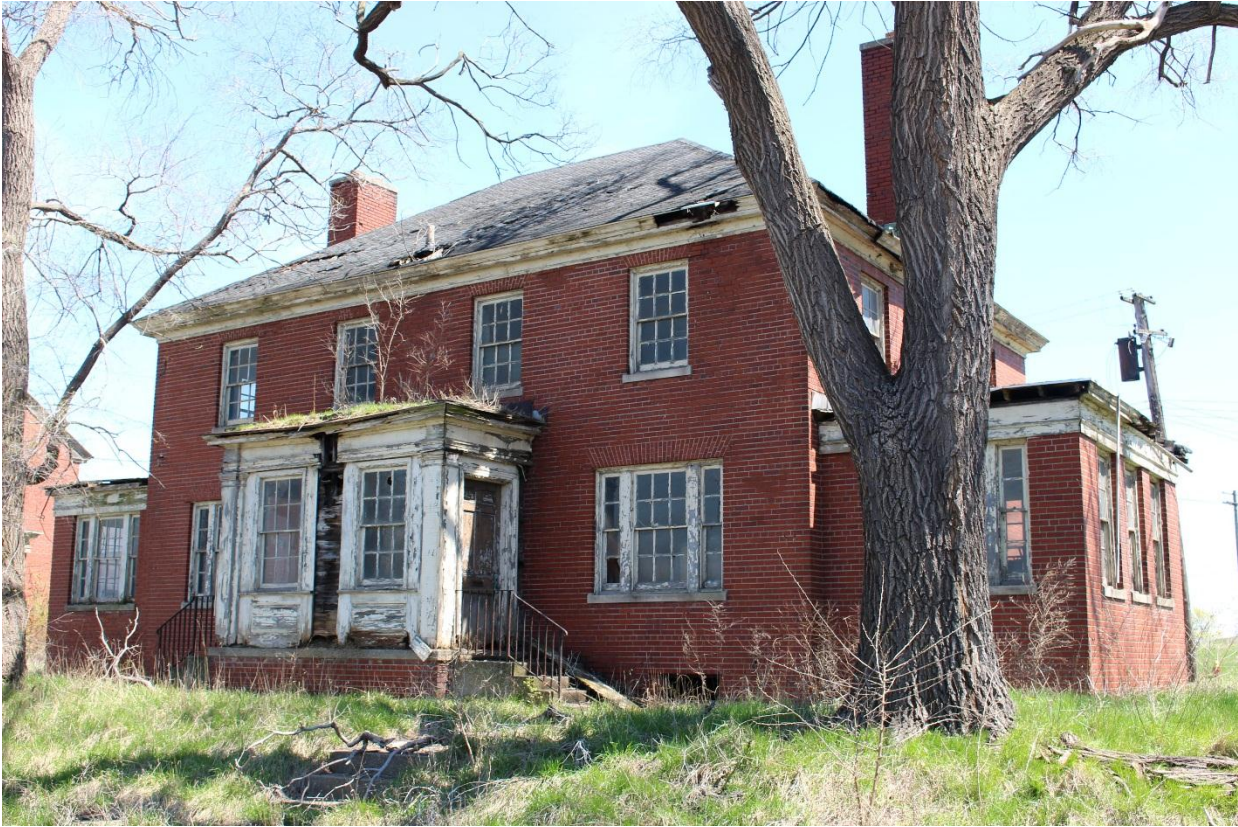
Front (northwest) facade, April 2019
