## Building 303: Post Theatre

**Construction Date:** 1939

**Historic Use:** Assembly (Stage and Film Theatre)

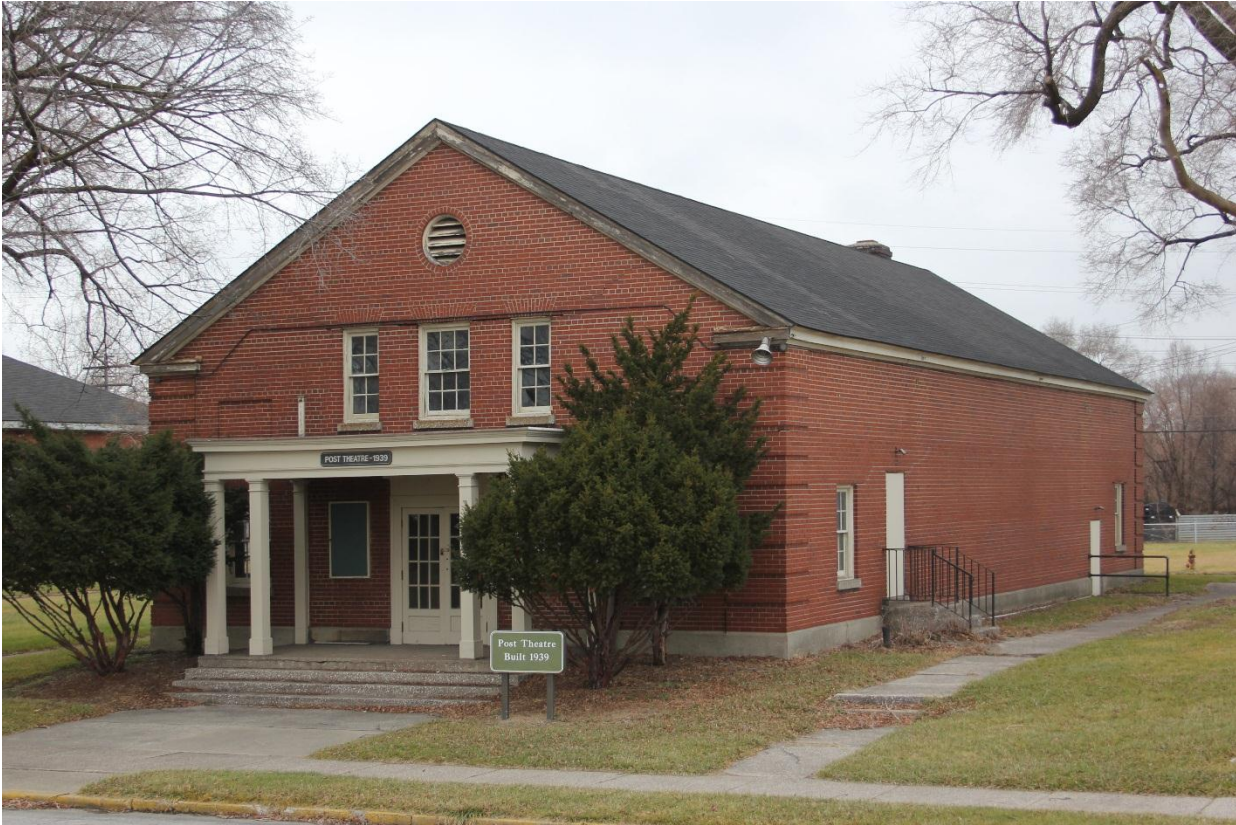
*Front (south) facade, February 2017*

**General Condition:** This building is in fair condition, according to a 2015 report. A condition assessment conducted in 2008 identifies rusted lintels with minor jacking and shifting of brick, a deteriorated chimney cap, wood trim in fair condition, gutter and leader missing on west side, paint in poor condition, front porches in poor condition with handrails in need of replacement. A new roof was added in 2004. The building has suffered additional deterioration since 2008.
