## Building 201: Post Engineer's Storehouse

*Front (south) facade, April 2019*

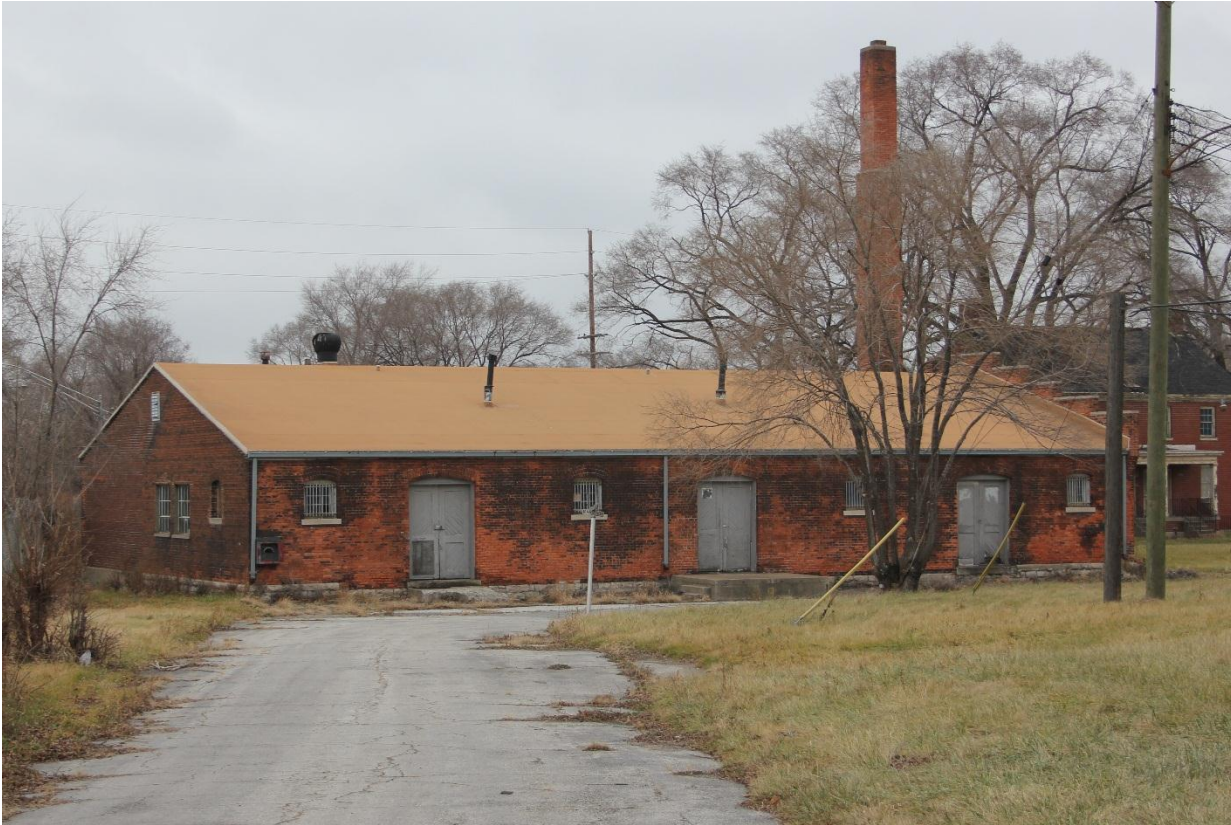
**General Condition:** This building is in good condition, according to a 2015 report. A 2003 conditions assessment identified wood trim in fair condition, paint in poor condition, extensive open masonry joints in brick and foundation, one concrete porch in poor condition, rail and stile doors in poor condition with rot and missing panels, windows in fair condition. The roof consists of relatively new materials and is in good condition.
