STAFF REPORT: 04/10/2024 REGULAR MEETING

APPLICATION NUMBER: HDC2024-00121

ADDRESS: 19690 SHREWSBURY

SCOPE: DEMOLISH GARAGE, ERECT GARAGE AND DECK

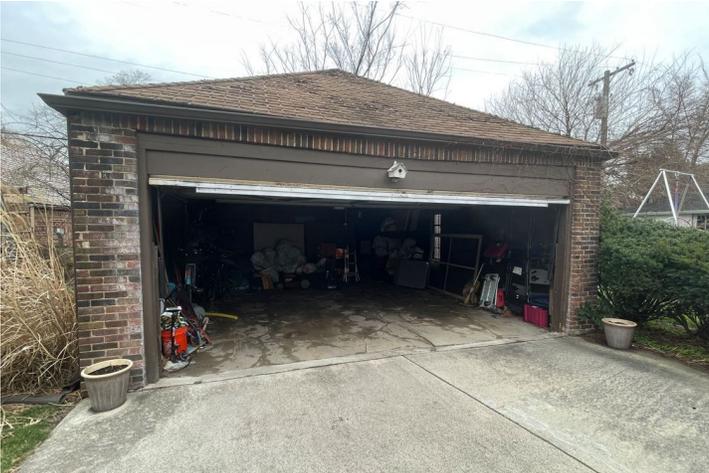
Site Photo 2, by Staff March 27, 2024: (West) front elevation of garage, showing foundation cracks, bowing of center roof, and some efflorescence and cracks in the masonry.

- Staff visited the site with the owner and observed the garage’s conditions inside and outside. Staff observed that the general condition of the property has been draining towards the garage and that there is substantial foundation damage in the concrete slab and on the sides of the garage, which contributes to a slight bowing of the main garage door lintel. Step cracking can be observed along the north and south mortar joints of the walls, especially near the foundation. Some efflorescence is evident as well as “rising damp” as the internal wood framing pulls moisture from the ground surface up into the lower walls. The rear wall from the exterior appeared to have little to no damage. The roof had previous support work completed, and the exterior roof appears to need new shingles. Staff’s initial assessment was that the foundation was failing and requested the applicant to provide the option for an assessment on restoration of the garage, looking at alternatives, perhaps lifting and restoring the foundation of the garage.

- **Foundation:** Upon assessment of the foundation, cracking and displacement of below-grade foundation are likely present and have caused resultant cracks and shifting in above grade brick wall. This may be due to frost heave during unseasonably cold winters where frost depth exceeded the 42” inch below grade design standard.

- **Slab:** A longitudinal crack in the concrete floor slab was observed and the elevation of the slab measured to be higher along this crack line suggesting damage from frost heave.

- **Walls:**
 - Masonry walls: single wythe brick masonry wall was observed to have vertical cracking indicating foundation issues.

It is staff's opinion that the demolition of the demolition of the garage, construction of the new garage, new deck, new patio, driveway and garden bed are appropriate. Staff therefore recommends the Commission issue a Certificate of Appropriateness for the work as proposed because it meets the Secretary of the Interior Standards for Rehabilitation and the Sherwood Forest Historic District Elements of Design.

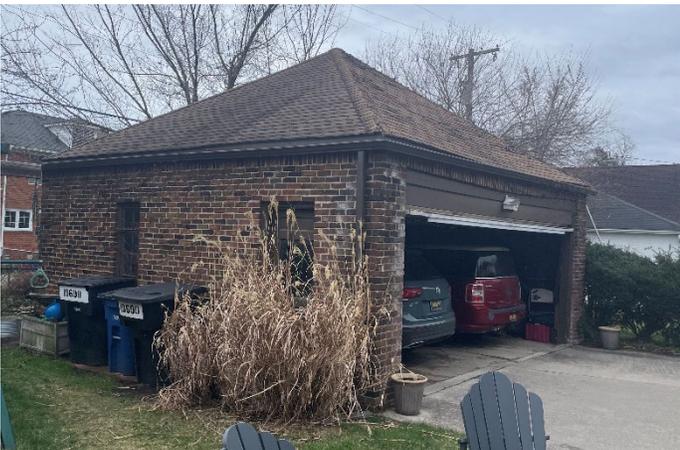
Site Photo 3, by Staff March 27, 2024: (North) side elevation of garage, showing some step cracks in the masonry.

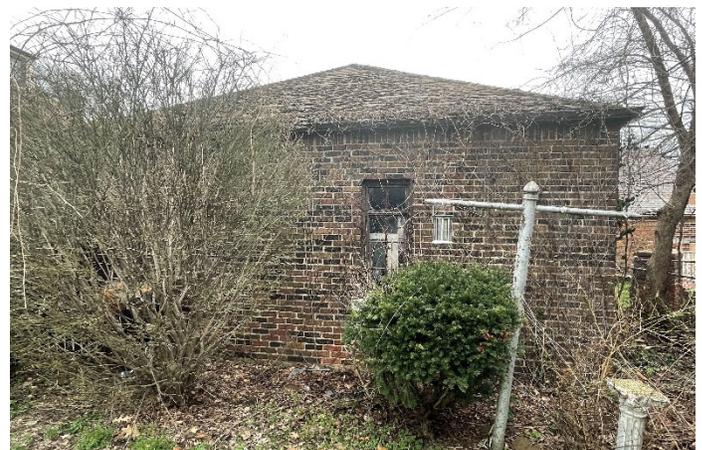
Site Photo 4, by Staff March 27, 2024: (South) side elevation of garage, showing cracks in the masonry and along the foundation areas.
