STAFF REPORT: APRIL 10, 2024 SPECIAL MEETING
APPLICATION NUMBER: HDC2023-00066
ADDRESS: 1180 VINEWOOD
HISTORIC DISTRICT: HUBBARD FARMS
APPLICANT: VALERIA LOPEZ
PROPERTY OWNER: VALERIA LOPEZ
DATE OF PROVISIONALLY COMPLETE APPLICATION: MARCH 23, 2024
DATE OF STAFF SITE VISIT: MARCH 28, 2024 **AND APRIL 5, 2024**

SCOPE: ALTER DWELLING INCLUDING WINDOW AND DOOR OPENINGS, ROOF, SIDING, AND PORCH (WORK COMPLETED WITHOUT APPROVAL)

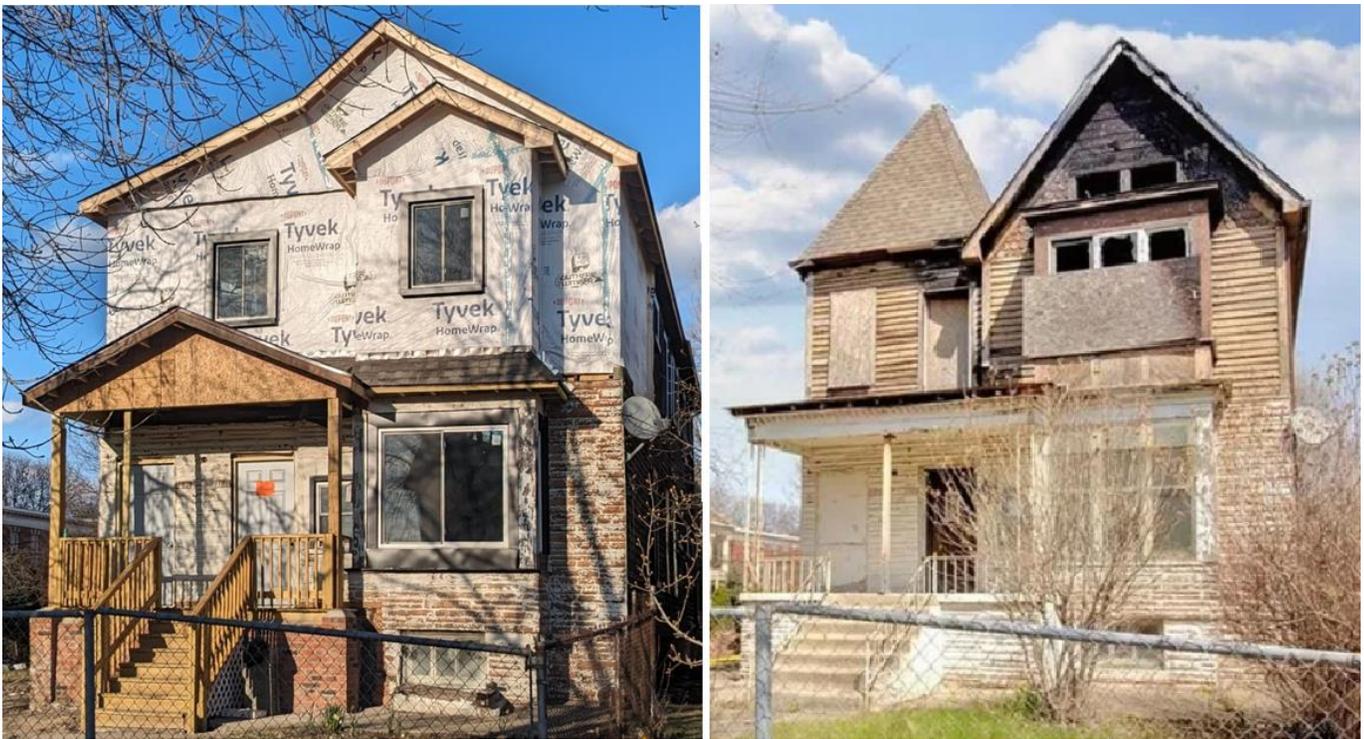
1180 Vinewood was built in 1900 and faces west onto the street. In recent months it has been heavily altered without review or approval by the Historic District Commission.

Left: March 2024 photo by staff. Right: Photo from July 2023 listing on realtor.com.

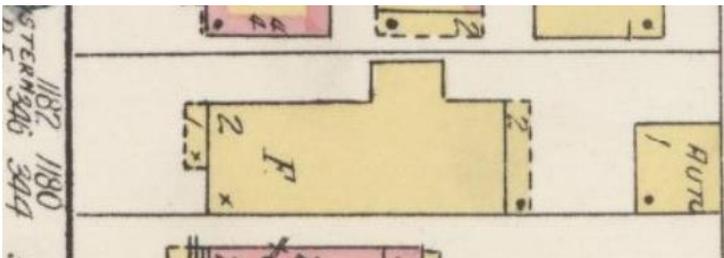
The subject property as depicted on a 1921 Sanborn map. The rear porch and garage have since been removed.

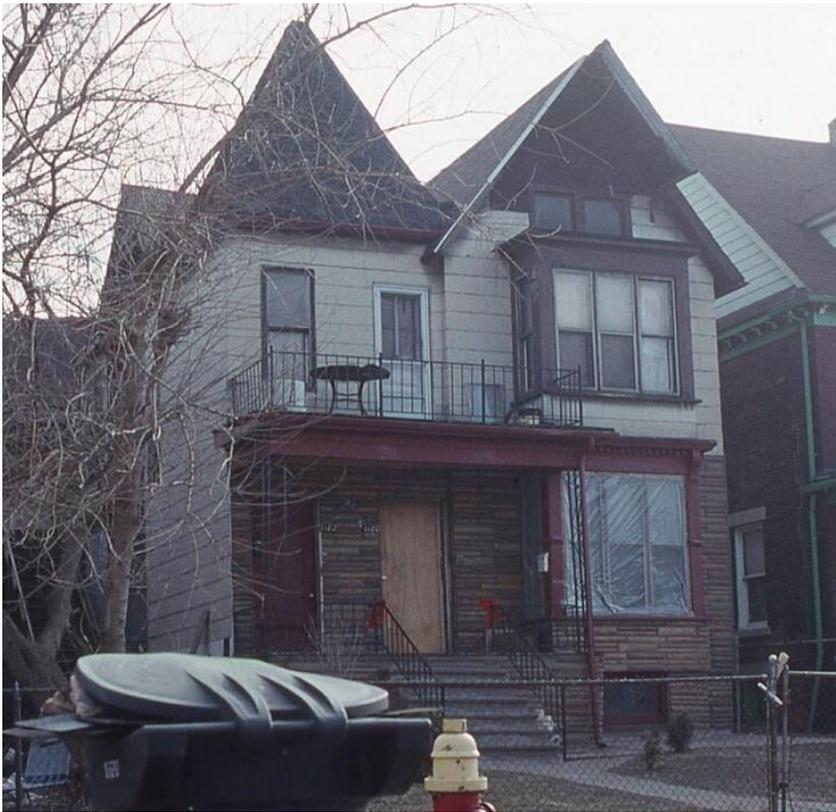
The house around 1993. Photo by the Historic Designation Advisory Board.

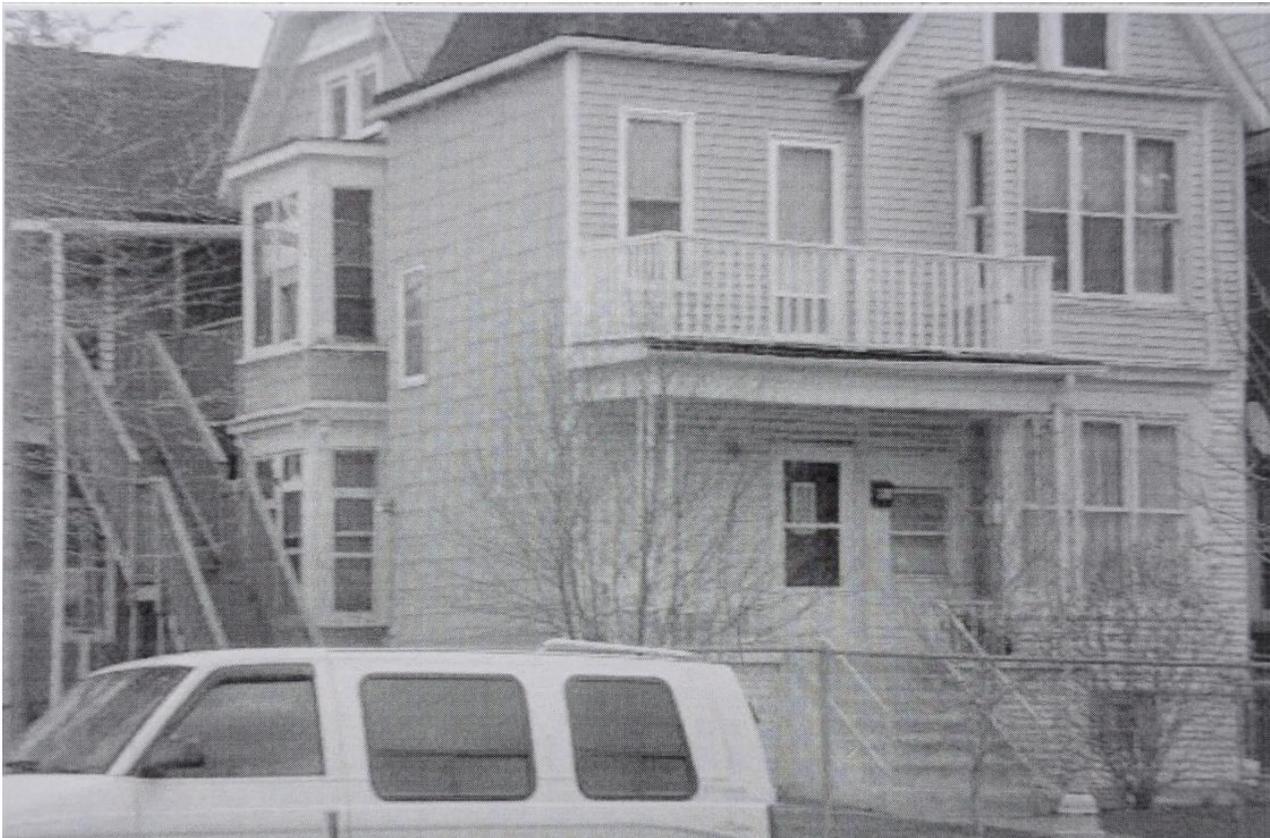
The house in 2006. Photo by staff.

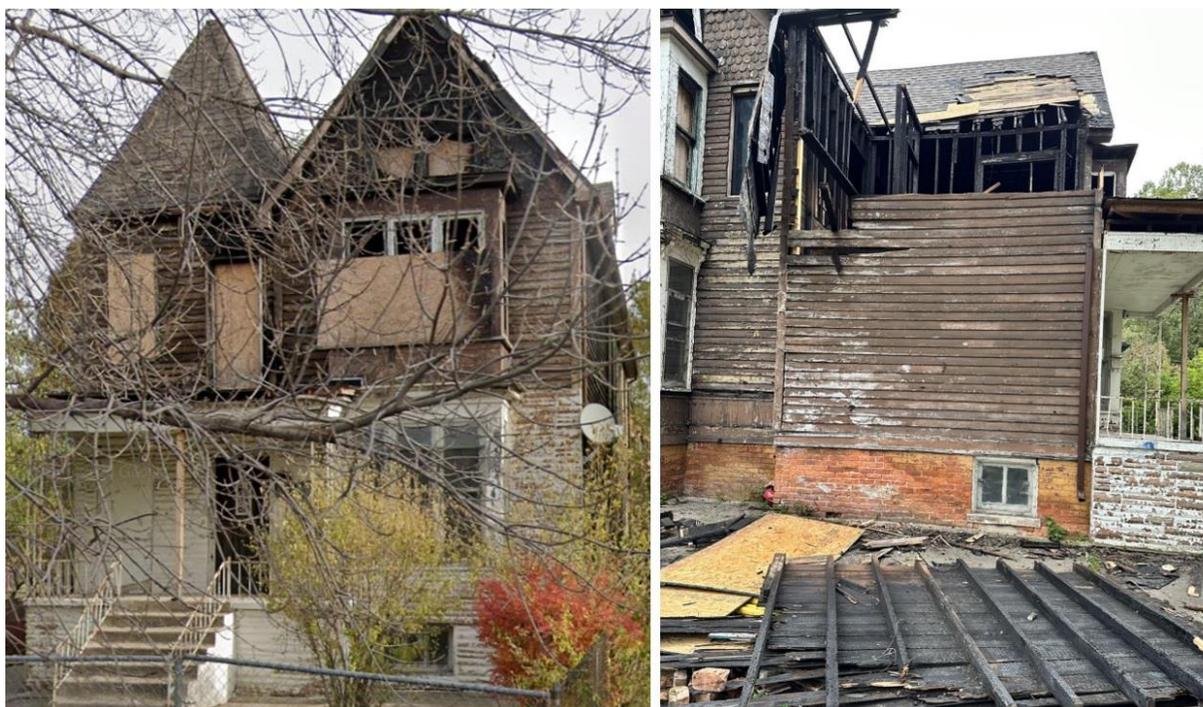
Left: November 2020 photo from Google Street View. Right: Image from 2023 application documents, view from the north. Note that the pyramidal roof tower is missing; red arrow is added by staff to indicate former tower location.

At some time between May 2019 and November 2020¹ a fire damaged the house's second story and attic half-story. The fire caused damage to the interior framing of the building, as seen in a photo provided by the applicant, and also caused damage visible on the building exterior.

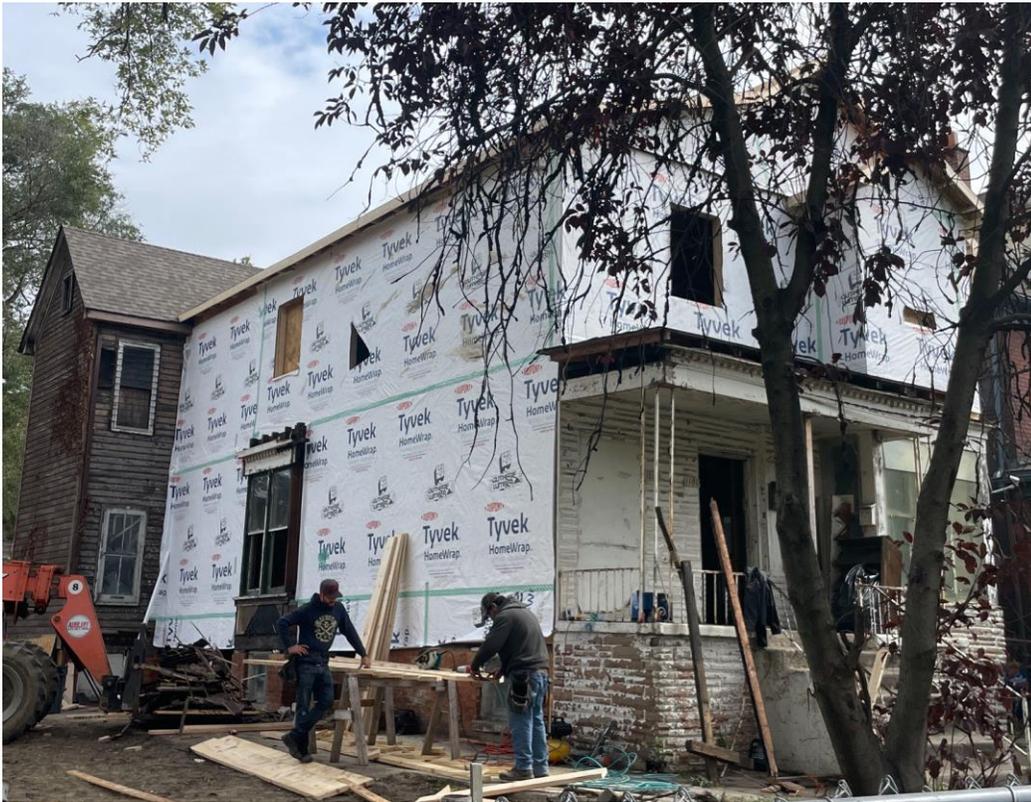
In 2023, staff observed extensive work completed at the property without Historic District Commission approval. Perhaps most noticeably, the attic half-story had been shortened, eliminating its pyramidal tower, front-facing gable, north-facing cross gable, and south-facing dormer. The fenestration pattern had been altered, with many window openings reduced in size or eliminated altogether. The footprint of the north wall was expanded slightly, eliminating a recessed central section and creating a solid plane. The north-facing box-bay window had been reduced from two stories to one, and the front-facing box-bay window had been altered by either removing or covering over a Classical entablature with dentils and adding a gable to the top of its second story. Expanses of building paper suggest that much of the historic siding had been removed as well. A few historic, wood, one-over-one or two-over-two windows remained on the building, along with Classical trim on the historic porch and what remained of the north-facing box bay window.

October 11, 2023, photo by staff.

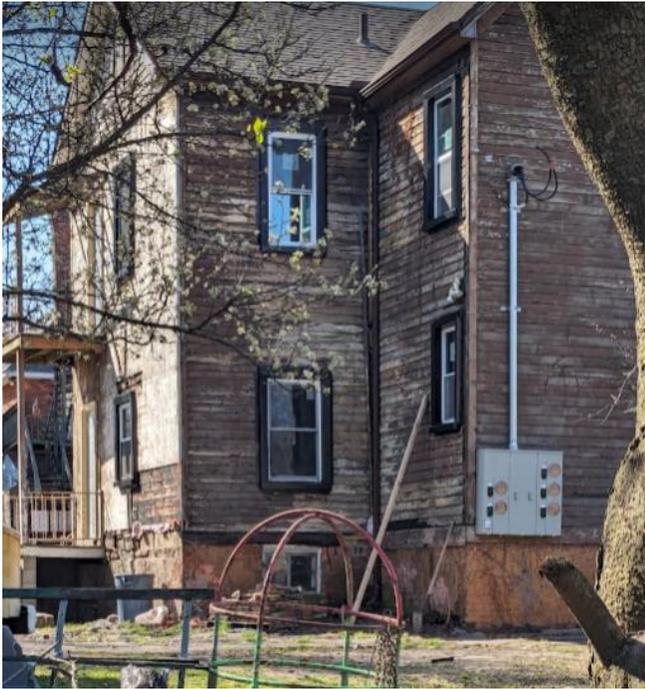
After the Stop Work order, staff observed additional work on the house: New electrical service connections were added on the exterior, north elevation. This work was visible on April 5, 2024, but not present on March 28, 2024.

April 2024 staff photo; new electrical service connections visible at bottom right.

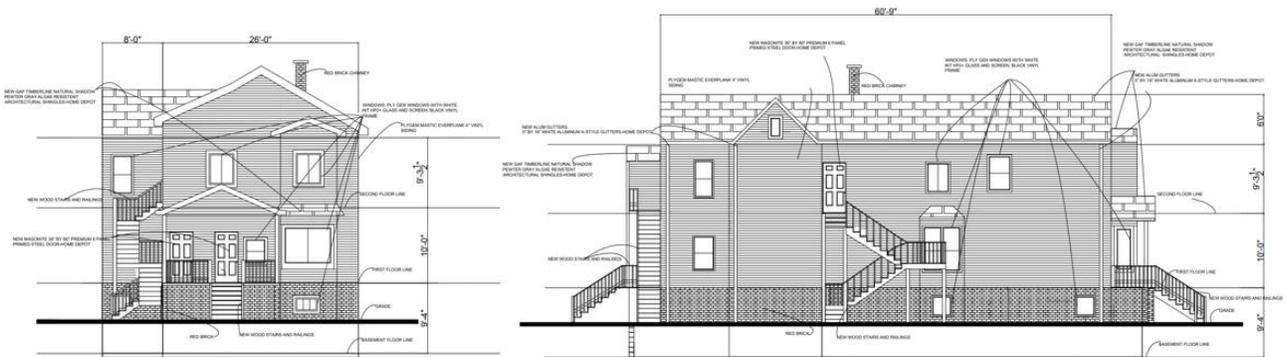
West (left) and north (right) elevations of proposed work. Please see application materials for full drawing set.
