**STAFF REPORT:** 04/10/2024 REGULAR MEETING

**APPLICATION NUMBER:** HDC2024-00115

**ADDRESS:** 4093 CORTLAND

**SCOPE:** REPLACE ORIGINAL WINDOWS WITH VINYL WINDOWS, REMOVE AWNINGS

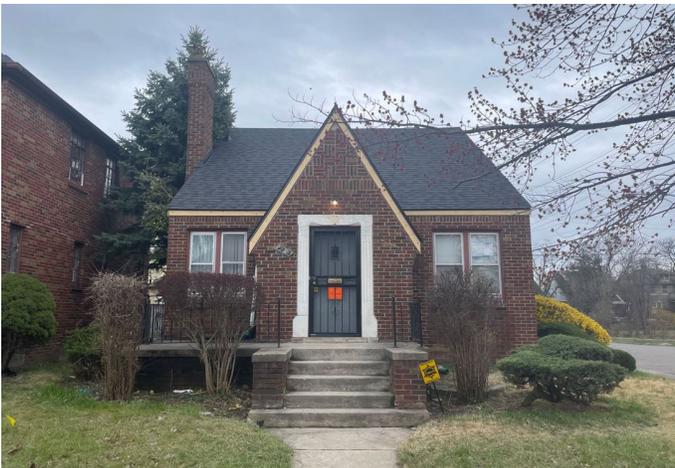
*Site Photo 1, by Staff March 26, 2024: (North) front elevation showing original windows in place. The new shingled roof and fascia were installed prior to HDC staff approval.*

- It is staff’s opinion that these original wood windows, their double-hung operation, and 1/1 formation are distinctive character-defining features. From the interior and exterior photos received, most original windows are still in repairable condition in staff’s opinion. Staff has not received a report that states the windows are beyond repair.

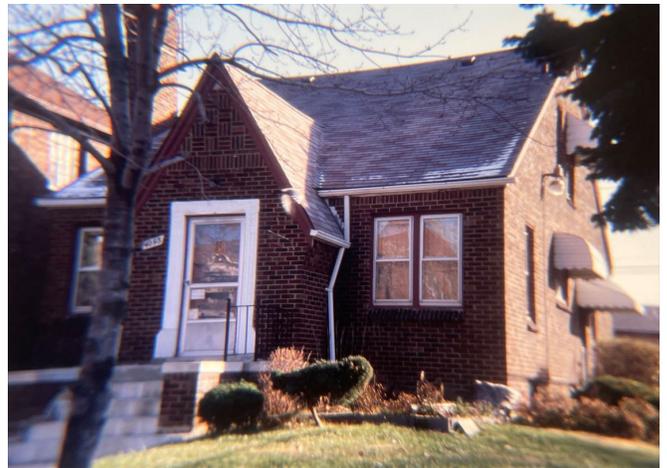
*Designation photo 1999: (northwest) front and side elevations, showing existing, original 1/1 windows and awnings.*

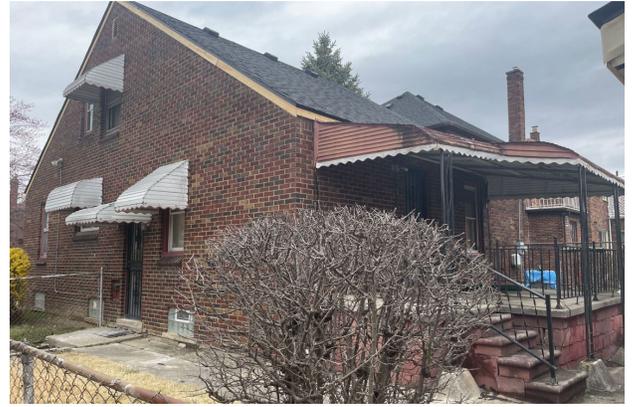
Site Photo 2, by Staff March 26, 2024: (West) side and rear elevation of the house showing existing awnings proposed for removal.

- Staff observed that many of the brickmoulds surrounding the windows have coil stock covers, which the applicant proposes to remove during replacement of the windows. It is staff's opinion that that removal of this non-historic feature is appropriate while maintaining the original windows and brick mould.
- It is staff's opinion that the awnings are not distinctive, historic character-defining features, and therefore their proposed removal is appropriate.

It is staff's opinion that the removal of the awnings and coil stock is appropriate. Staff therefore recommends the Commission issue a Certificate of Appropriateness for the work because it meets the Secretary of the Interior Standards for Rehabilitation and the Russell Woods-Sullivan Historic District Elements of Design.

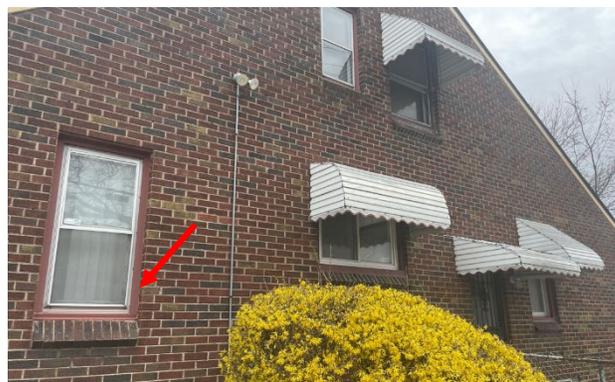
- Staff observed that one of the original windows of the house may have been previously replaced: an existing slider windows on the west side of the house. Staff observed that this property has previously received a COA for the replacement of a window and two doors due to a fire damage in 2005. Staff does not have records of exactly which window was replaced at that time, it is likely that this kitchen window may be the one that was replaced. It is staff’s opinion, however, that the proposed replacement of slider windows with a vinyl slider window, would not be appropriate. The National Park Service (NPS) Guidelines recommends that any new window at these locations must be *compatible* by reflecting materiality that is harmonious with the house, dimensions and scale that align with the building’s openings and respect the architectural expression of its historic style.

*Site Photo 3, by Staff, March 26, 2024 showing centrally located slider window, proposed awnings to be removed, and coil stock covers (arrow) around existing windows.*

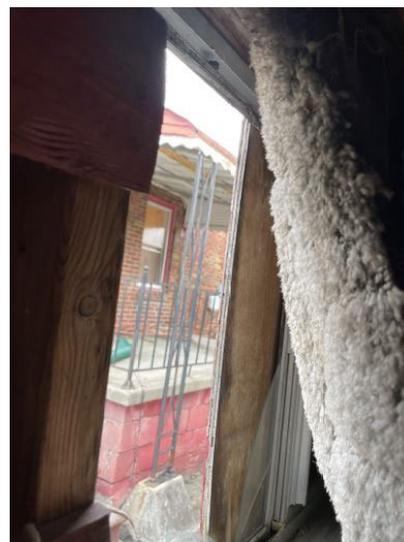
*Site Photo 4, by Applicant, showing interior garage door window slider with wood framing and metal sash, which is proposed for replacement with a vinyl slider.*

- Staff received confirmation that the proposal includes replacement of the garage window with a vinyl slider window. Staff observed that the metal framed slider inserted in the wood frame of this garage window is a replacement of the original wood window. Similar to the proposal to replace the kitchen slider window with a vinyl slider, it is staff’s opinion that replacement of this window with a slider window is not appropriate.
