Edward Palmer
15004 Warwick St.
Parcel#27163044
Historic District:
Rosedale Park, Detroit, MI

To the Historic District Commission:

Photos

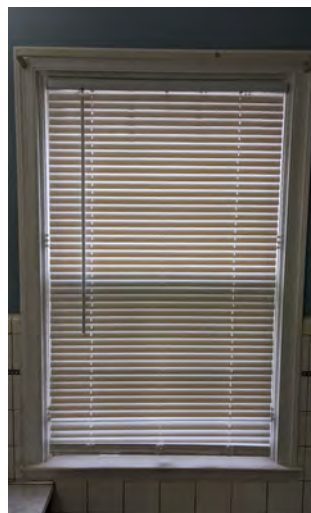
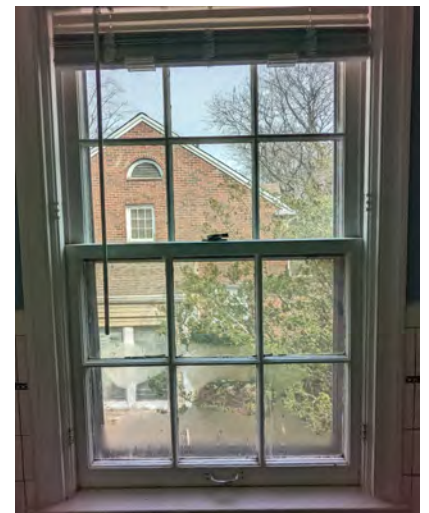
6. Bathroom Window
Has major chipping of paint. Caulking pulling away from brick exterior. single pane glass with bad glazing. No glass storm for lower 1/2. Condensation that pools on interior as seen in the detail picture to the right.

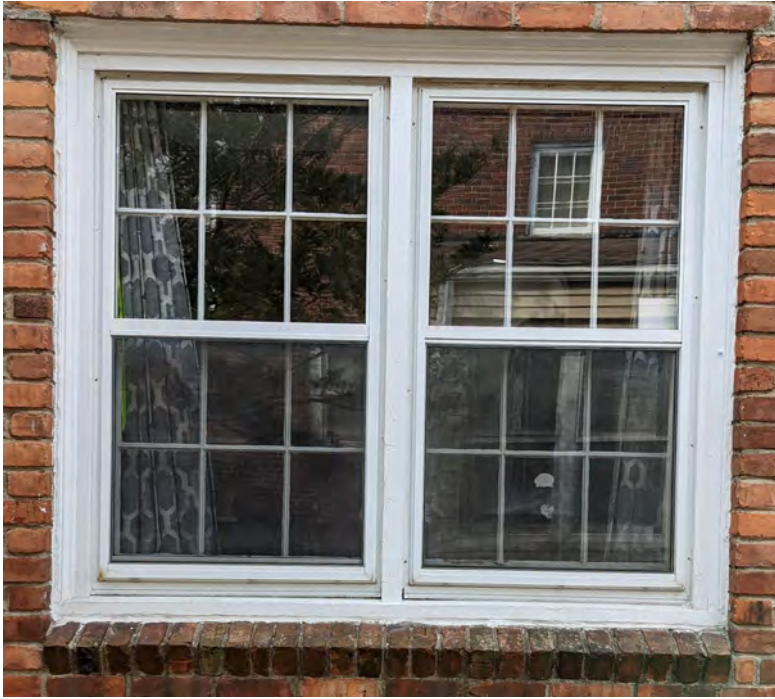
Windows 9 and 10 I refinished the exterior During the Covid shutdown period in 2020. The grills glazing is chipping and lifting. The storm is a white aluminum. One of the many styles of storm mix matched across the home.

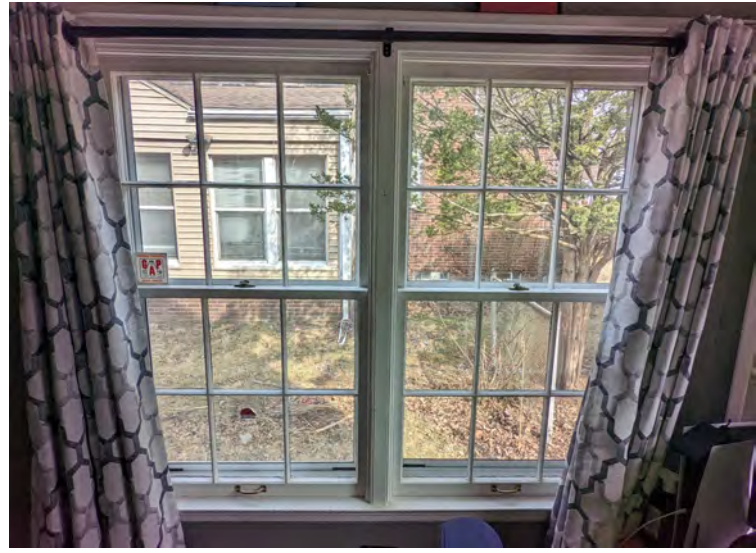
Interior view of 9 and 10 although may look ok in this photo they also suffer from moisture pooling on sills and has mold growth. Windows 8, 9, and 10 all have a screen insert as well as glass storm system which is the white aluminum and have faired the best in the existing wood windows because of it.

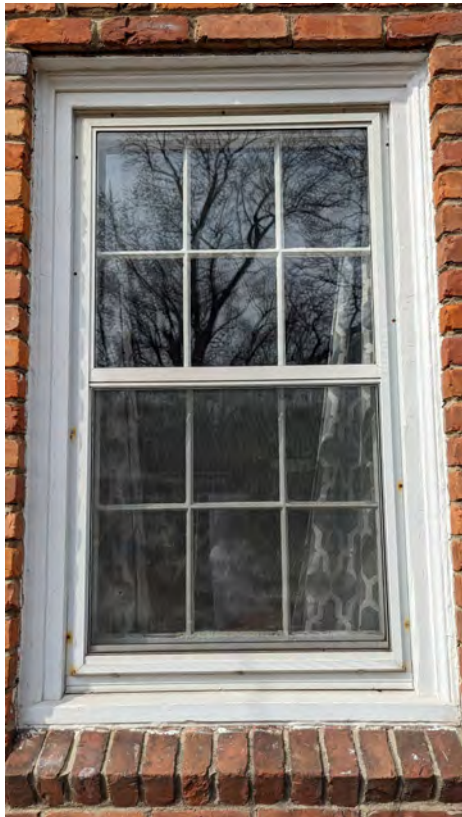
8. exterior view rusting frame and fasteners

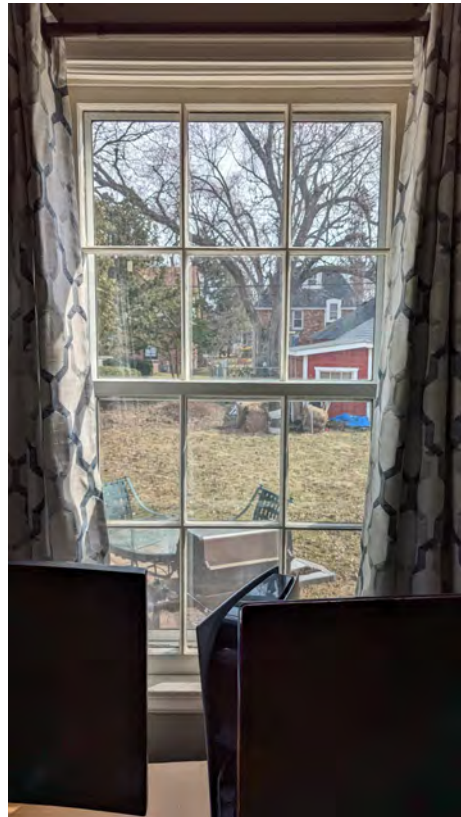
8. interior view also pools moisture

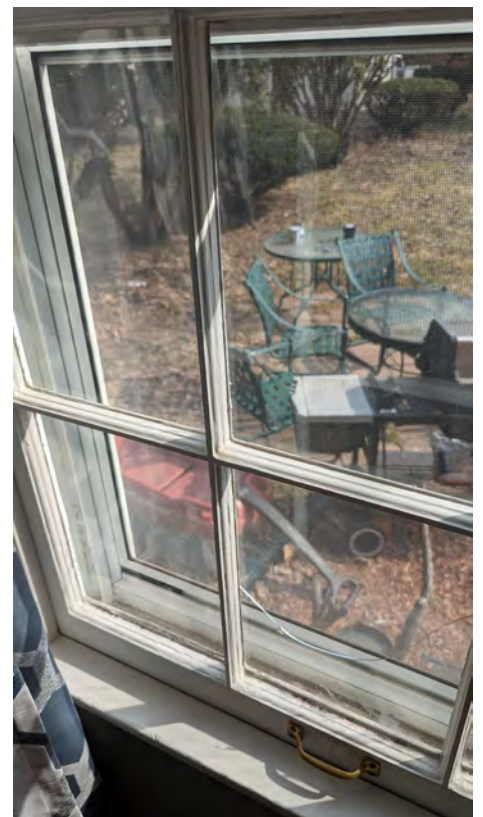
8. interior detail view. notice cracked pane and moisture

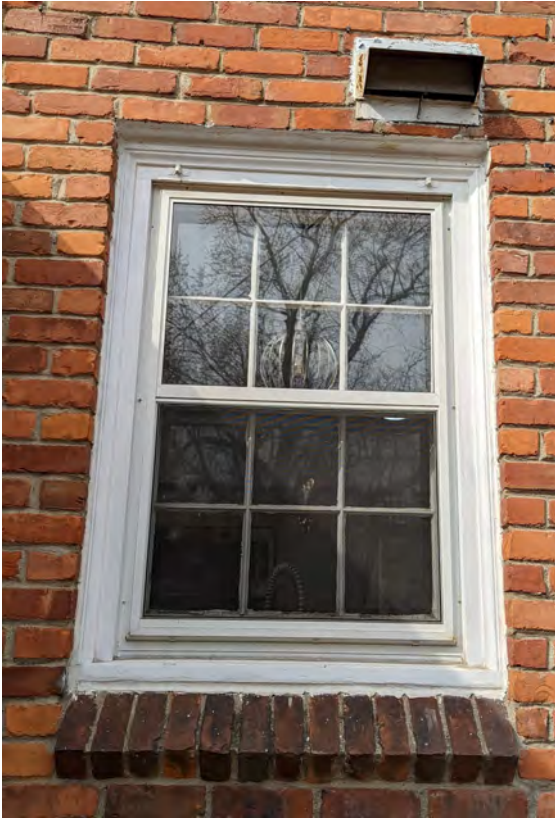
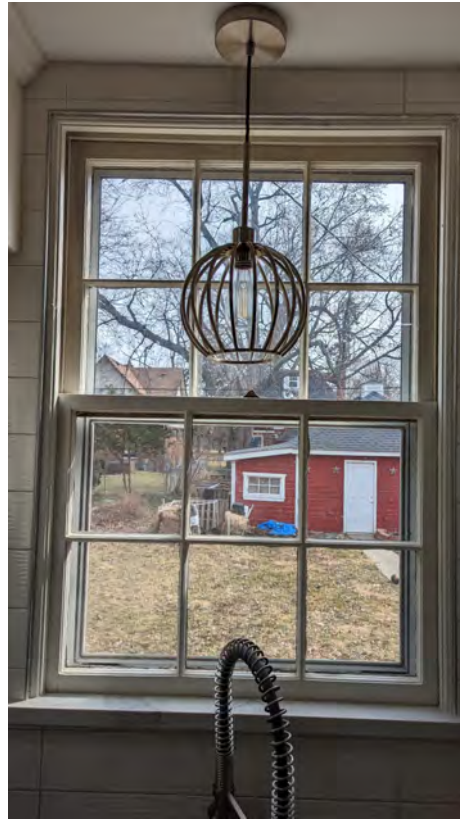
11. Kitchen Sink window
This is another window I have attempted to repair. This lower glass portion of this storm is missing and therefore deals with a lot of moisture pooling. The interior of this window was painted in 2021 with a high quality latex paint and it still has visible mold on the lower sill when you zoom into the photo. The sound of the wind is pronounced at this window and we fear is a major point of escaping heat and energy loss.

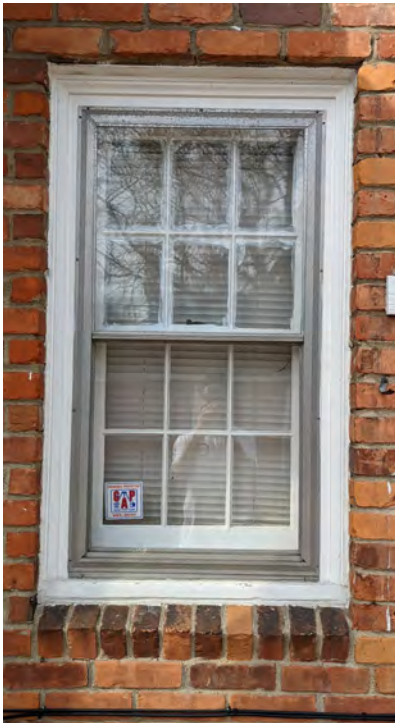
12. Kitchen half bath exterior

These photos are a good demonstration of my best attempt at repairing the grills and properly repairing the window glazing. As you can see from the interior photo that the moisture that collects inside still damages and molds when left unchecked even for a short amount of time. Interior and exterior was painted at the same time. We do not lift up the blind on this window and was shocked to see this current state. Notice and make note of the bare aluminum storm window.

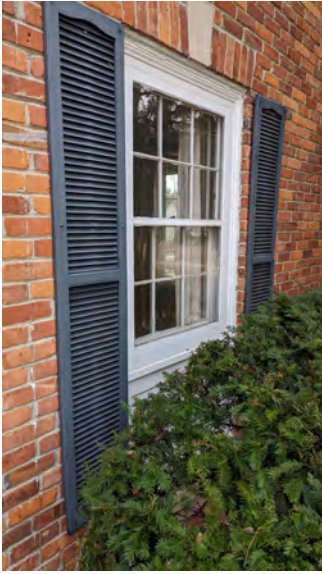
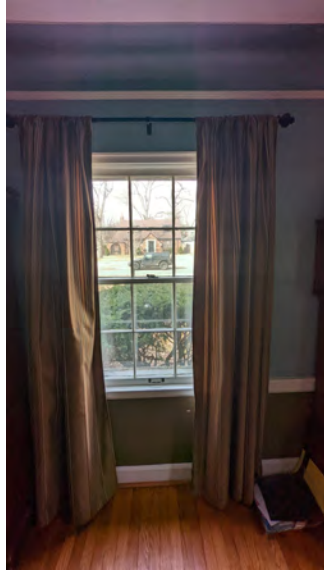
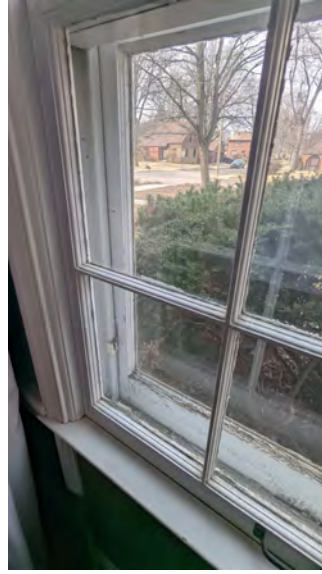
2. Dining Area Exterior, Dining Area Interior, and Dining Area Interior Detail (L to R)

In this set of 2. Dining Area Window photos to the left you will notice the third style of storm window. There is only 2 of this style of storm in the home, here and found in the Living Room. These windows have shown very little moisture on the interior sills. I would attribute this in all most likely hood to have had caulked the storm shut when I repainted the exterior.

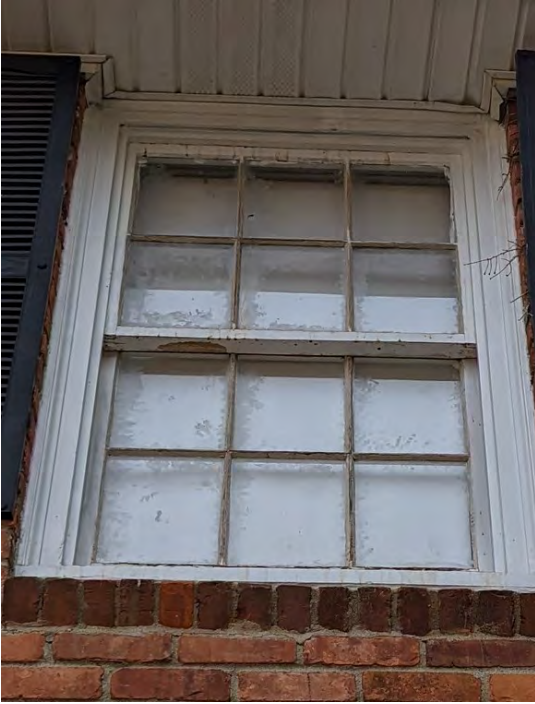
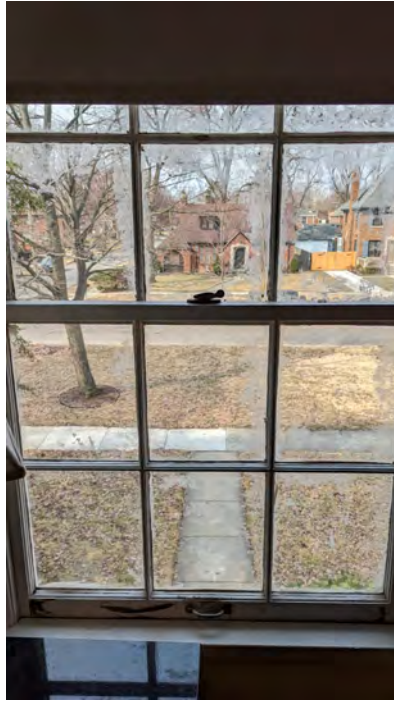
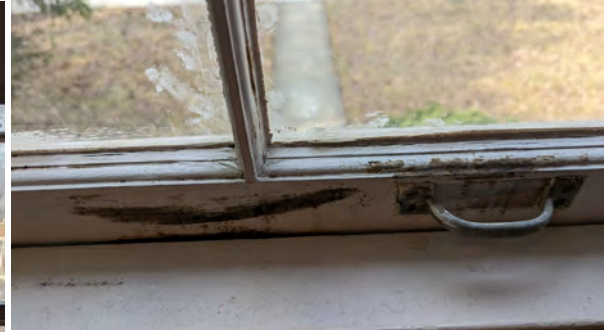
4. Upstairs Bedroom 1 Exterior, Interior, and Interior Detail.

*Note Storm is missing completely from this window and lets in a massive draft. In the exterior photo you can notice fresh window glazing that is unpainted due to weather temp dropping last year before we could complete the restoration of the panes. Major mold growth this year discovered at time of taking these photos.
