EXISTING RESIDENTIAL GARAGE STRUCTURAL ASSESSMENT REPORT

Project: Existing Residential Garage Assessment

19690 Shrewsbury Rd.
Detroit, MI 48221

CURRENT STATE OF GARAGE DISREPAIR

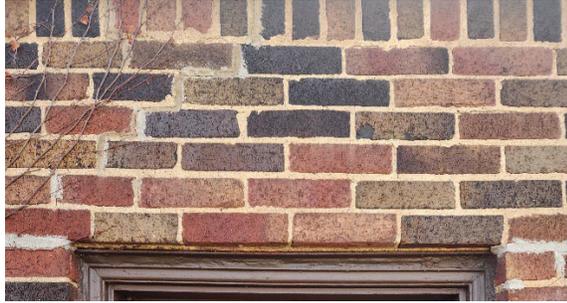
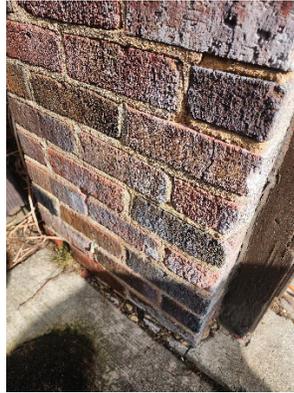
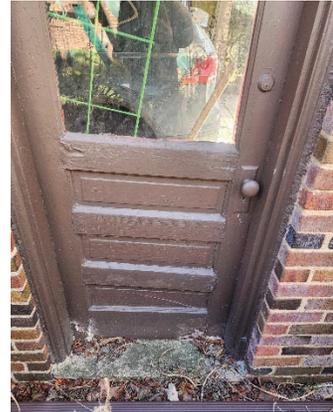
- **Foundation:**
 - Upon assessment of the foundation, cracking and displacement of below-grade foundation are likely present and have caused resultant cracks and shifting in above grade brick wall. This may be due to frost heave during unseasonably cold winters where frost depth exceeded the 42" inch below grade design standard.

- **Walls:**
 - **Masonry walls:** single wythe brick masonry wall was observed to have vertical cracking indicating foundation issues.
 - **Stud framed walls:** Base plates of stud walls were observed to have dry rot due to periodic exposure to moisture. Dry rot was also observed on the first approx. 4" of studs in several locations.

Vertical cracks in mortar throughout garage indicate foundation issues. Door is no longer functional

Multiple structural issues were observed during our site visit leading to a conclusion that repair of the garage is not a viable option. We conclude that demolishing the structure in its entirety and building a new structure is the best course of action.

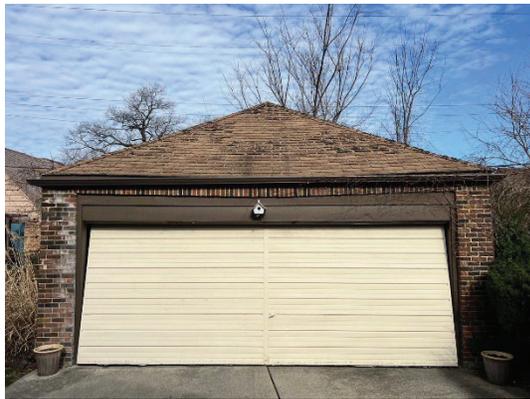
- **Garage door lintel:**
 - Sagging in the steel lintel above the garage door was observed. This may be due to inadequate beam sizing during original construction and/or loss of cross-sectional area over time from rusting. This sag has caused mortar joints to crack and bricks to be displaced. The cracking has also allowed more water to penetrate to lintel exacerbating rust.

Sagging above garage door

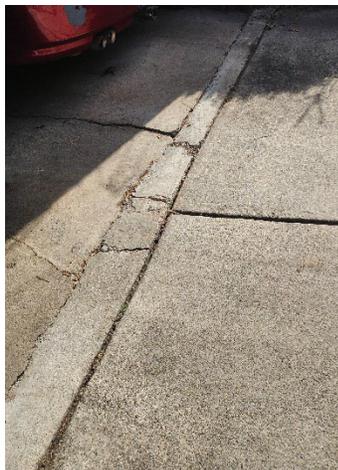
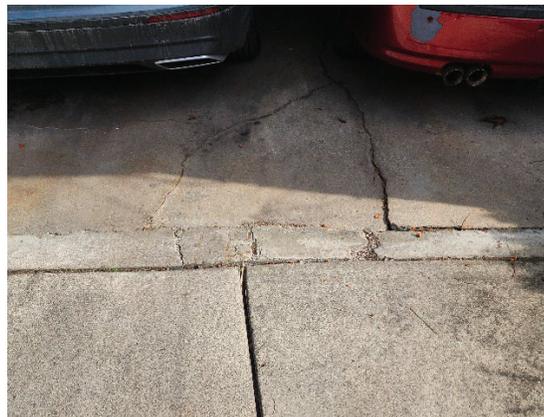
- **Slab:**
 - A longitudinal crack in the concrete floor slab was observed and the elevation of the slab measured to be higher along this crack line suggesting damage from frost heave.

Uneven concrete slab with crack down the center, moisture comes up from ground

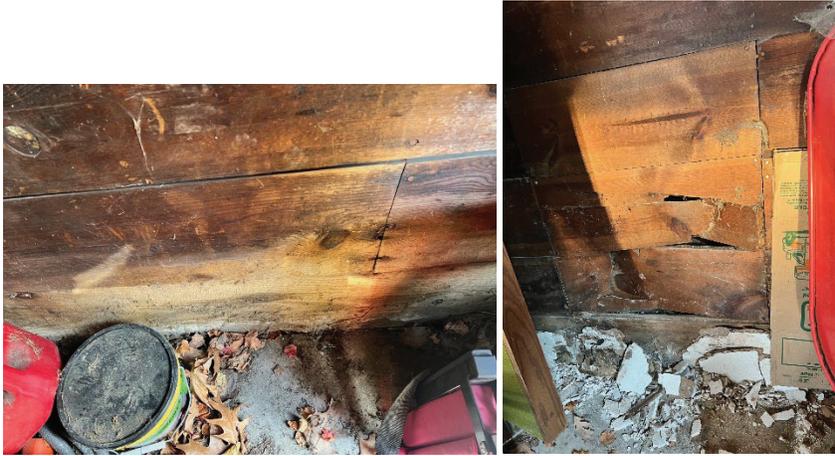
Base plates of stud walls have dry rot due to periodic exposure to moisture.
Dry rot was also observed on the first approx. 4" of studs in several locations
