Building 107: Duplex Officer's Quarters

Construction Date: 1890

Condition: Poor¹

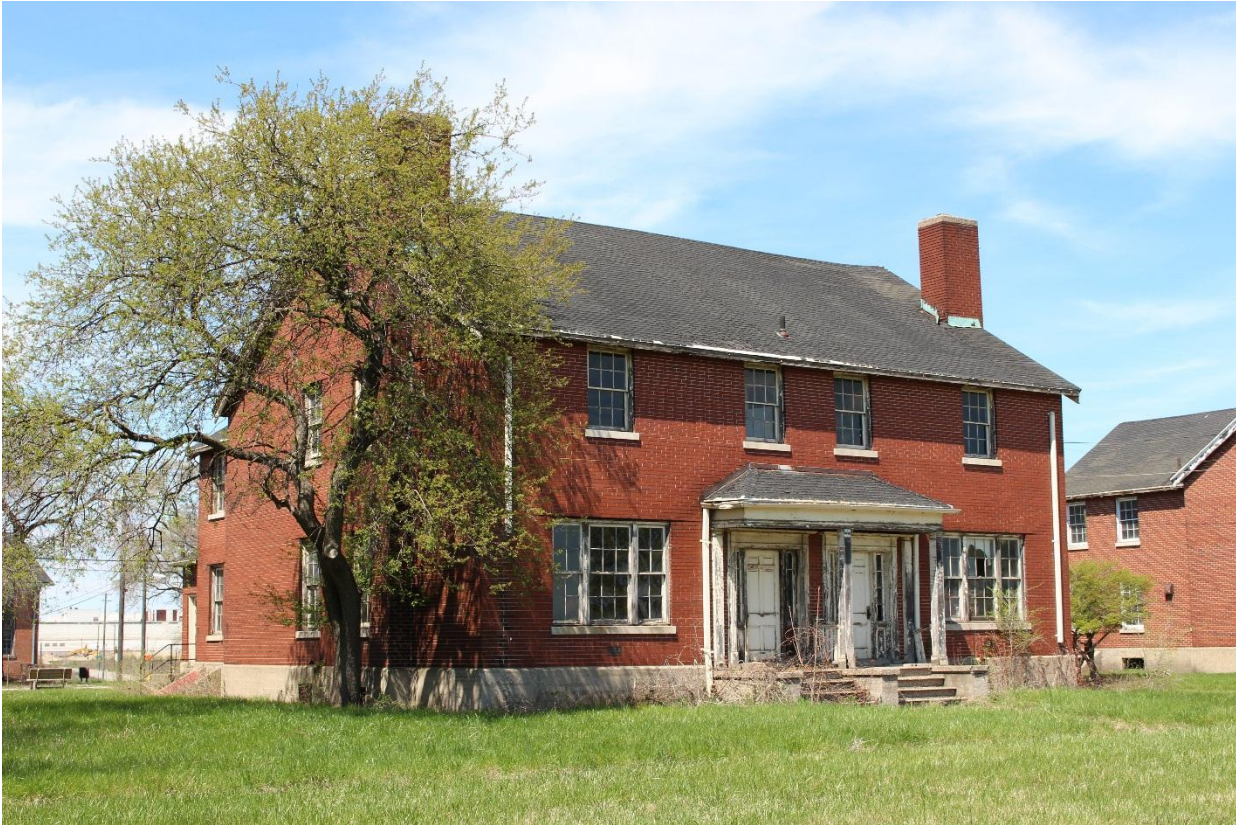
Front (southeast) facade, April 2019

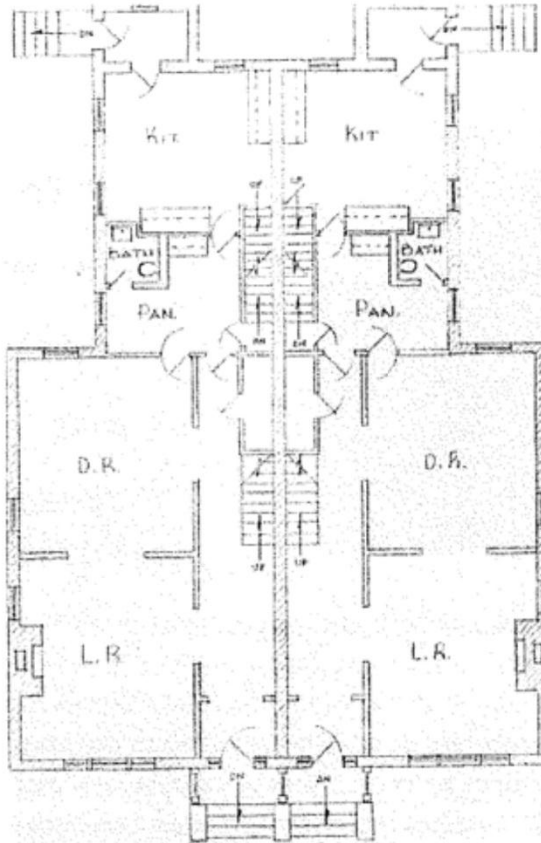
FIRST FLOOR PLAN
 BUILDINGS 105, 106, 107, 108, 111 & 112
 FORT WAYNE
 SCALE: 1/8" = 1'-0" JULY 1974

Interior Description: This duplex residential building is two stories with full basement. Each unit's first floor consists of a front entrance vestibule, front hall, living room, dining room, pantry, half bath, kitchen, and rear entrance. The front stair to the second floor is open to the front hall. The rear stair to the second floor is accessed from the kitchen. The second floor contains a stair hall, three bedrooms, closets, and two full three-piece bathrooms. The two main floor levels have fully plastered walls and ceilings. All original plaster and woodwork was removed and replaced in 1935-39. Primary floors are wood some of which are covered with carpet. The entrance vestibule has a quarry tile and ceramic tile wainscot (1935-39). The bathrooms have ceramic tile floor and wainscot (circa 1935-39). The basement is subdivided into several separate rooms and a central hall. Major walls are masonry and there are plastered ceilings throughout.
