**REQUEST FOR EGLE REVIEW –
 RESPONSE ACTIVITY PLAN TO COMPLY WITH 7A(1)(B)**

Section A: Submitter Information			
Legal Entity/Person requesting review: MLK on 2 nd Limited Dividend Housing Association, LLC		Complete if contact for questions if different from legal entity: Relationship of contact person to the submitter: Consultant	
Street Address: 32500 Telegraph Road, Suite 102		Contact Name: J. Adam Patton	
City: Bingham Farms	State: MI	Zip: 48025	Contact Title: Vice President
Contact Name: T. Van Fox		Street Address: 4080 W. 11 Mile	
Contact Title: President		City: Berkley	State: MI Zip: 48072
Phone: 248-833-0550		Phone: 517-202-4288	
Email: vanfox@mhthousing.net		Email: patton@pmenv.com

MLK on 2nd Limited Dividend Housing Association, LLC intends to develop the subject property with a mixed use residential and commercial multi-story building (Figure 2). The assessing information and Proposed Development Site Concept Drawings and Renderings for the subject property are included as Appendix A. The proposed development plans are illustrated on Figure 2. MLK on 2nd Limited Dividend Housing Association, LLC intends to construct one four-story, slab-on-grade foundation with an ele

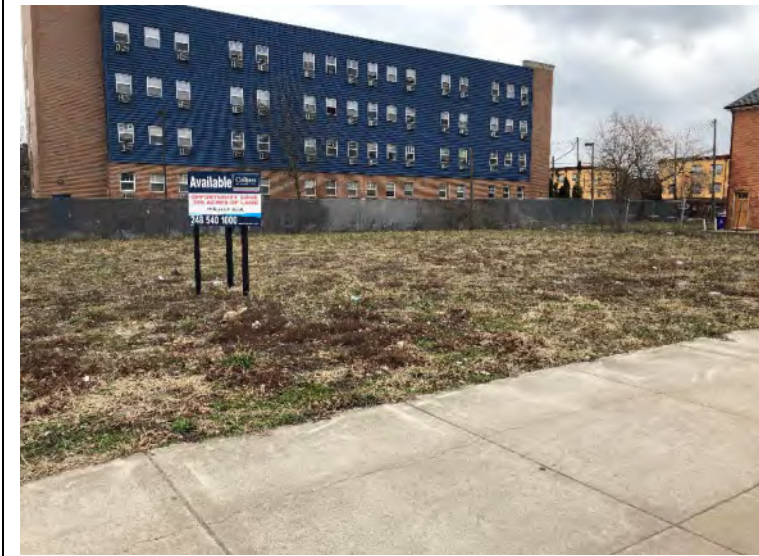
Photo 1. The Subject Property, facing northwest near the corner of MLK and 2nd

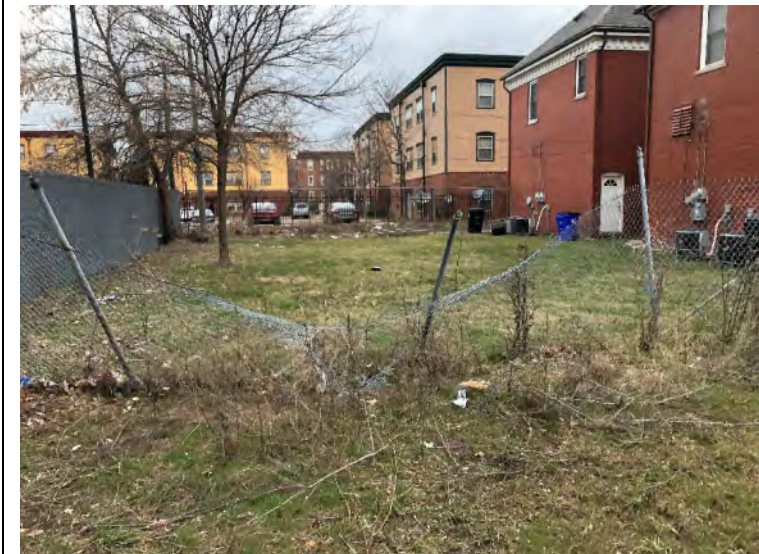
Photo 3. The fence-enclosed area near the north adjoining dwellings

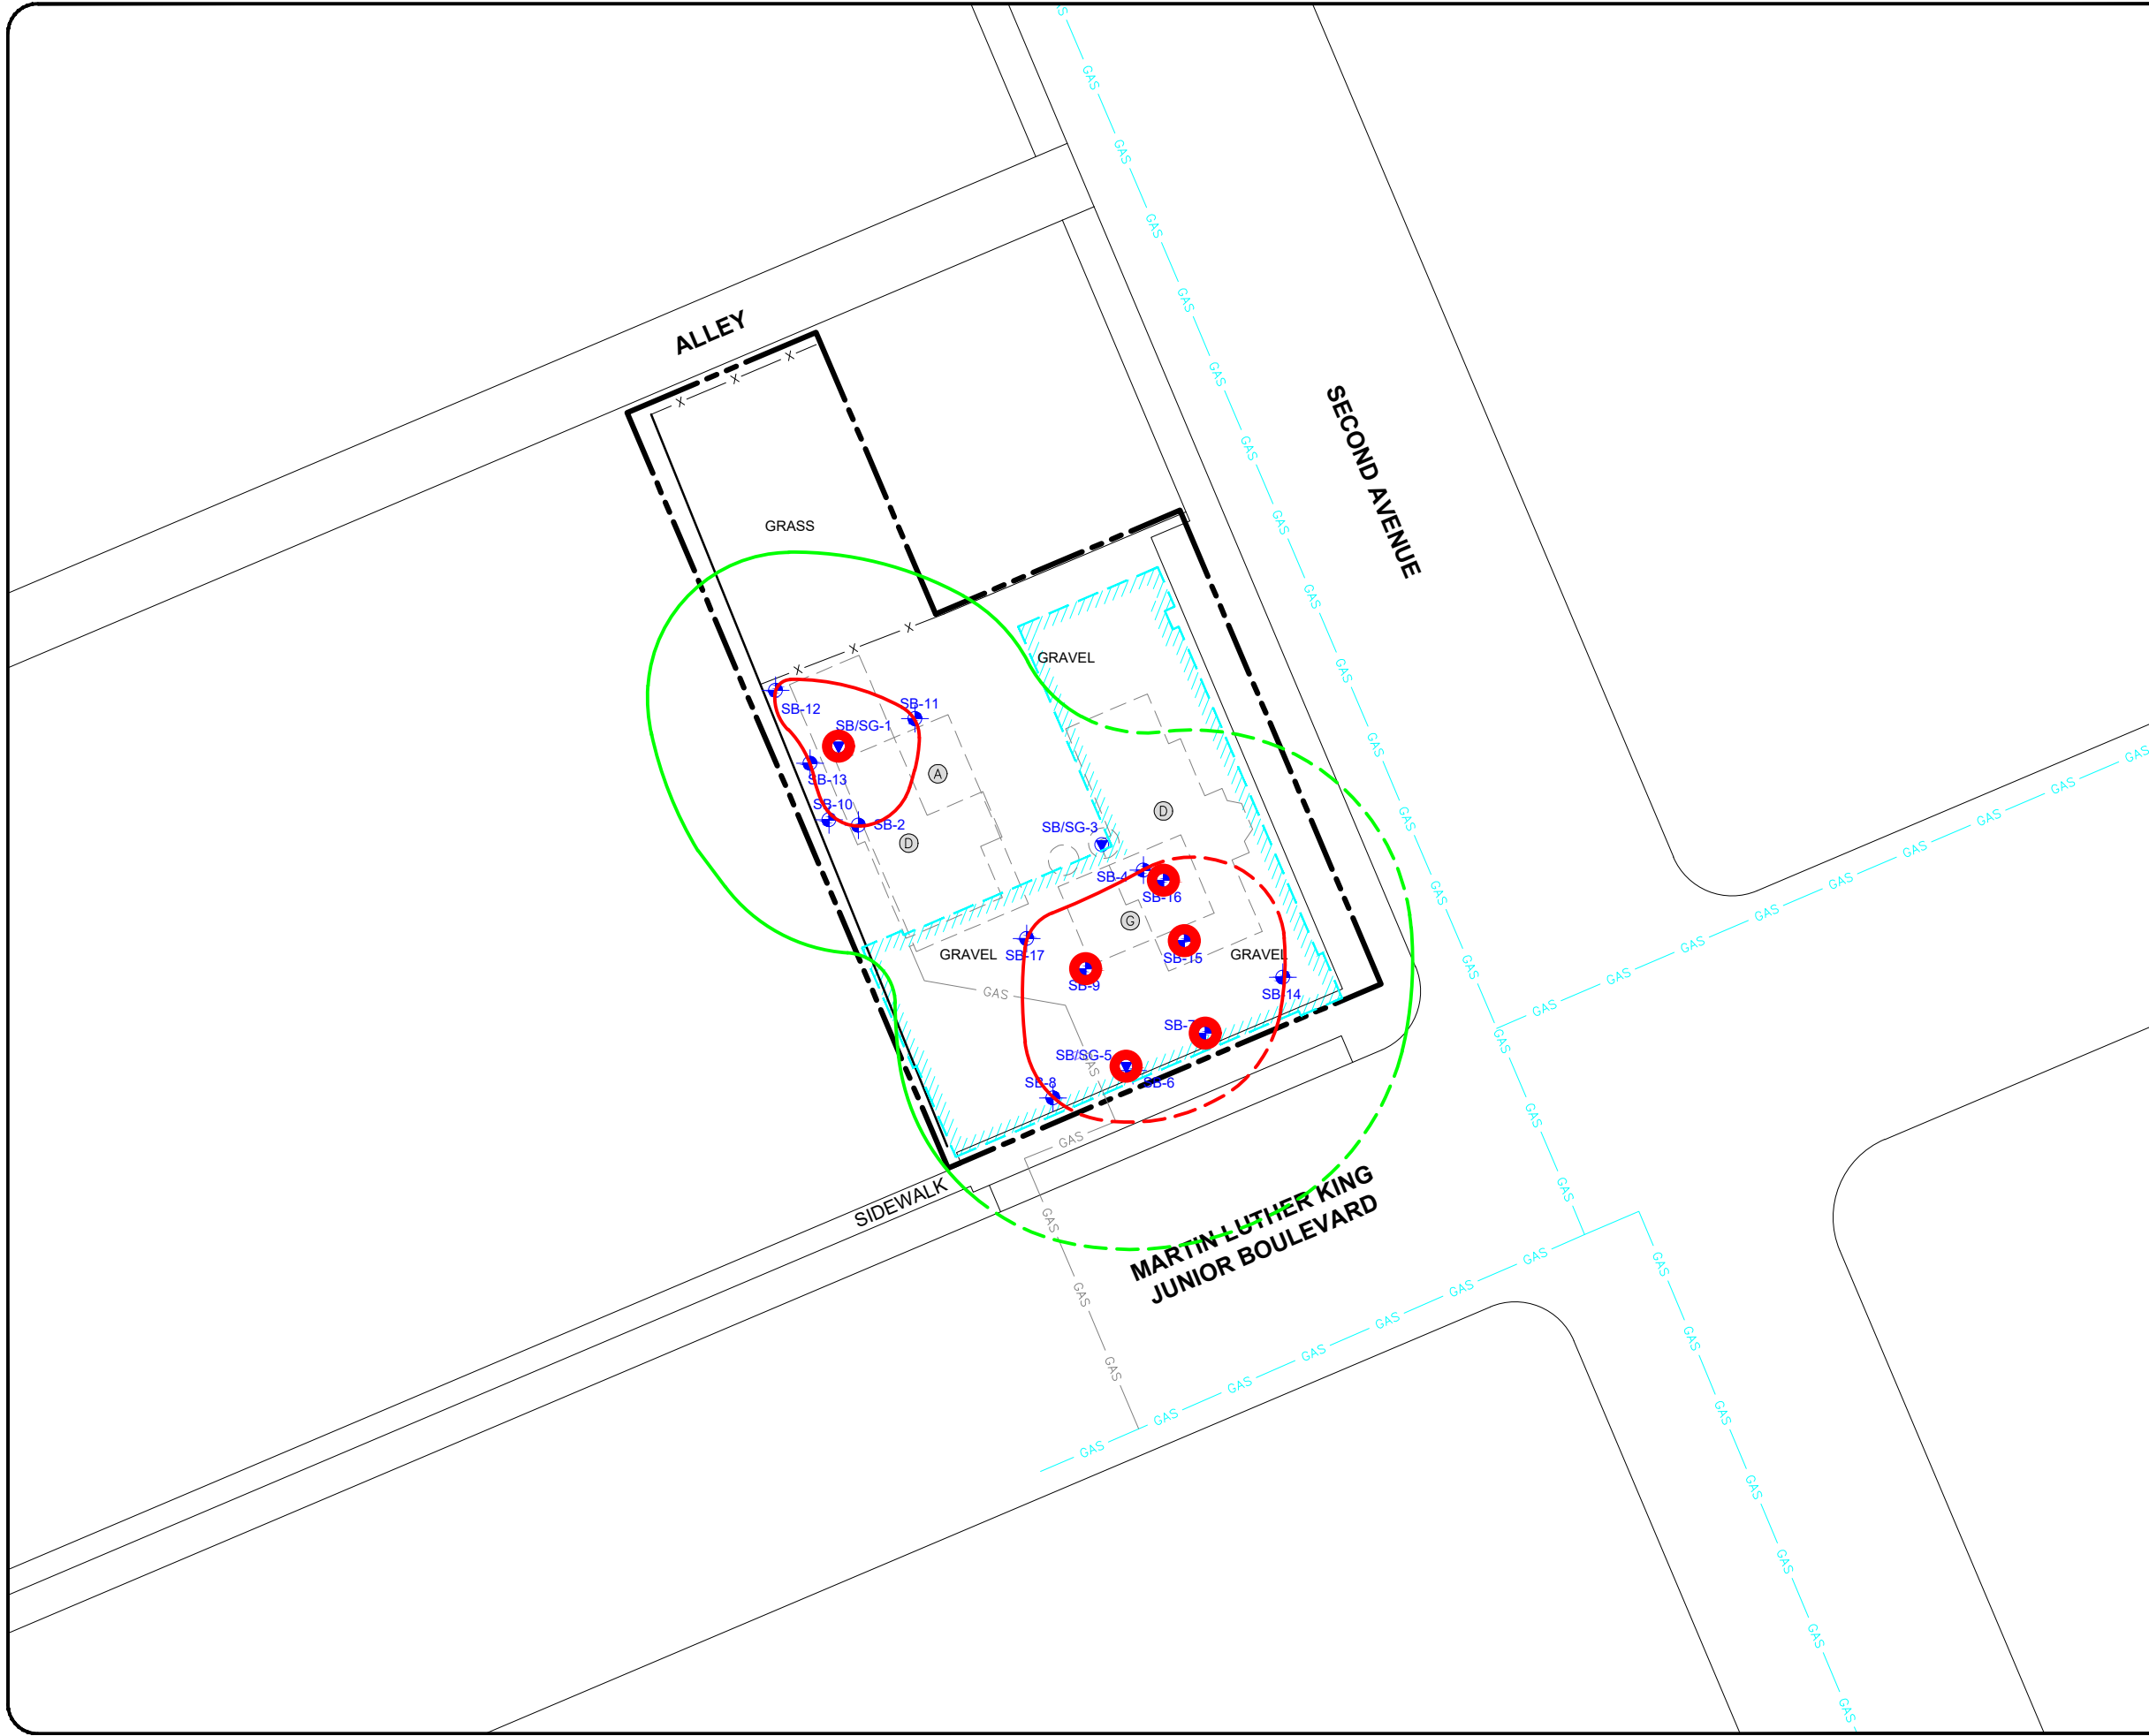
FIGURE 2
SUBJECT PROPERTY AND ADJOINING PROPERTIES
WITH GPR SURVEY AREA

SUBJECT PROPERTY
	APPROXIMATE FORMER/HISTORICAL SITE FEATURES
	FENCE
	GAS
	GAS
	PROPOSED SITE FEATURES
	UST
	FORMER AUTOMOTIVE / BATTERY / TIRE SHOP
	FORMER DWELLING
	FORMER GASOLINE FILLING STATION / DISPENSERS / UST
	SOIL BORING
	SOIL GAS SAMPLE
	EXTENT OF PLUME
	ESTIMATED EXTENT OF PLUME
	LATERAL INCLUSION ZONE
	ESTIMATED LATERAL INCLUSION ZONE
	SSSVIAC PETROLEUM SOIL / SOIL GAS EXCEEDANCE LOCATION

The subject property consists of one parcel of land totaling 0.356 acres and is located on the northwest corner of Martin Luther King Jr. Boulevard and 2ND Avenue, in Detroit, Wayne County, Michigan (Figure 1). The subject property is currently vacant and contains areas of gravel and grass. The northern portion of the property is surrounded by chain-link fence (Figure 2).

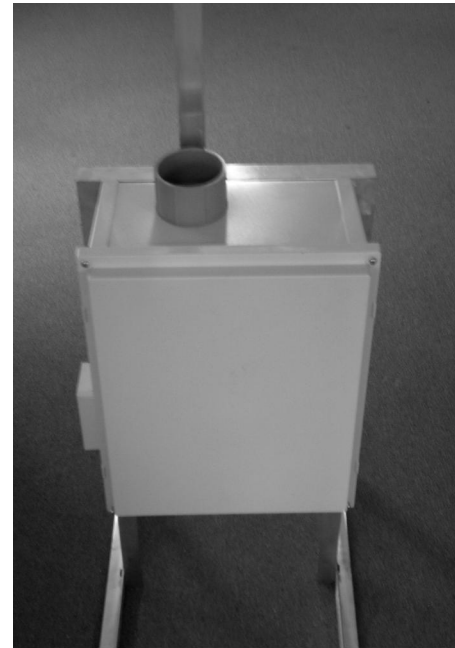
GBR89 WITH ROOF MOUNT

- GBR89 HA 14" WC at 100CFM max flow 500 CFM.
- Built in speed control to customize performance.
- Condensate bypass built in.
- 12 month warranty 40,000 hr sealed bearings.

- Our modular design means the blower and manifold assembly can be removed and replaced as a unit. This makes repairs cost effective and easy and allows contractors to upgrade systems simply by swapping assemblies.
- The GBR series is based on a bypass blower designed to handle combustible materials.
- The housing is not required to be air tight so you can add gauges and alarms without compromising the system.
- Built in condensate bypass.
- Built in speed control.
- Quick disconnect electrical harness.
- All UL listed components including UL listed enclosure for outside use.
- Wall fastening lugs included.
- GBR series roof and wall mounts available to quickly configure the blowers for your installation while providing a custom built look.
- Compact design 18"x 16"x 10" weighing only 18 lbs.
- 4" schedule 40 inlet and 6" schedule 40 exhaust.

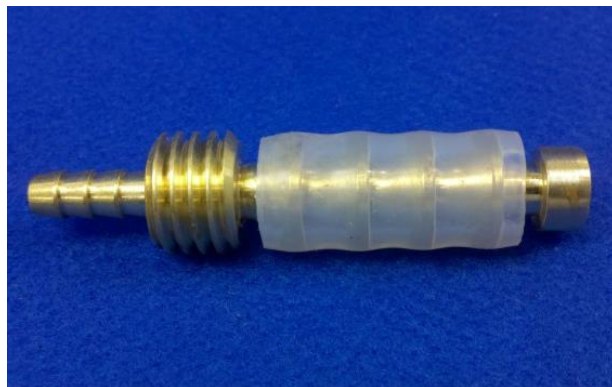
Figure 1. Assembled VAPOR PIN® sampling device

- Dead blow hammer;
- VAPOR PIN® sampling device flush mount cover, if desired;
- VAPOR PIN® sampling device drilling guide, if desired;
- VAPOR PIN® sampling device protective cap; and
- VOC-free hole patching material (hydraulic cement) and putty knife or trowel for repairing the hole following the extraction of the VAPOR PIN® sampling device.

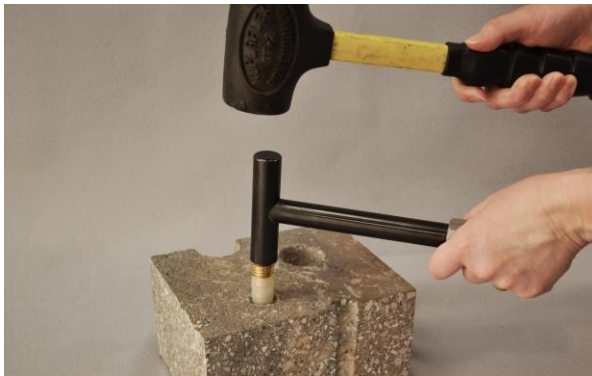
Figure 2. Installing the VAPOR PIN®

- 4) Drill a 5/8-inch (16mm) diameter hole through the slab and approximately 1-inch (25mm) into the underlying soil to form a void. Hole **must** be 5/8-inch (16mm) in diameter to ensure seal. It is recommended that you use the drill guide.
- 5) Remove the drill bit, brush the hole with the bottle brush, and remove the loose cuttings with the vacuum.
- 6) Place the lower end of VAPOR PIN® sampling device assembly into the drilled hole. Place the small hole located in the handle of the installation/extraction tool over the vapor pin to protect the barb fitting, and tap the vapor pin into place using a dead blow hammer (Figure 2). Make sure the installation/extraction tool is aligned parallel to the vapor pin to avoid damaging the barb fitting.

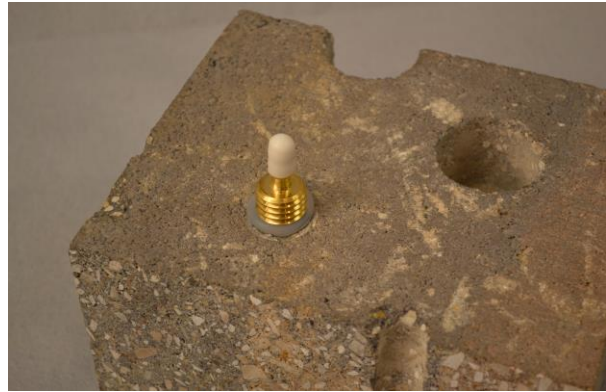
Figure 3. Installed VAPOR PIN® sampling device

During installation, the silicone sleeve will form a slight bulge between the slab and the VAPOR PIN® sampling device shoulder. Place the protective cap on VAPOR PIN® sampling device to prevent vapor loss prior to sampling (Figure 3).

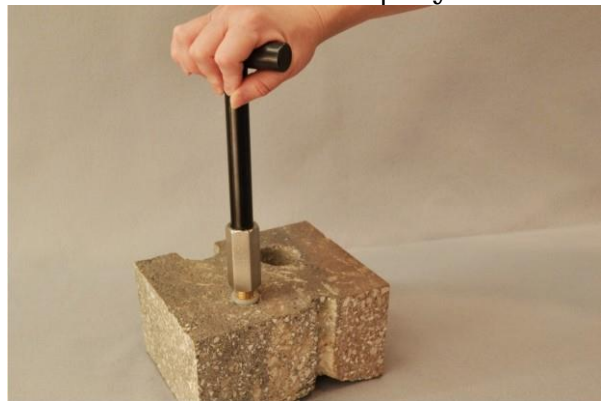
Figure 7. Removing the VAPOR PIN® sampling device

- 1) Remove the protective cap, and thread the installation/extraction tool onto the barrel of the VAPOR PIN® sampling device (Figure 7). Turn the tool clockwise continuously, don't stop turning, the VAPOR PIN® sampling device will feed into the bottom of the installation/extraction tool and will extract from the hole like a wine cork, DO NOT PULL.
- 2) Fill the void with hydraulic cement and smooth with a trowel or putty knife.

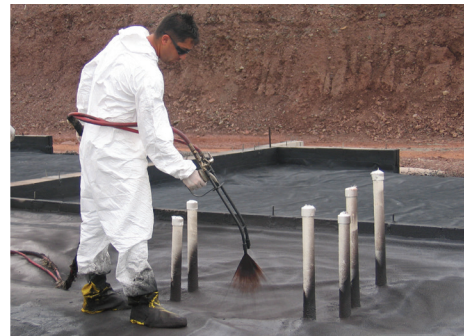
In addition to superior chemical resistance performance, LIQUID BOOT® spray-application effectively seals penetrations, footings, grade beams and other irregular surfaces that are considered critical vapor intrusion pathways.

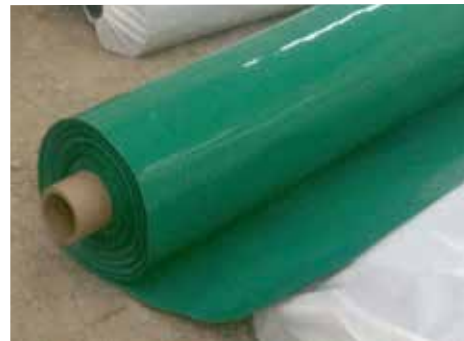
For use as a component of the Liquid Boot® Plus system, VI-20™ geomembrane is rolled out on prepared sub-grade, overlapping seams a minimum of six inches (6"). The geomembrane is cut around penetrations so that it lays flat on the sub-grade and tight at all inside corners. A thin (20 mil) tack coat of Liquid Boot® ("A" side without catalyst) is sprayed within the seam overlap. Once the VI-20™ geomembrane is installed, penetrations are then treated with VI-20™ Detailing Fabric prior to installation of the Liquid Boot® spray-applied vapor intrusion membrane and UltraShield™ G-1000 protection course.

EVOH technology provided in VI-20™ geomembrane has been shown to have VOC diffusion coefficients 20 times lower than an 80 mil (2 mm) HDPE geomembrane.
