**STAFF REPORT:** 04/10/2024 REGULAR MEETING

**APPLICATION NUMBER:** HDC2024-00054

**ADDRESS:** 3669 LINCOLN

**SCOPE:** REMOVE BRICK CARRIAGE HOUSE/BRICK WALL RUINS, ERECT FENCE

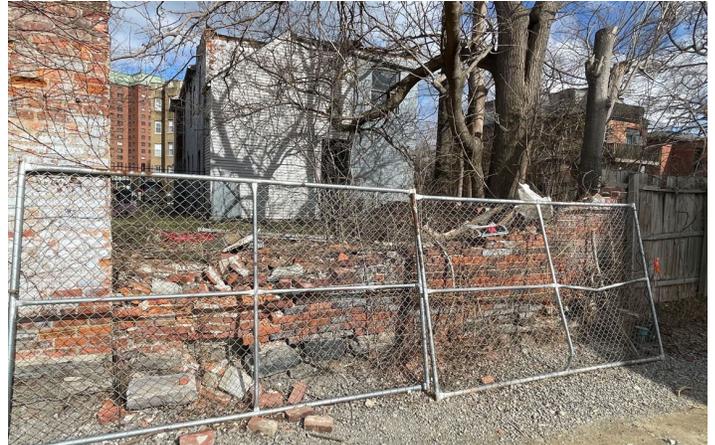
Site Photo 2, by Staff March 20, 2024: (Facing east) showing existing conditions of carriage house/brick wall ruins at alley.

- The applicant provided access to the site for staff. Staff walked the site and took photos and observed existing conditions. After review, it is staff’s opinion that the structure has suffered severe damage and is beyond feasible repair.

It is the staff’s opinion that the demolition of the carriage house and the remaining proposed work are appropriate. Staff therefore recommend the Commission issue a Certificate of Appropriateness for the work as proposed and completed because it meets the Secretary of the Interior Standards for Rehabilitation and the Woodbridge Farm Historic District Elements of Design.

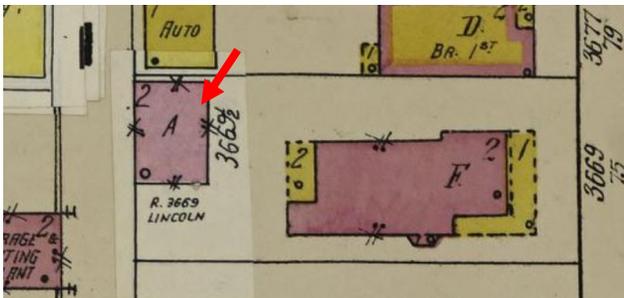
Figure 1 by 1921-1950 Sanborn Vol 2, showing original carriage house (arrow).

- Per Sanborn maps, the carriage house was likely built contemporaneous to the house.
- City building permit cards indicate that the carriage house may have had modifications done in the 1950s to the second floor. Sanborn maps indicate other modifications have been made over time.

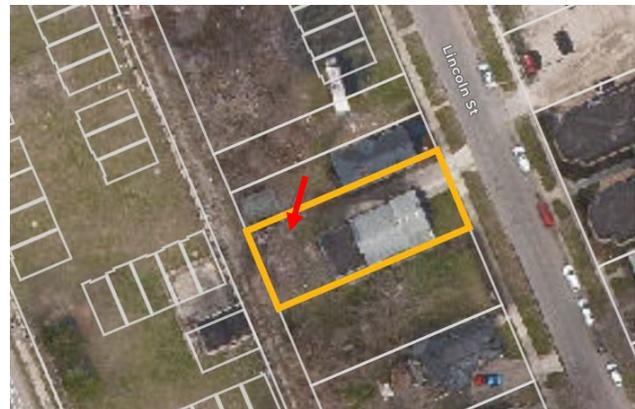
Aerial 1 of Parcel # 06005785 by Detroit Parcel Viewer, showing the former carriage house location (arrow).

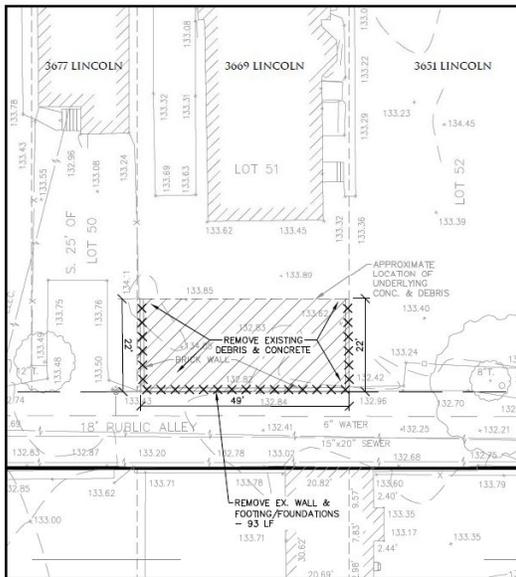
DEMOLITION DETAIL

- Demolish and remove existing carriage house wall, footing, and foundation.
- Remove all excess concrete and debris within 22'x49' area as shown in site plan.
- Add clean dirt and topsoil as needed, fine grade area as shown in site plan.
- Seed area with grass seed.

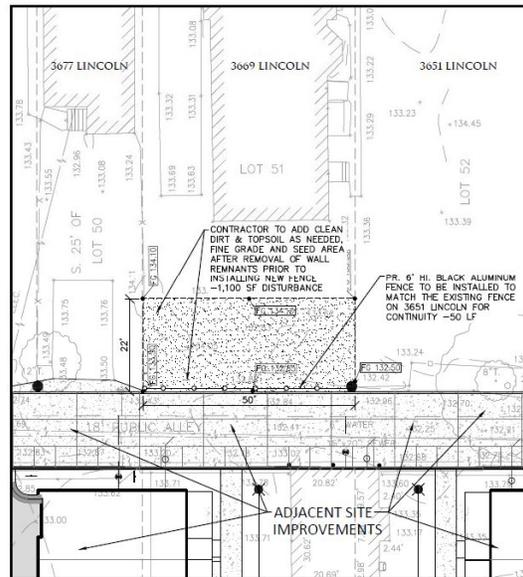
PROPOSED SITE PLAN

- Install 6' aluminum fence, painted black to match existing fence along alley.

Figure 2 by Applicant showing proposed work and location.

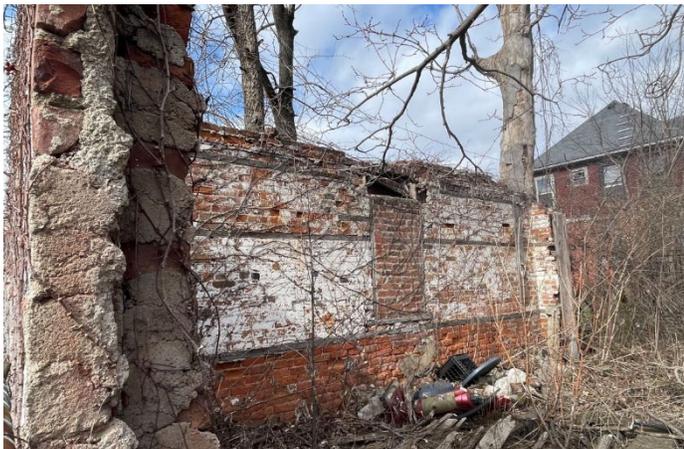
Site Photo 3, by Staff March 20, 2024: (Facing northeast) showing remains of north wall of the carriage house.

- While the carriage house was a contributing structure to the property and the historic district, at some point, it lost integrity necessary to convey its historic significance, because of its ruinous condition. Given the marginal contributing status of the current state, staff finds it is reasonable to approve demolition rather than require a complex and expensive repair. Demolition of a contributing structure that has lost its historic integrity due to catastrophic damage would meet the Standards. (See also attached document *National Park Service Best Practices Review “Evaluating Garages and Outbuildings in Historic Districts”*.)

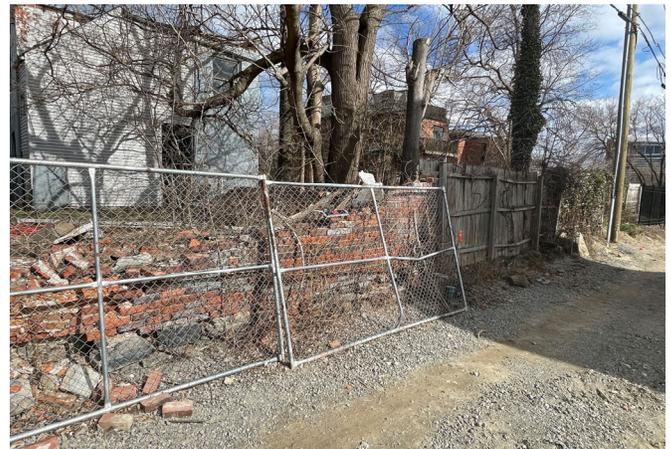
Site Photo 4, by Staff March 20, 2024: (Facing southeast) showing existing conditions of carriage house/brick wall ruins along the alley.

- It is staff’s opinion that the garage’s structure is severely compromised, and the building has lost its historic integrity. Given these conditions, staff finds it reasonable to approve demolition.
- Staff have no issues with the proposed remaining work in this application.

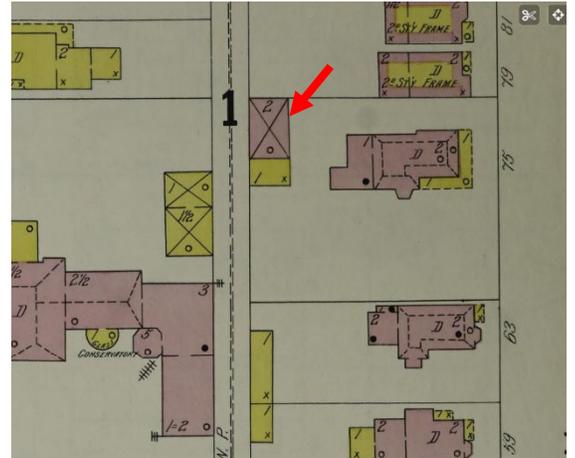
Figure 3 by 1897 Sanborn Vol 2, Sheet 107, showing original carriage house (arrow).
