Edward Palmer
15004 Warwick St.
Parcel#27163044
Historic District:
Rosedale Park, Detroit, MI

To the Historic District Commission:

Photos

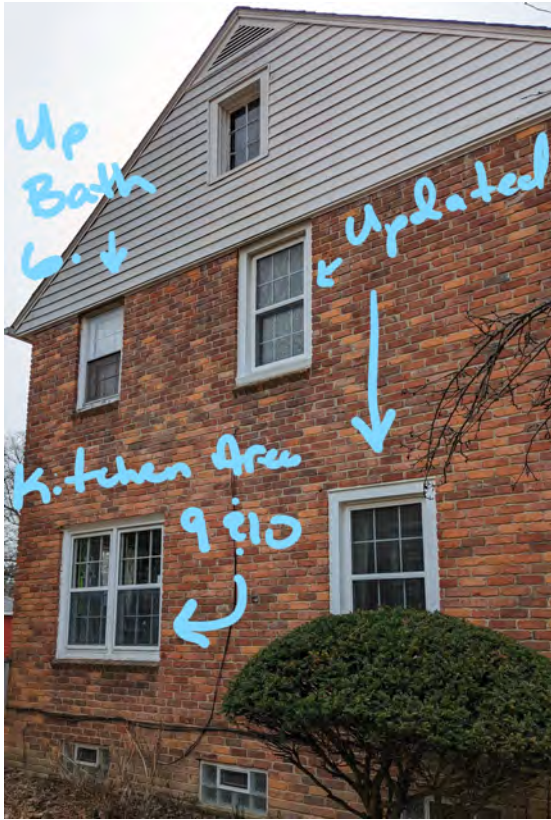
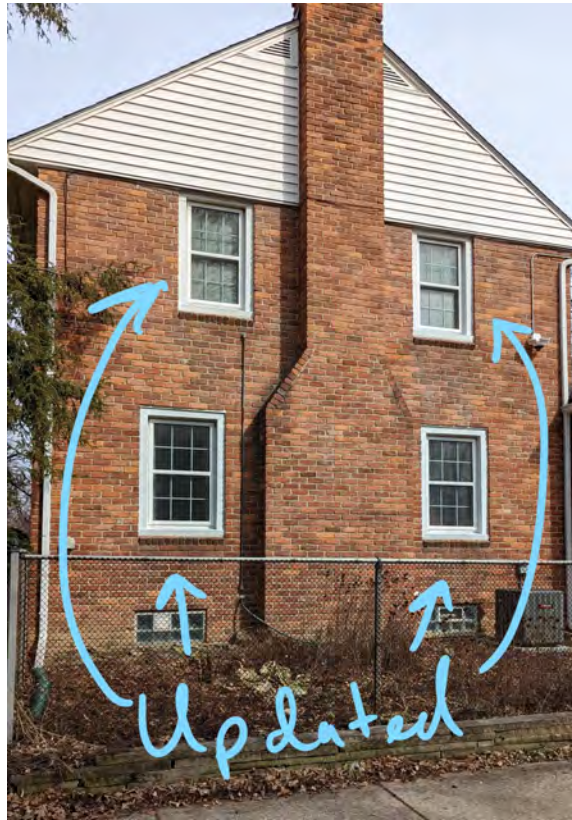
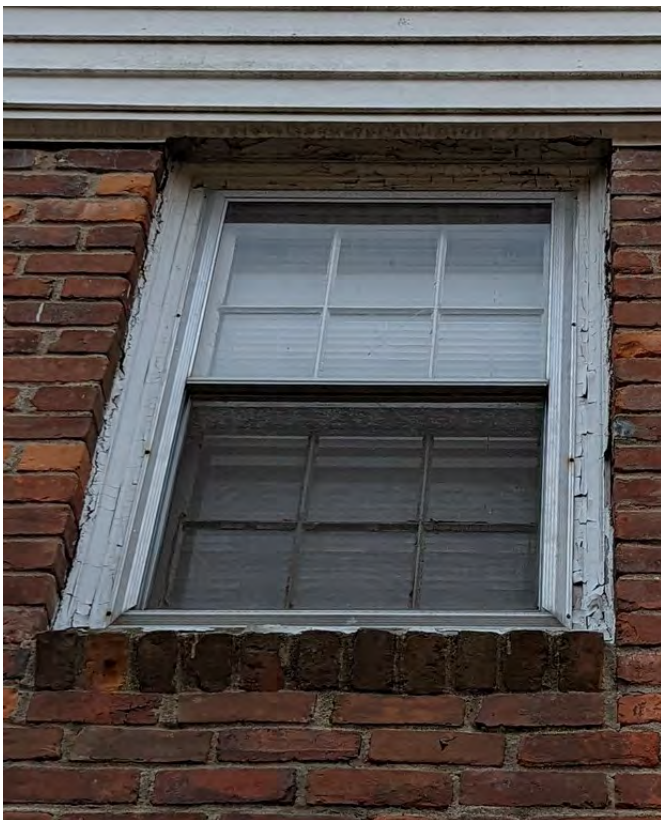
6. Bathroom Window
Has major chipping of paint. Caulking pulling away from brick exterior. single pane glass with bad glazing. No glass storm for lower 1/2. Condensation that pools on interior as seen in the detail picture to the right.

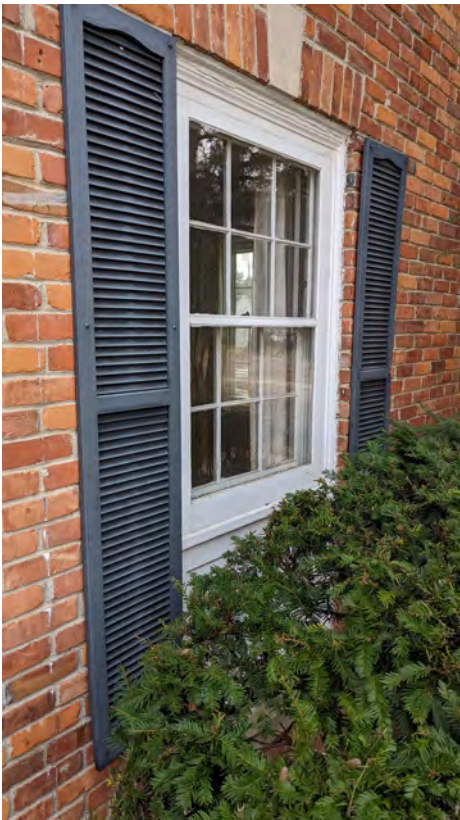
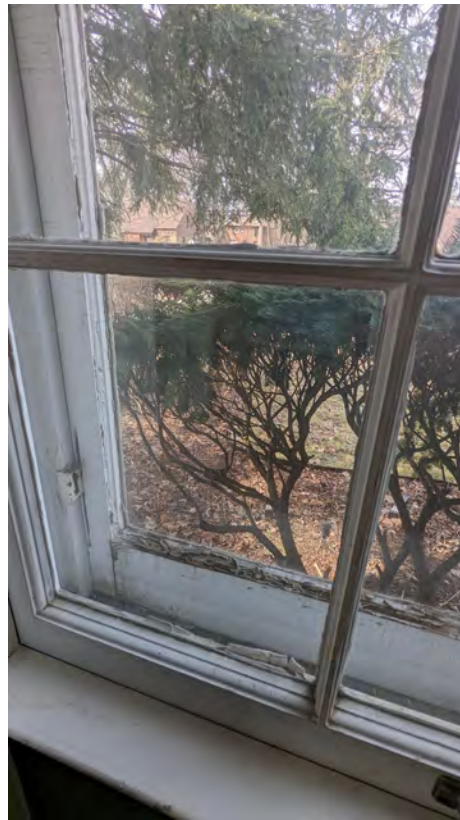
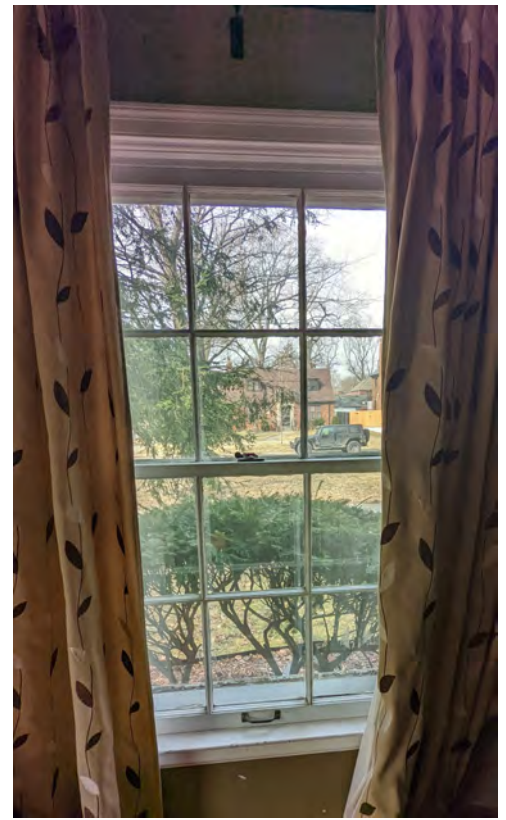
2. Dining Area Exterior, Dining Area Interior, and Dining Area Interior Detail (L to R)

In this set of 2. Dining Area Window photos to the left you will notice the third style of storm window. There is only 2 of this style of storm in the home, here and found in the Living Room. These windows have shown very little moisture on the interior sills. I would attribute this in all most likely hood to have had caulked the storm shut when I repainted the exterior.
