STAFF REPORT: APRIL 10, 2024, REGULAR MEETING

APPLICATION NUMBER: HDC2024-00100

ADDRESS: 762 SEMINOLE

SCOPE: RECONSTRUCT PORCH

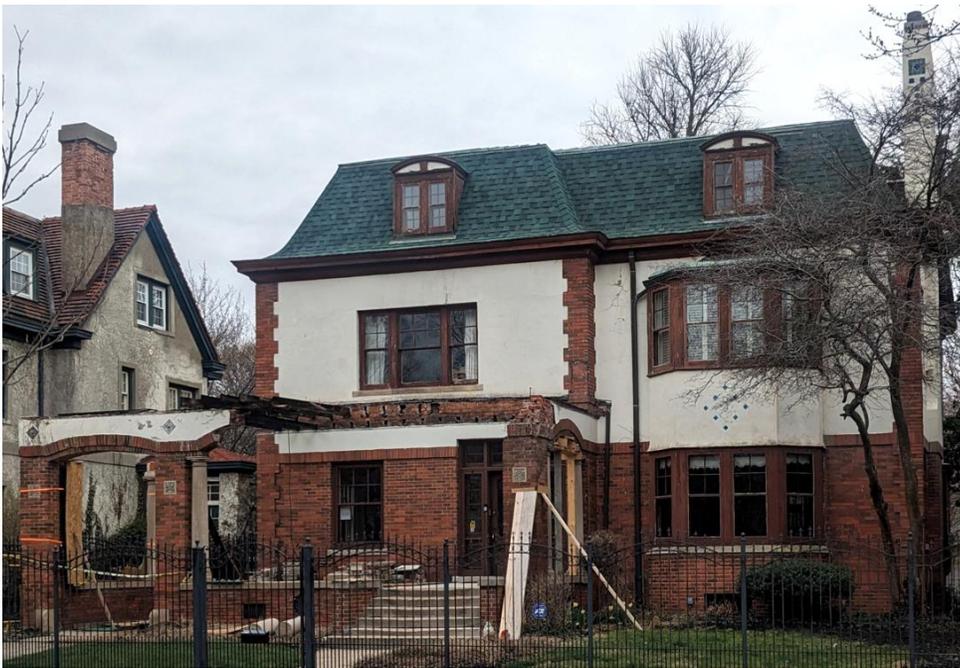
House at 762 Seminole. March 2024 photo by staff.

The building at 762 Seminole, built in 1908, is a two-and-one-half story house facing east onto the street, on the southernmost block of the Indian Village Historic District. Features including its flared Mansard roof, stucco cladding with prominent brick quoins, and arched, flat-roofed, columned porch place it within the French Eclectic style—an uncommon style in Detroit, even in the architecturally diverse Indian Village. Decorative tiles on the porch, bay window, and chimney are also important features.

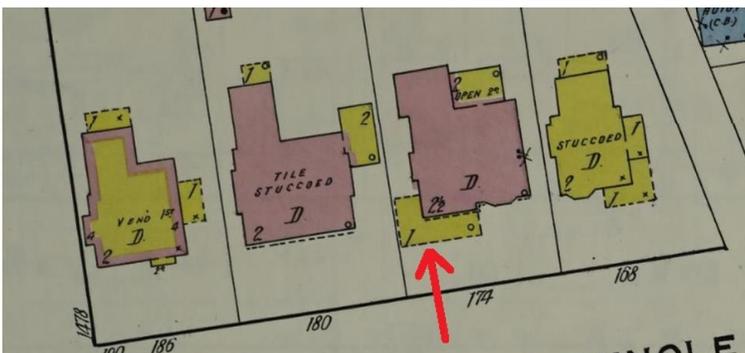
Subject property shown in 1951 Sanborn map; arrow added by staff to indicate porch.

- Staff concludes that the porch is almost certainly an original feature of the building.
 - A Sanborn map (see page 1 of this report) shows a historic porch with the same footprint. Although the yellow shading of the porch might be interpreted to indicate frame construction, staff observed that other masonry porches in the same edition are also colored yellow; it appears that the convention was to color porches yellow regardless of construction.

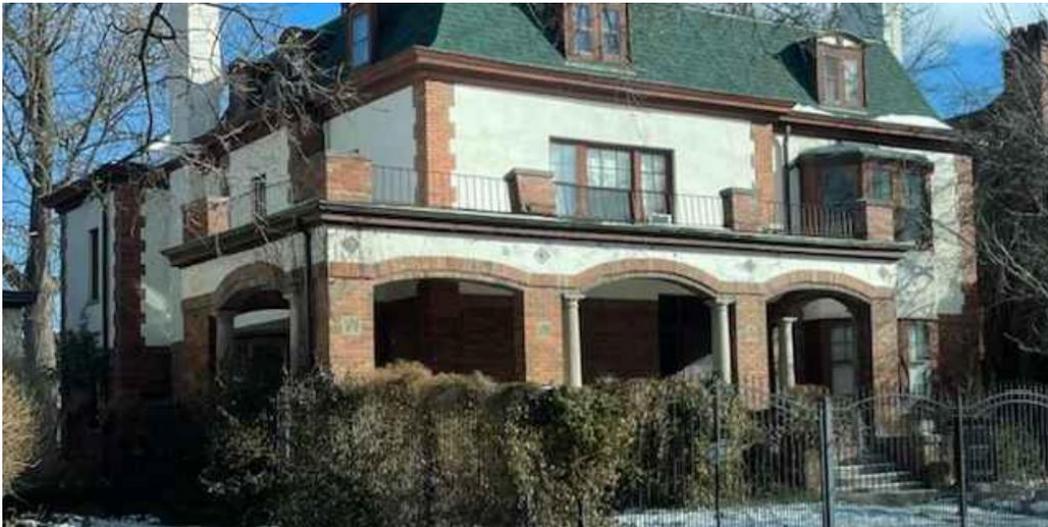
Subject of this application, the porch largely collapsed in 2023. Prior to the collapse, it was topped by a metal balustrade anchored by brick piers.

The porch in 2022. Image from application documents.

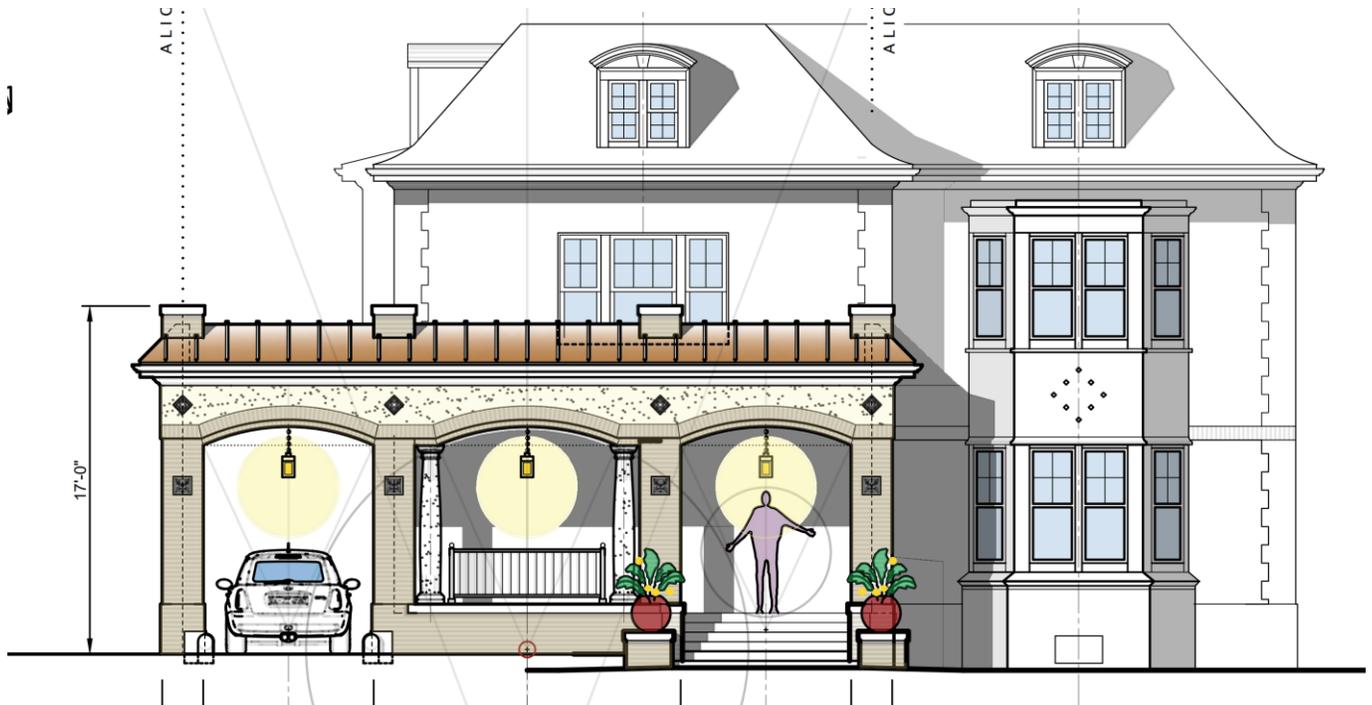
West elevation of proposed work. Image from application documents.

The applicant proposes to reconstruct the damaged porch. The proposed work would largely restore the condition of the porch prior to the 2022 collapse; however, the metal balustrade would be eliminated. In its place, a sloped, hipped, standing-seam copper parapet would be added. Behind the parapet, the roof would step down to an EPDM flat roof.

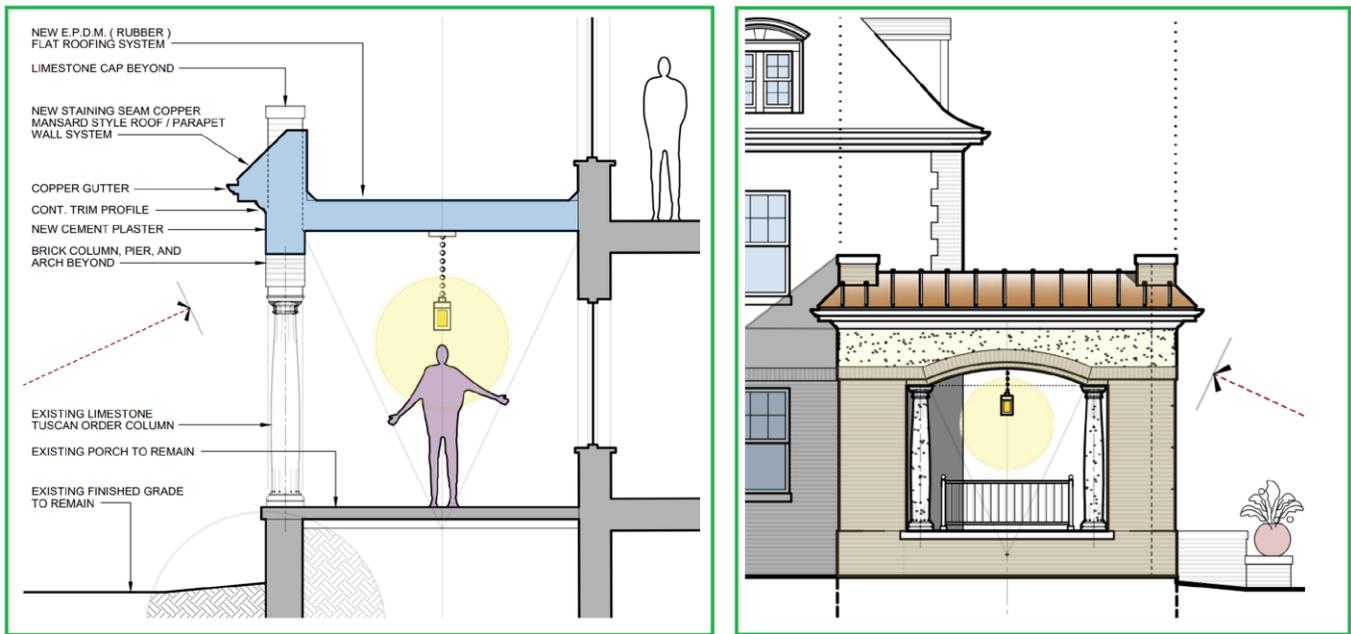
Left: Section of proposed work showing EPDM flat roof area and relationship to second-story window. Right: North elevation of proposed work. Note light fixture, balustrade, and plant shelf. Images from application documents, cropped by staff.

In addition to the parapet, the proposed work would add new features to the porch. Three hanging light fixtures would be added. On the lower level, A new balustrade would be added to each (north and south) side of the lower level and to the central bay of the front (west) elevation. Adjacent to each of the porch’s wingwalls, a plant shelf would be added.

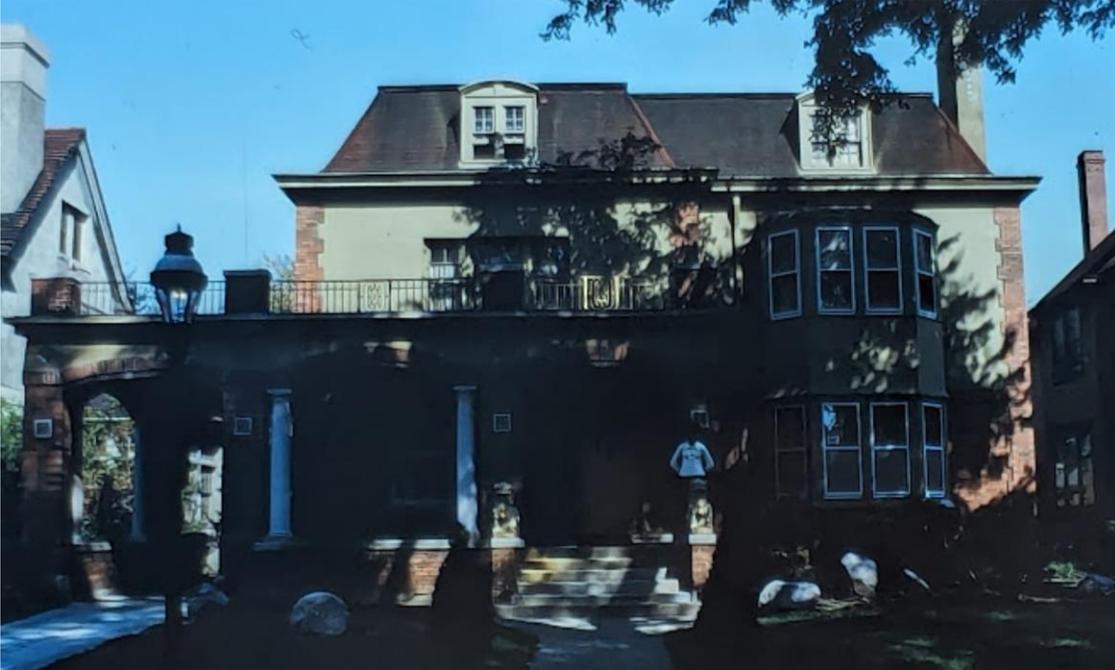
1978 Historic Designation Advisory Board photo.

- A 1978 photo by the Historic Designation Advisory Board shows what appears to be an original, cast iron balustrade, with decorative panels centered on each bay. The apparent age and style of this feature suggests that the porch is original. (The feature was removed prior to the 1980 photo).

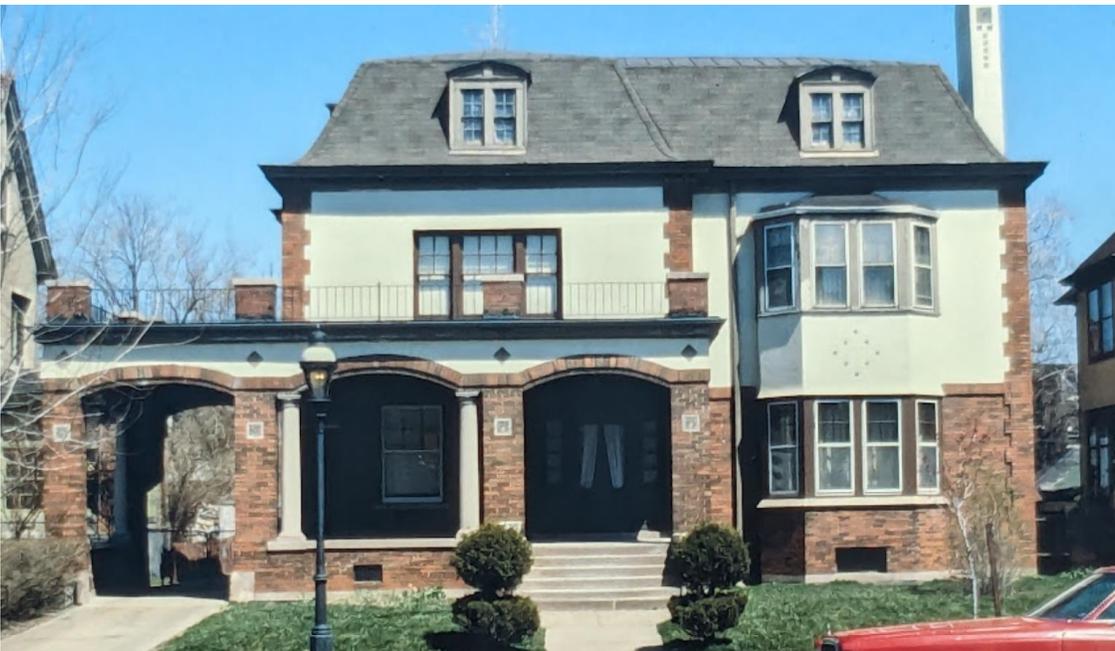
1980 Historic Designation Advisory Board photo.
